Confidential Inspection Report

**424 Wattle Tree Road
HOLGATE, NSW 2250**

October 26, 2021

VISUAL TIMBER PEST INSPECTION REPORT as per AS4349.3-2010

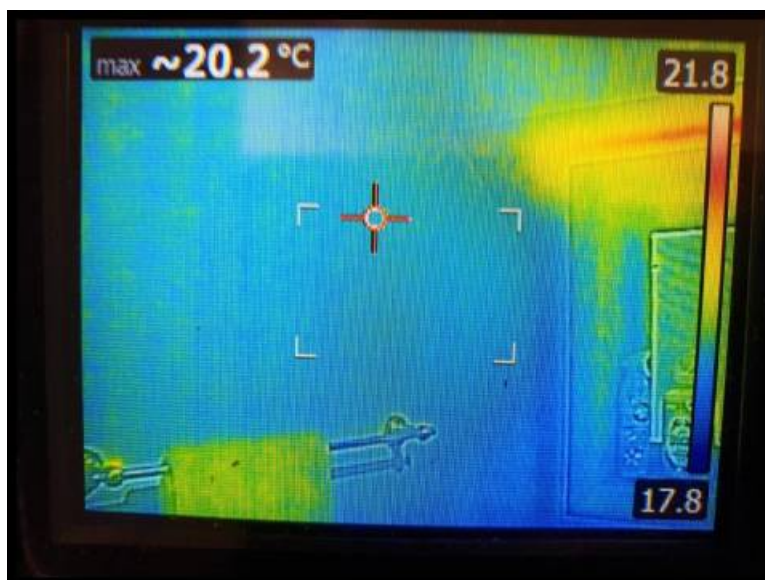
Thermal Imaging: Bathroom downstairs.

Thermal imaging has been carried out on internal unfurnished wall surfaces.

Thermal Imaging indicates a normal reading for hot and cold wall/ceiling temperatures. Blue indicates cold areas, Red to White indicates hot areas.

If there was active termites the reading would show 27-33 degrees and white to red in colour.
