Inspection reference: 592B

# Confidential Inspection Report

**308 Matcham Road  
MATCHAM, NSW 2250**

October 13, 2022

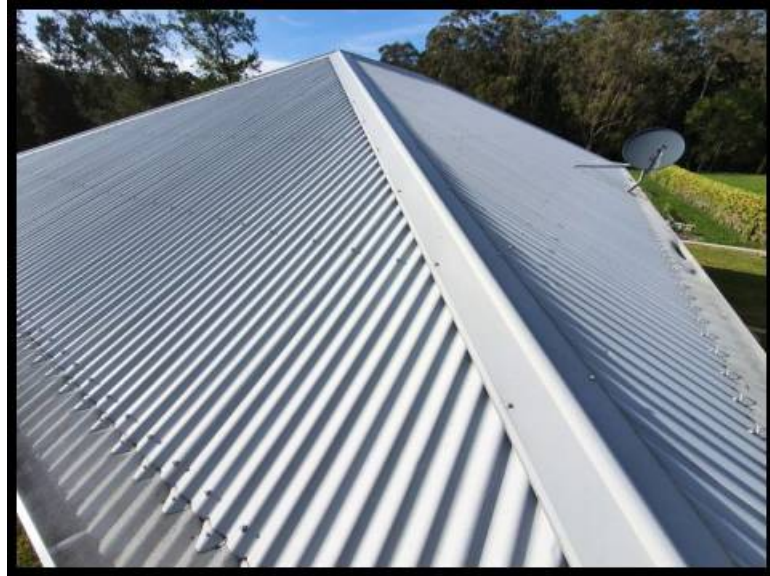
The roof is of pitched construction.

The overall condition of the roof coverings appear good.

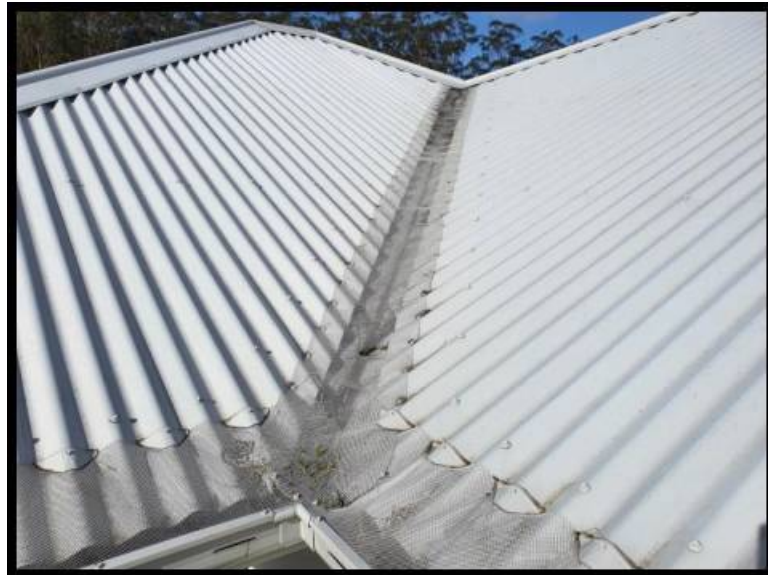
Gutter Guard present, some repairs are recommended.

The overall condition of the valley metal appears good to visible and accessible areas.

Gutter Guard restricted full visual inspection of the valley material, defects may be present and not detected.

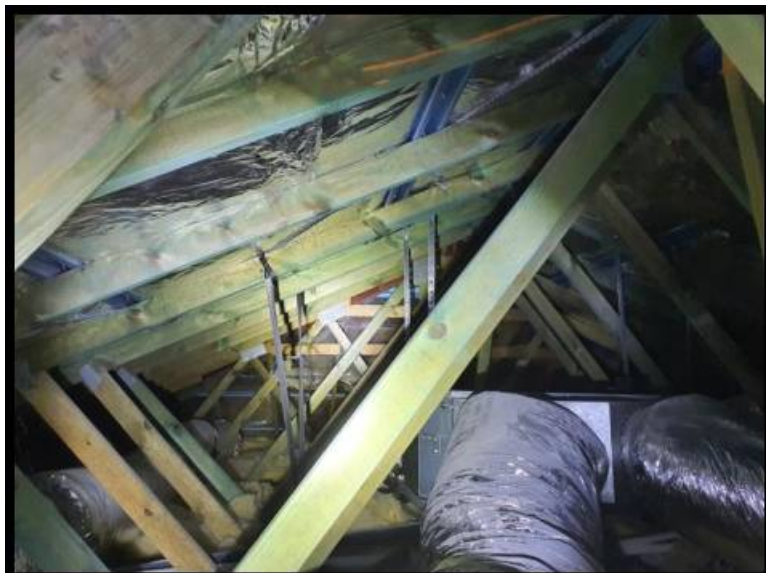
The truss roof system appears adequate for the roof covering.  
It is outside the inspectors scope to determine the engineering suitability and or truss design for roof loads and spans.

Species Type: Treated Radiata Pine Construction.

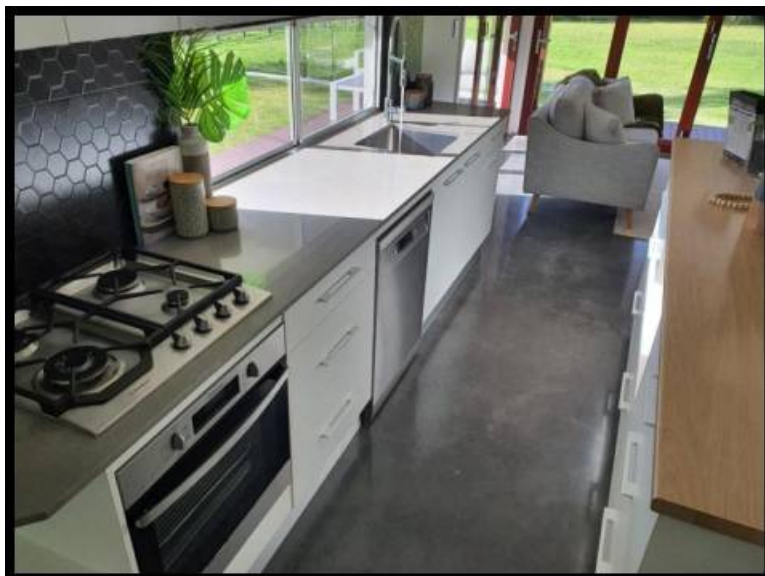
The sink and taps appear to be in a serviceable condition.  
The drain appears serviceable.

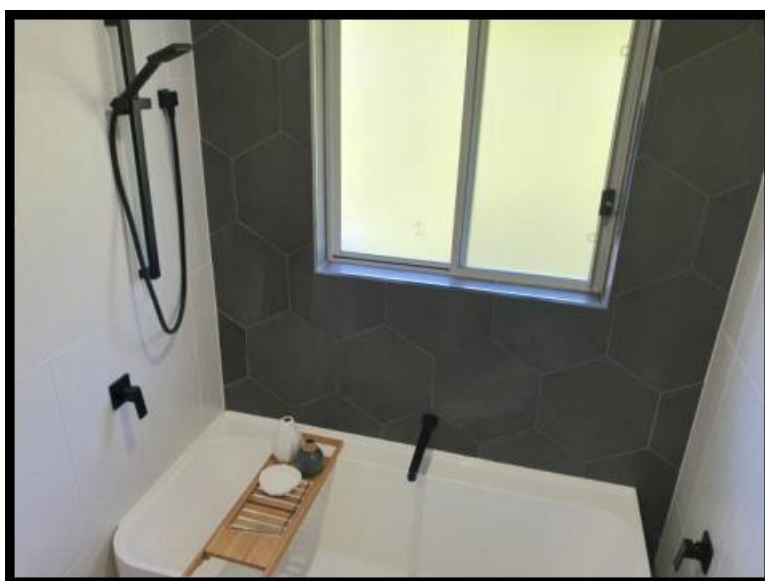
The shower located over bath is in good condition.  
Drain appears serviceable.

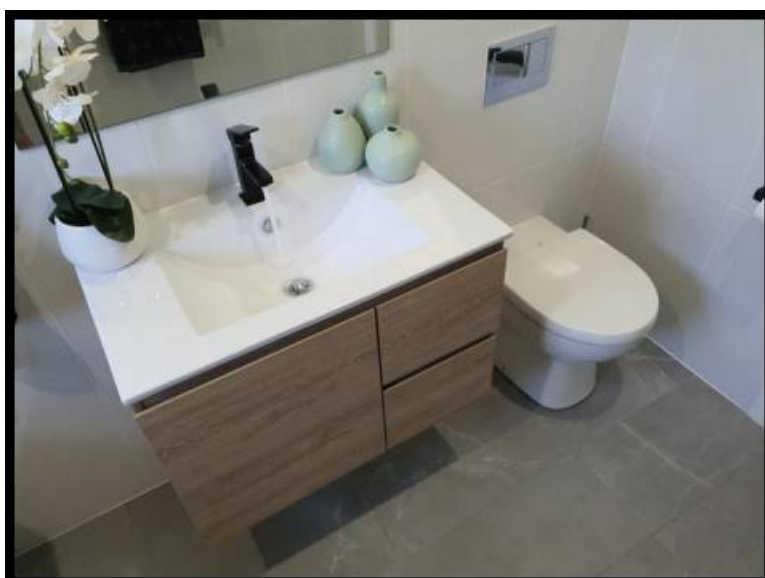
The basin/ taps and drain appear serviceable.

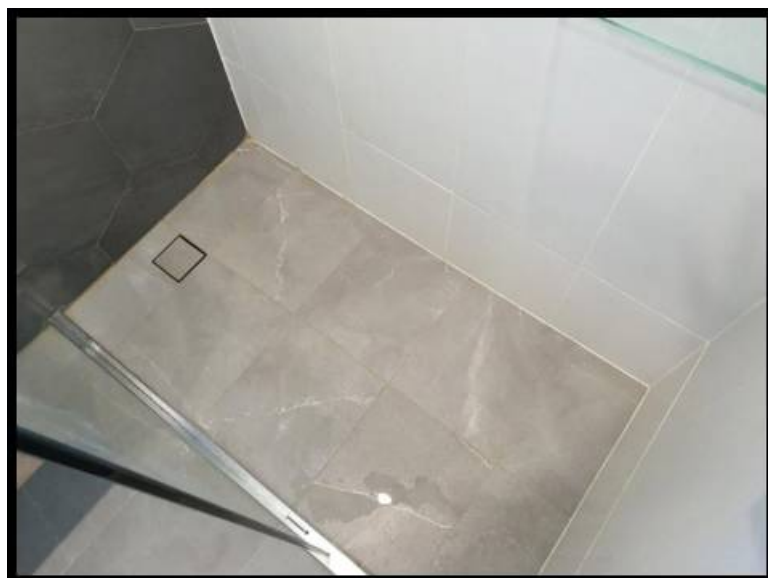
The shower recess was tested and there was no visible water penetration to surrounding areas.  
**IMPORTANT NOTE:** This test may not reveal water leaks until the shower is put into constant use and surrounding areas monitored over a period of time.  
Drain appears serviceable.

Shower screens that sit directly on the tiles are at risk of leaks.  
The area will need to be kept well sealed to prevent water penetration to surrounding areas.

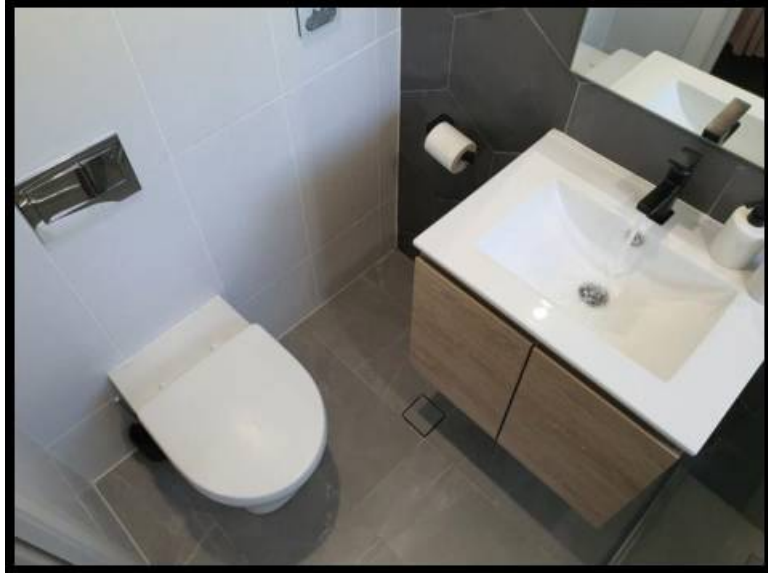
The basin/ taps and drain appear serviceable.

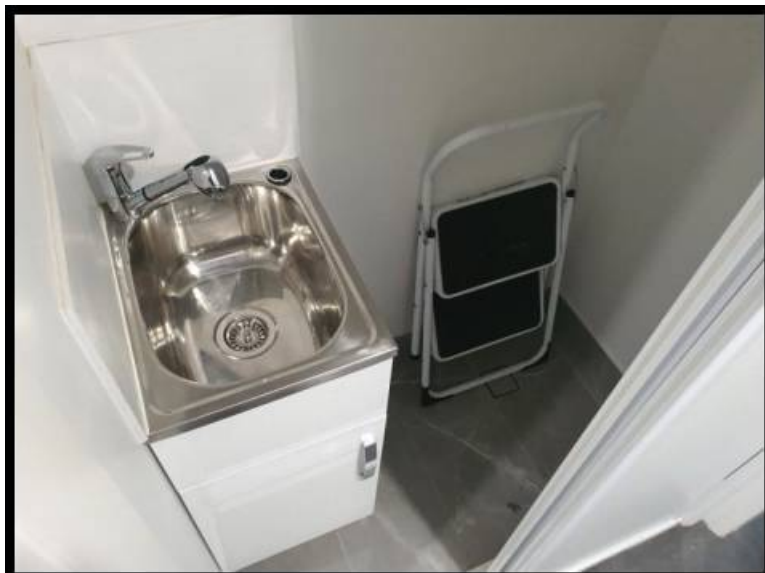
This area is generally in good condition for age of construction.

The metal tub/ taps and drain appear serviceable.

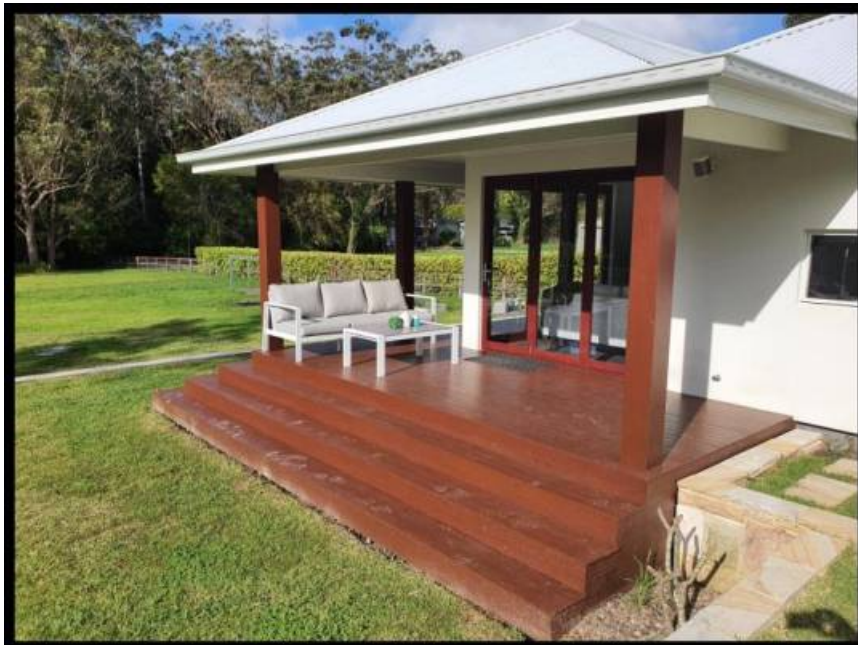
Front elevation.

The general condition of this structure is good for the age of construction. Constructed primarily from Timber.

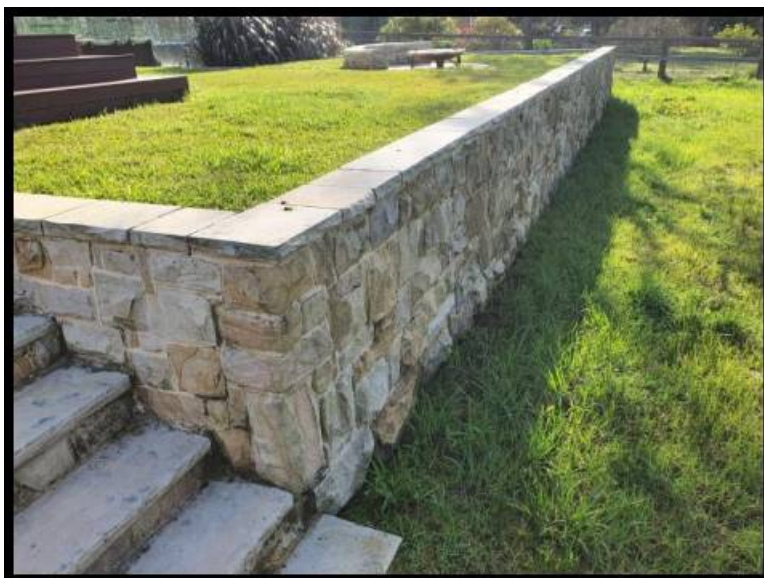
The retaining walls of blockwork construction are generally in good condition.

Any external retaining walls should be observed for any deterioration or subsidence, and inspected by a suitably qualified person to assess the condition and structural stability every 12 months.

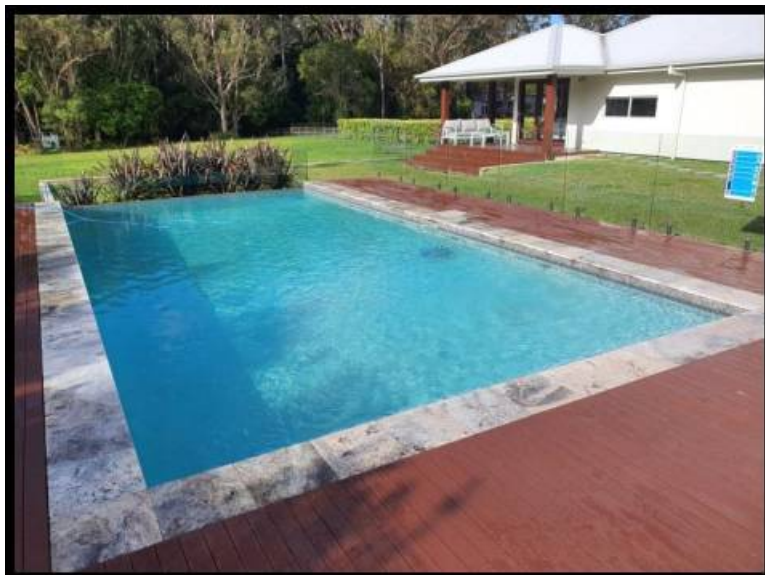
The timber decking to areas surrounding the swimming pool is in good condition.

Crawl space below the deck was limited due to the low method of construction resulting in a limited visual inspection from a distance being carried out.

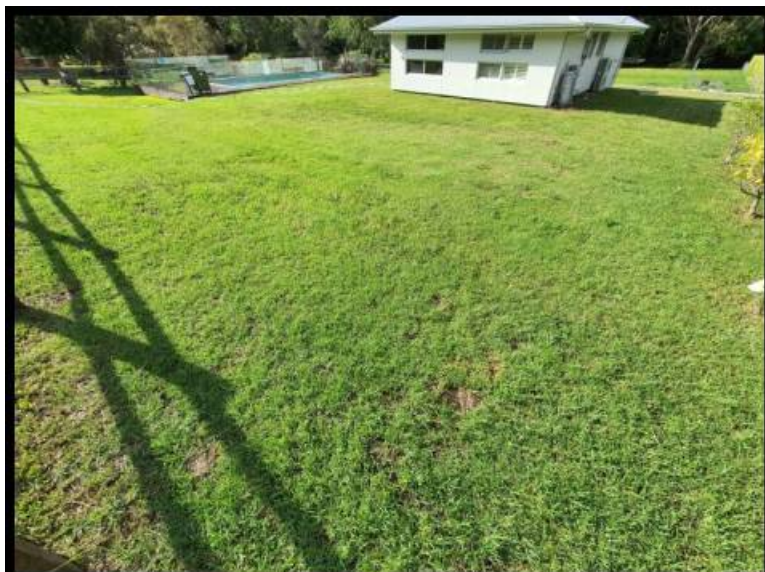
The drainage at the front of the property appears inadequate. As a result, evidence suggests that surface water has been ponding.

Poor site drainage can create unstable foundations that may have an adverse structural effect over time.

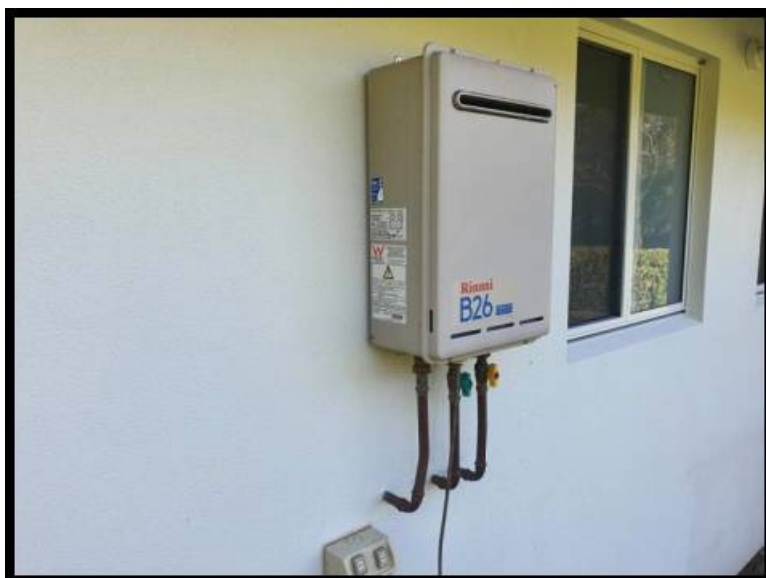
The hot water system appears to be in working condition.
