Inspection reference: 593P

## **Confidential Inspection Report**

**308 Matcham Road**  
**MATCHAM, NSW 2250**

# VISUAL TIMBER PEST INSPECTION REPORT as per AS4349.3-2010

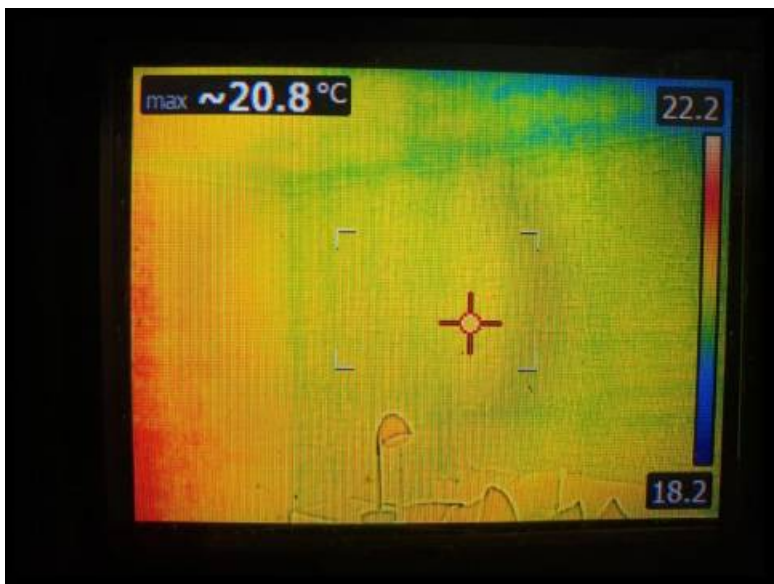
Thermal Imaging: Rear bedroom area

Thermal imaging has been carried out on internal unfurnished wall surfaces. Thermal Imaging indicates a normal reading for hot and cold wall/ceiling temperatures. Blue indicates cold areas, Red to White indicates hot areas. If there was active termites the reading would show 27-33 degrees and white to red in colour.
