**PRE SALE
STANDARD PROPERTY REPORT**

Report number: PPI202367

Inspection date: Wednesday 8th February 2023

Property address: 25 Yandala Place Clothiers Creek NSW

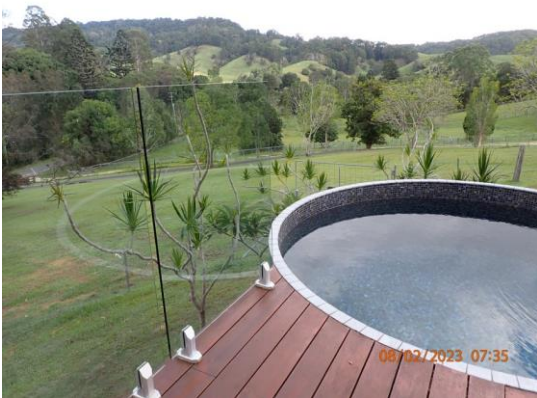
The handrail to the pool deck requires upgrading for safety reasons (see photo below). For advice and recommendations on handrails, please contact Tweed Shire Council.

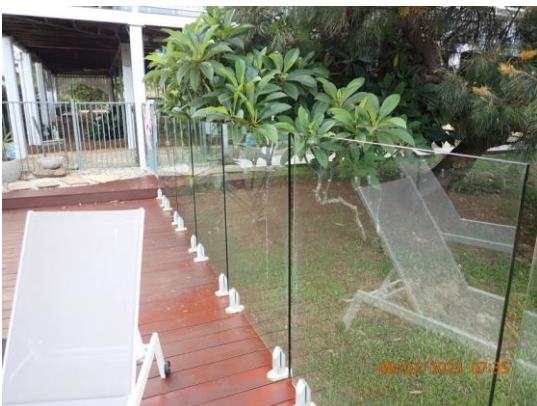
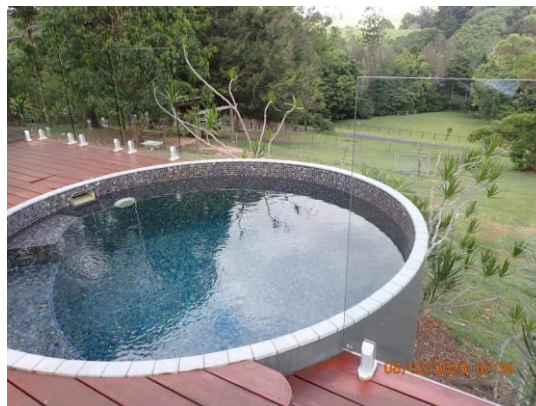
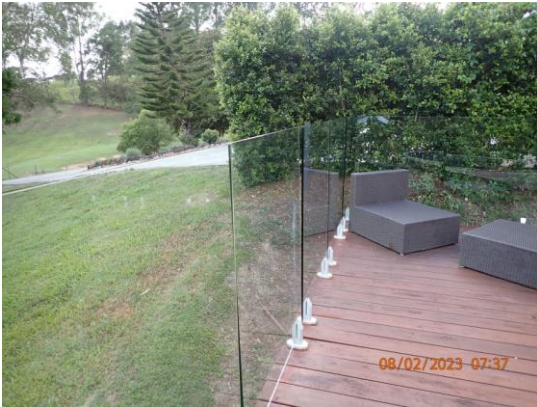
The pool handrail/pool fencing is loose and requires securing into position (see photos below)

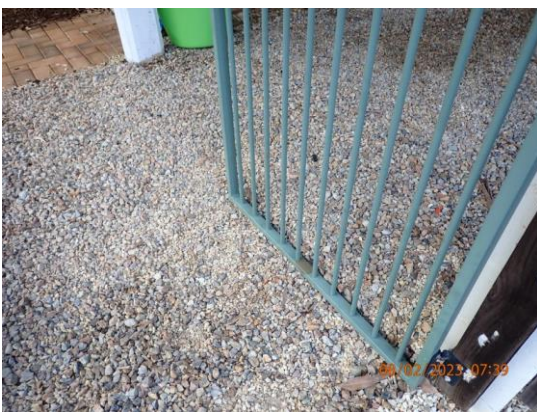
The pool gate is binding on the ground and requires adjustment, so it is self closing (see photo below)

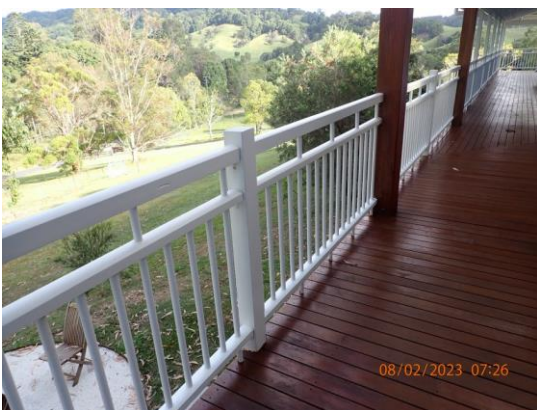
The handrail to the Verandah deck is loose and requires securing into position for safety reasons (see photo below).

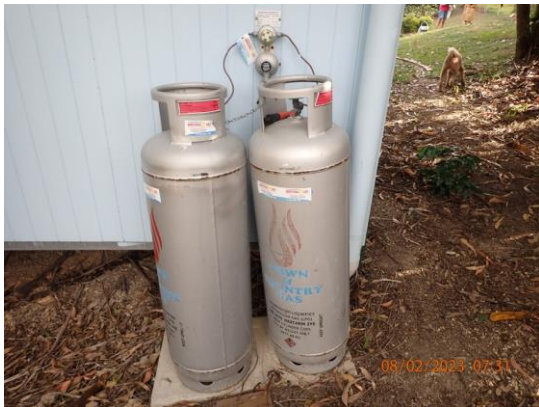
The gas bottles are leaning over and require stabilizing and releveling for safety reasons (see photo below)

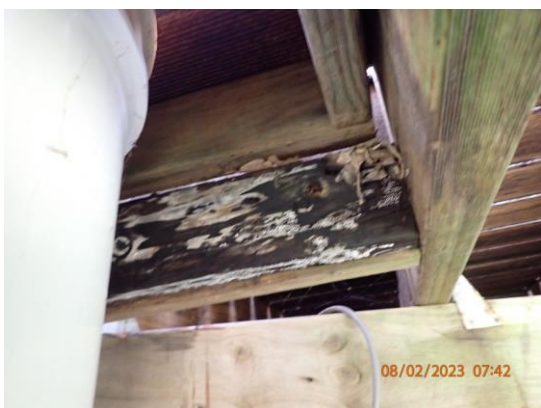
1

There is decay to the timber members of the pool deck in areas which requires repair and/or replacement where necessary (see photos below)

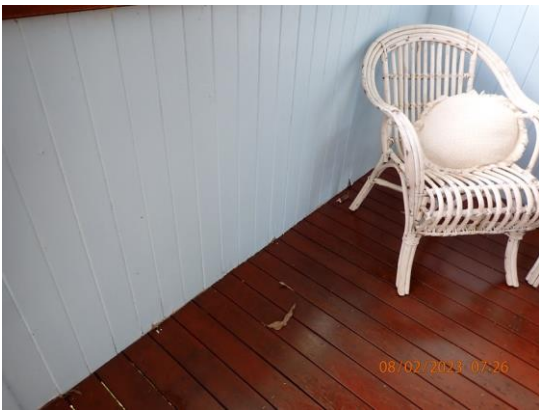
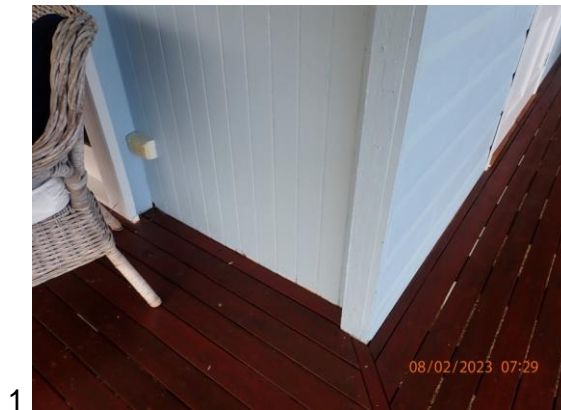
- There is blistering to the paint finish in areas (see photos below).

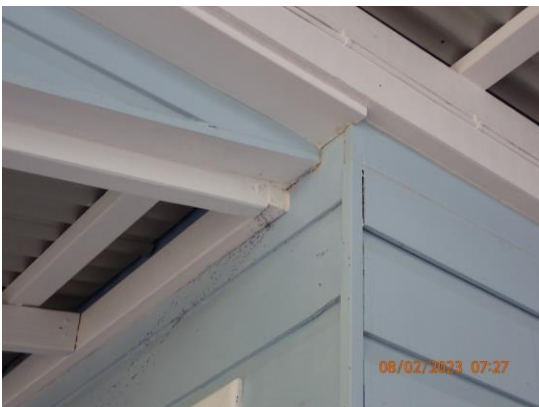
- There are stains to the weatherboards/roof junction which is indicative of a water leak (see photo below). There was no evidence of recent leaking at the time of the inspection. It is recommended that the affected areas be monitored to ensure there are no further leaks. If moisture becomes obvious, the leaks need to be located and repairs made to prevent premature deterioration of the building elements.

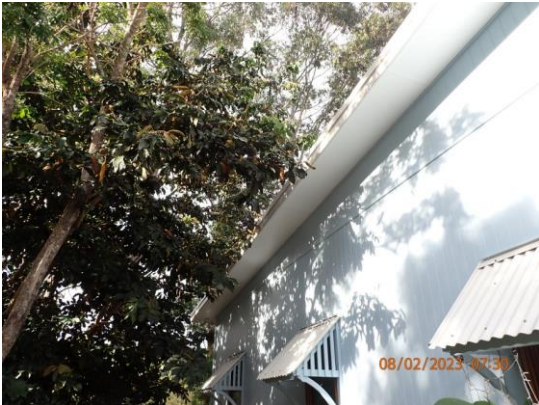
- The vegetation should be cleared away from the dwelling to prevent undetected access for termites into the dwelling as well as premature deterioration of some building elements (see photo below).

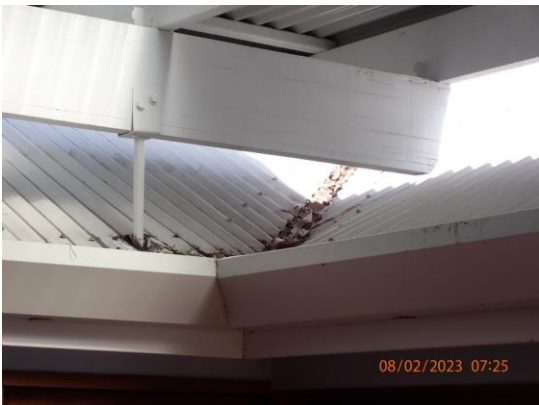
- All debris should be removed from the gutters of the Dwelling and Shed/Studio/Carport to allow water flow during times of rain and to prevent premature deterioration of the guttering (see photo below).

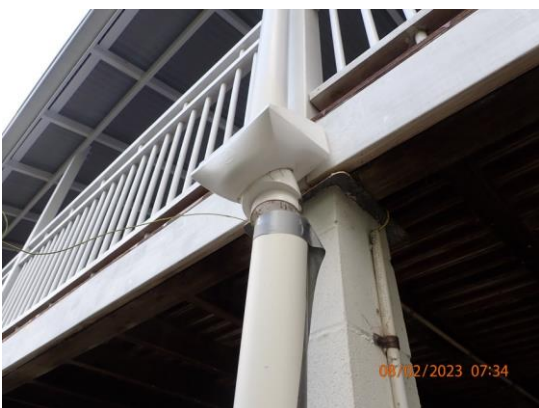
- The downpipe is coming apart and requires repair (see photo below).

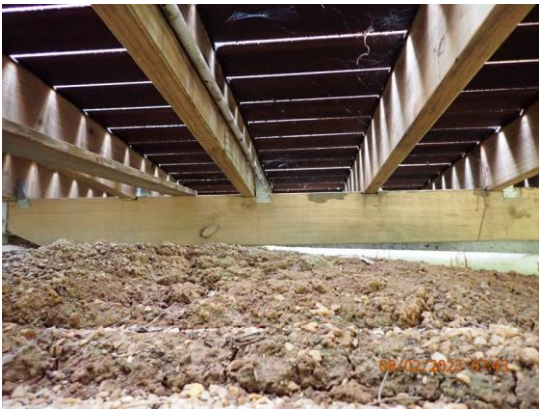
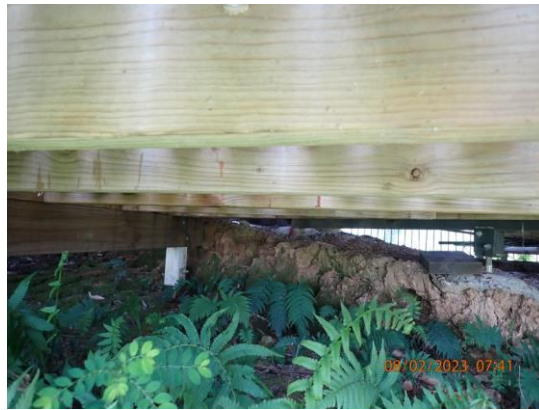
- There was limited access below the pool deck in areas for inspection due to its design (see photo below).

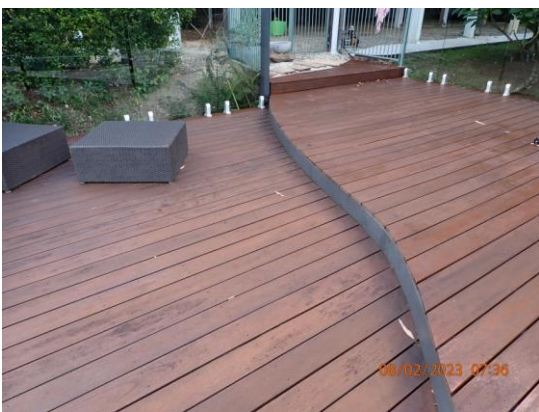
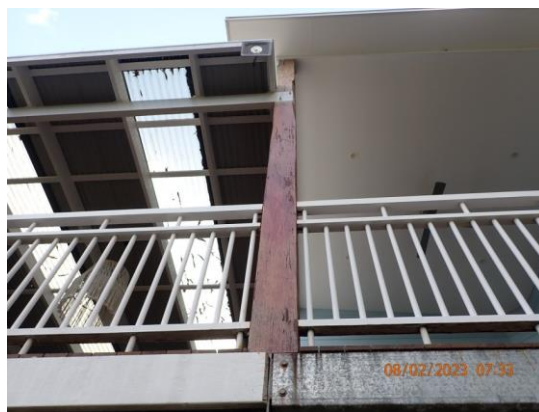
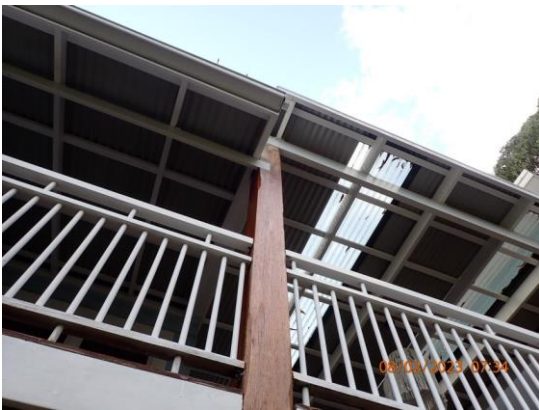
- There is evidence of weathering to the timber members of the pool deck and Verandah deck which require maintenance and treatment to prevent further deterioration (see photos below).

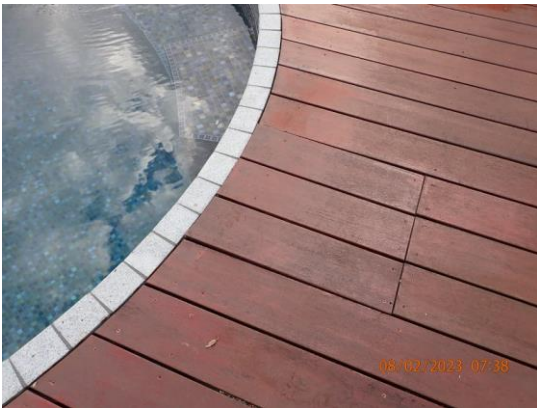
- The decking is uneven at the skimmer box lid which requires attention (see photo below)

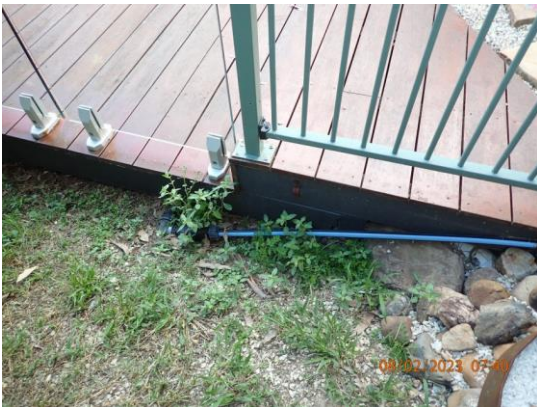
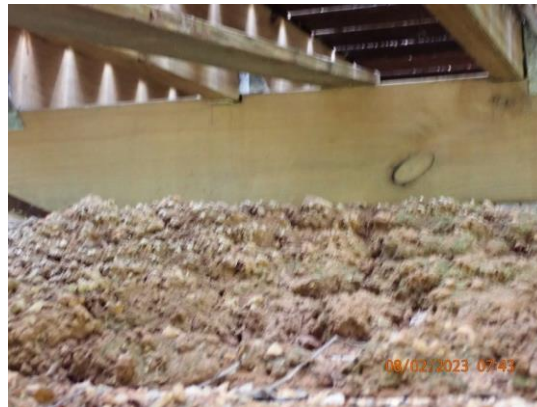
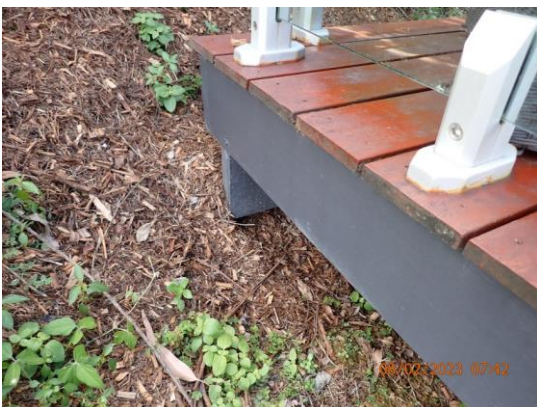
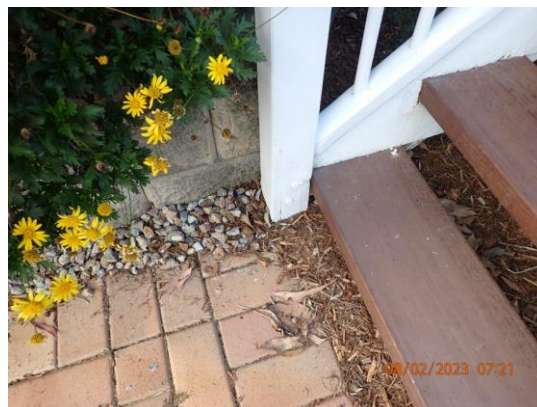
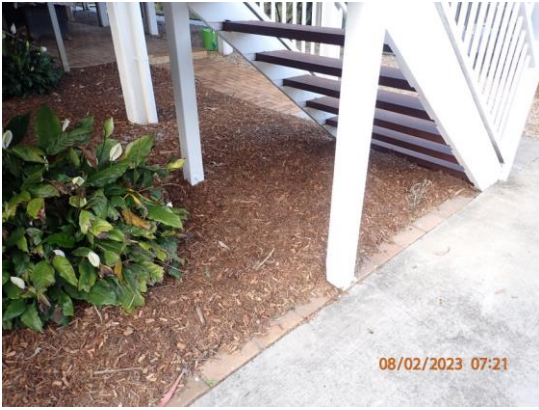
- The timber members of the decks are in contact with the ground and there should be a minimum clearance of 75 millimetres between the base of the members and ground level to prevent the undetected access of termites into the structure as well as premature deterioration of the building elements (see photos below).

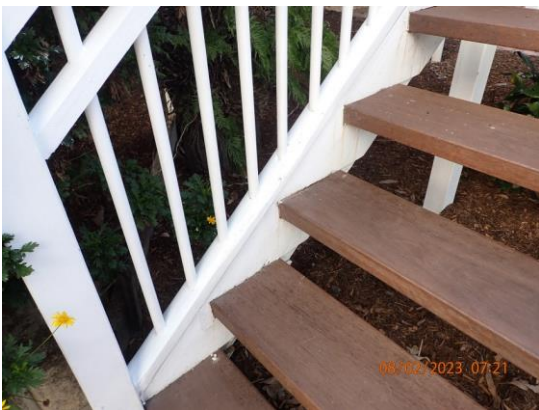
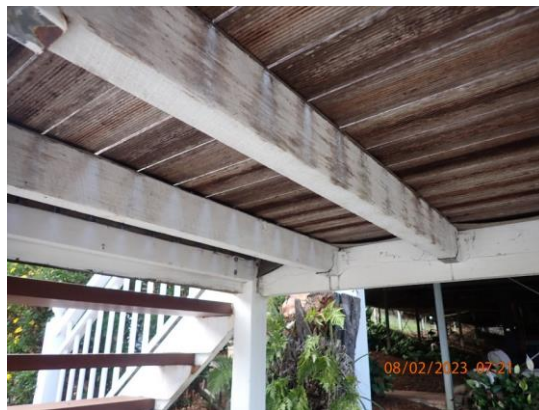
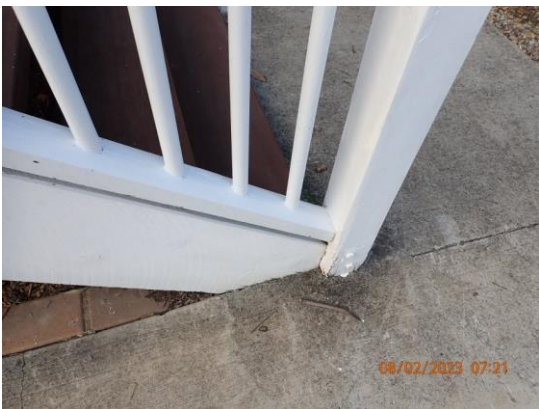
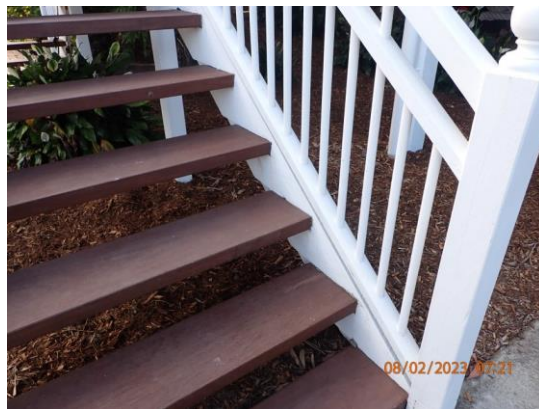
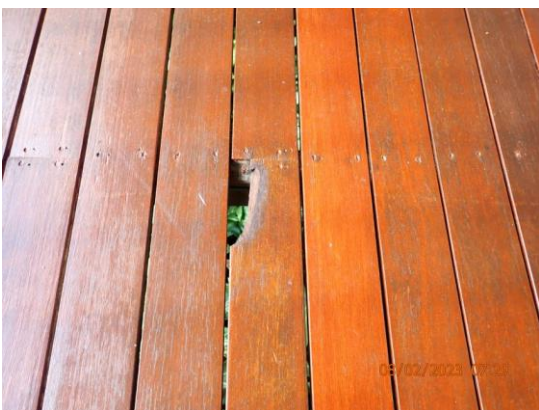
- There is evidence of weathering and decay to the timber members of the Verandah deck, which require repair, maintenance and treatment to prevent further deterioration (see photos below).

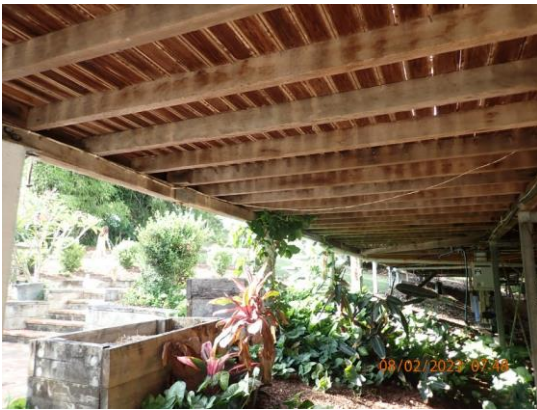
- There is deflection to the floor framing of the deck due to age and the building techniques used at the time of construction (see photo below)

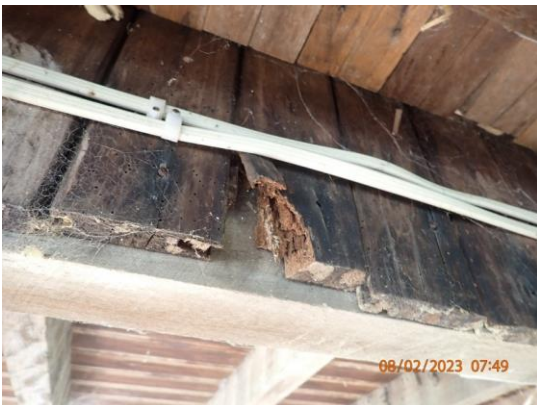
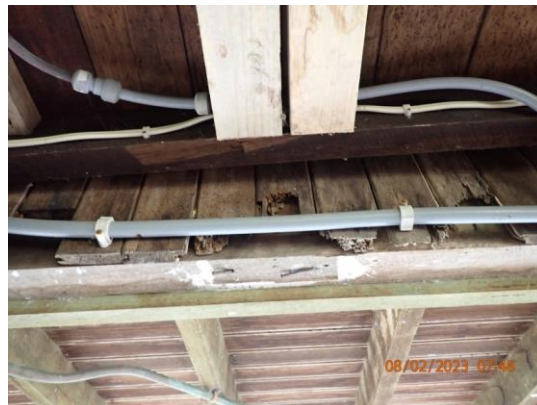
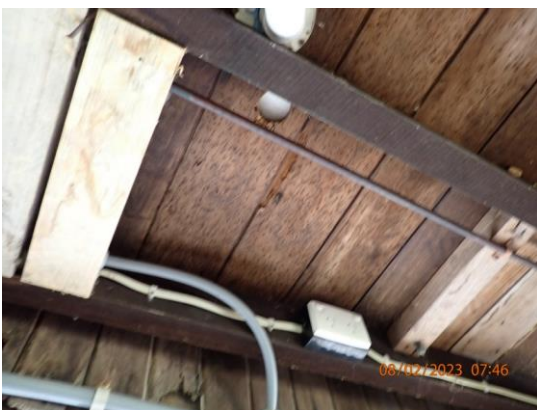
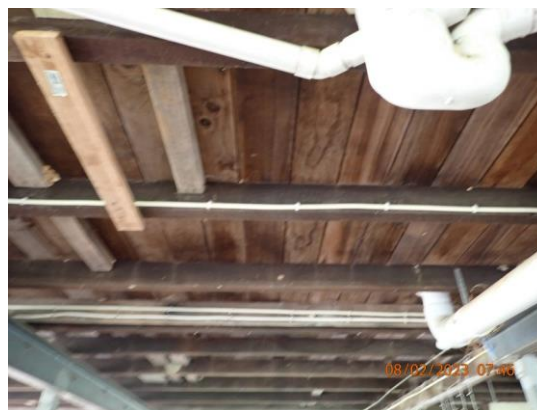
- There is evidence of decay and wood borer damage to the flooring and VJ lining which requires repair, maintenance and/or replacement where necessary (see photos below). It should be noted before sanding of the flooring, a section of floor should be tested to ensure there is no damage caused by wood borer.

- It is recommended that a Licensed Pest Control Operator be engaged to inspect, give advice and carry out eradication of the areas affected by the Wood Borer.

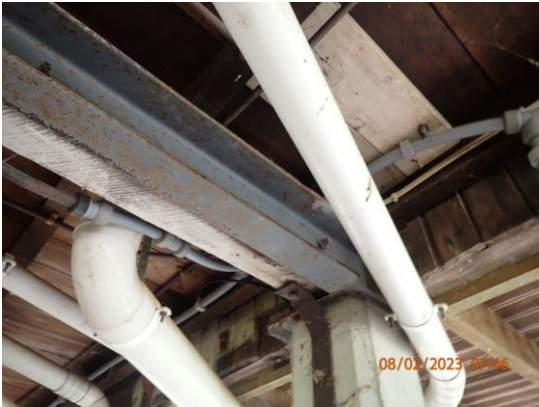
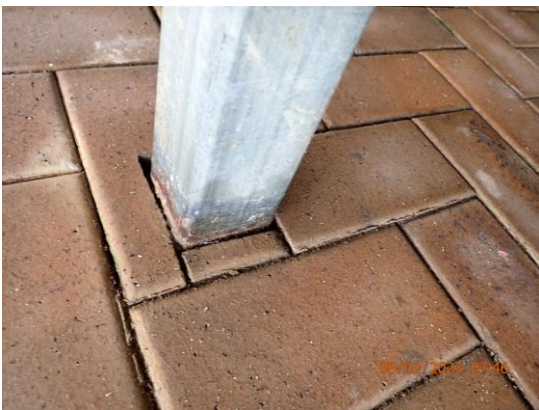
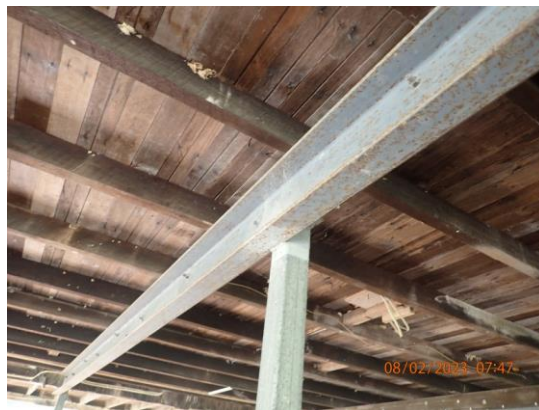
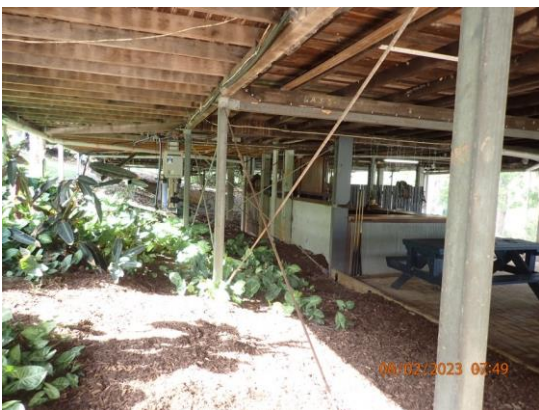
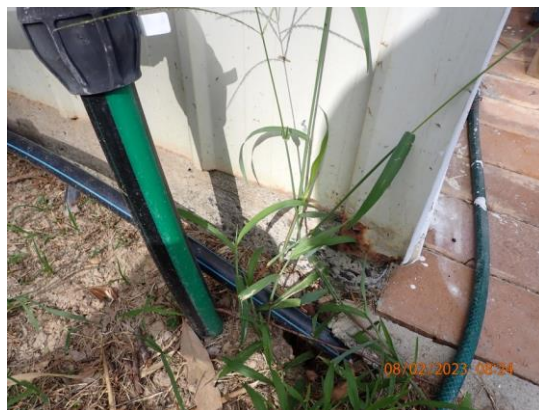
- There is rusting to the metal members of the sub floor (see photos 1 to 5) and cladding to the Shed/Carport/Studio (see photo 6) which require repair, maintenance and/or treatment with a rust inhibiting paint to prevent further deterioration.

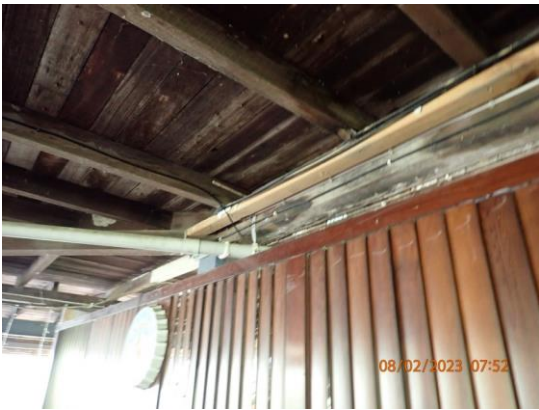
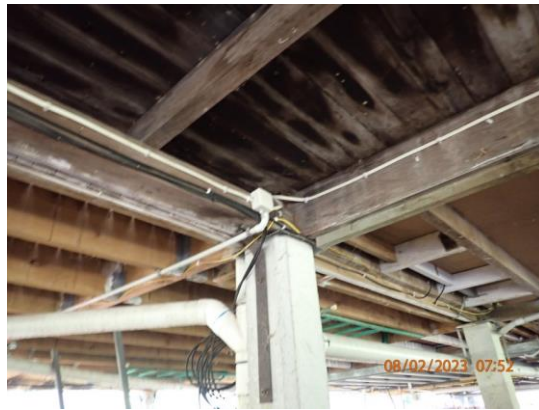
- There is decay to the timber members of the sub floor due to age and the building techniques used at the time of construction (see photos below)

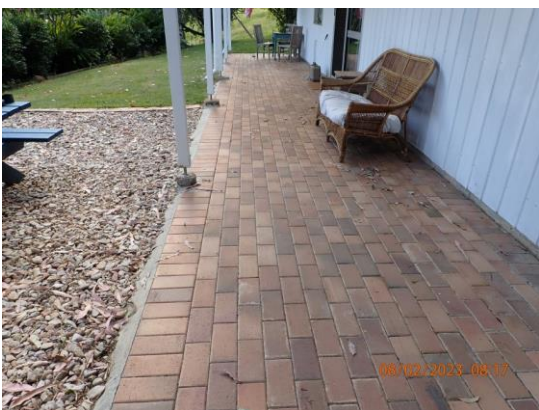
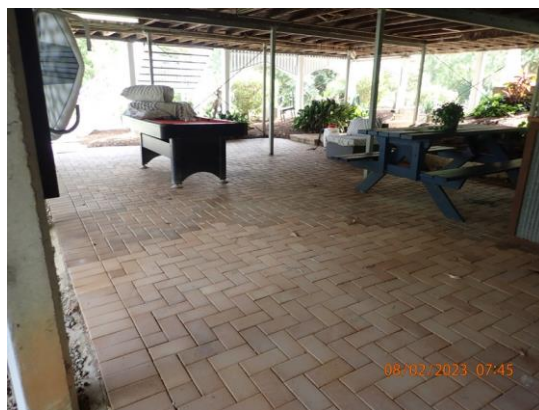
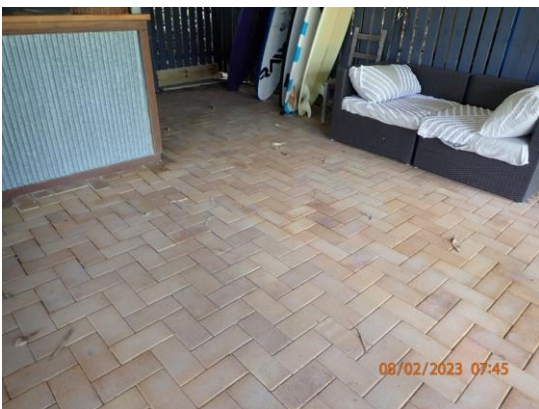
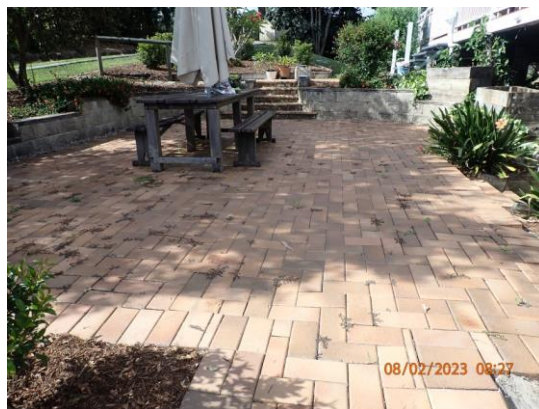
- There is settlement to the pavers which has caused the surface to become uneven and rectification works should be carried out on these areas (see photos below).

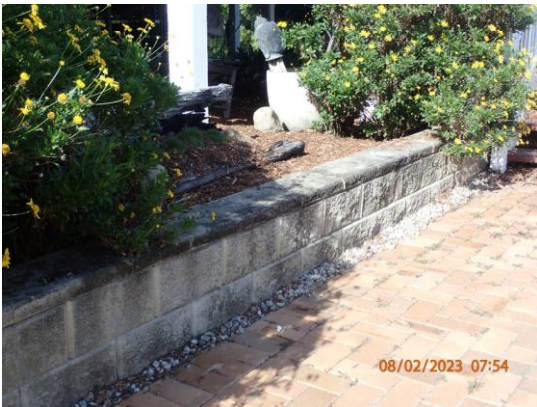
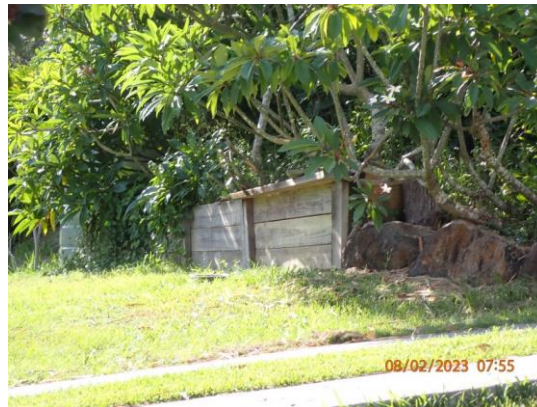
- There is weathering and decay to the timber members of the retaining wall which require repair, maintenance and treatment to prevent further deterioration.
- The garden block and timber retaining walls are leaning over in areas and require stabilizing (see photos below).

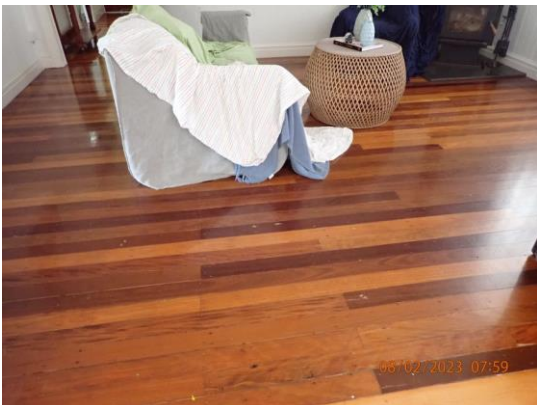
- Some of the windows and doors require repair and/or maintenance due to age and wear and tear.
- There are shrinkage gaps to the lounge room Tongue and Groove flooring due to timber shrinkage and age (see photo below).

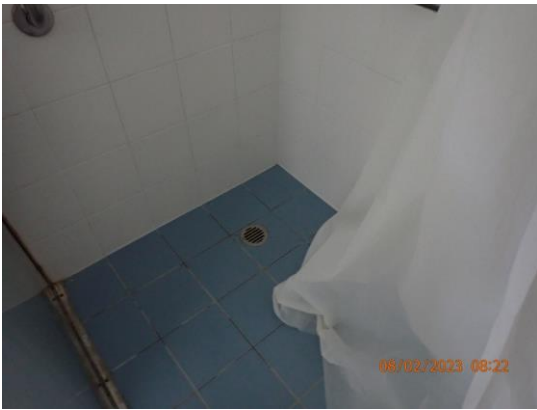
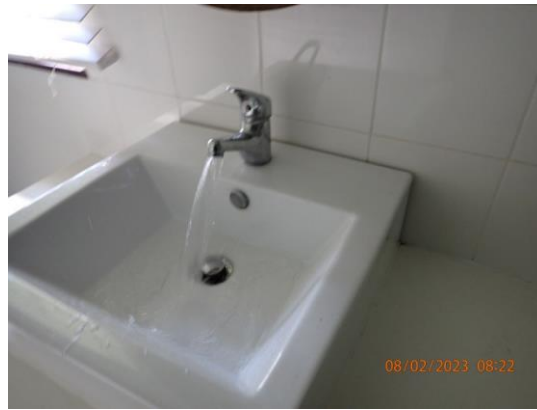
- The junctions in the Studio shower and around the vanity require sealing with a flexible sealant to prevent water build up behind the tiles or in the cavity (see photos below).

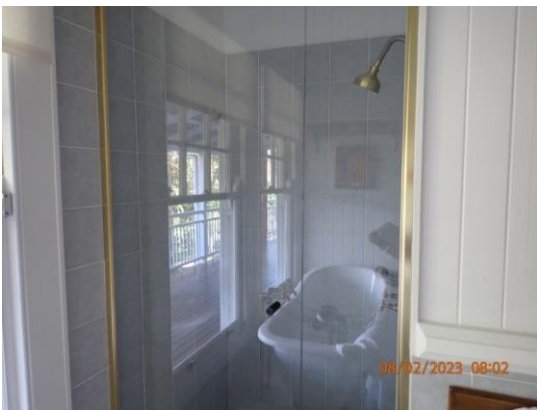
- Due to the design of Bathroom 1 frameless glass shower screen the water could come out of the opening when in use (see photo below).

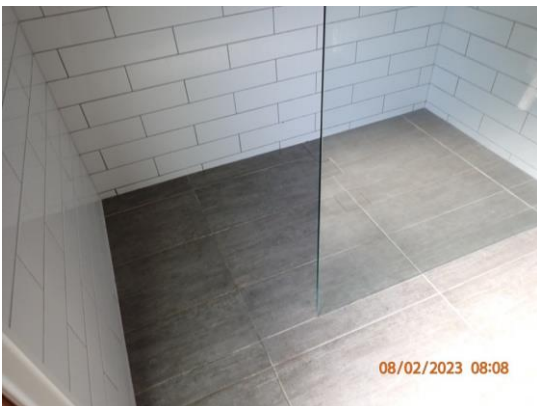
- Due to the design of bathroom 2 shower, water could come out of the opening when in use (see photo below).

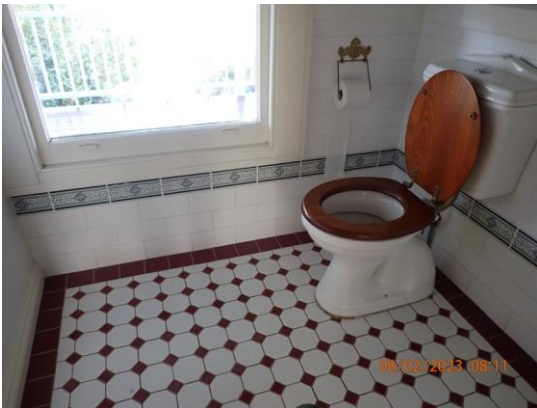
- There are drummy, loose wall tiles to toilet 2 which require refixing where necessary (see photo below).

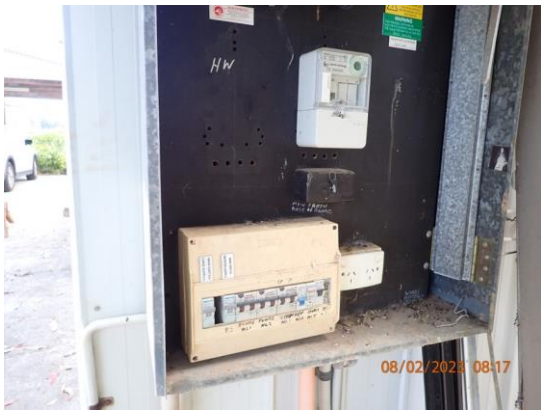
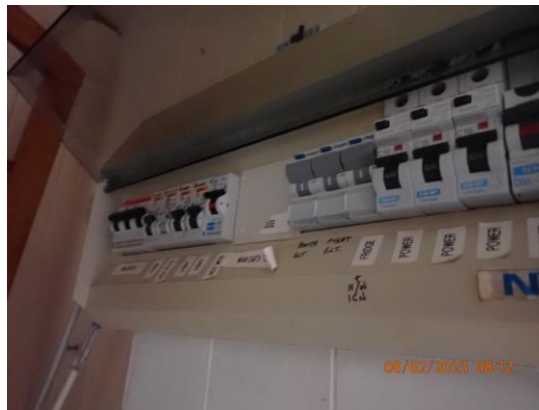
Safety switches have been provided to the meter box and sub board of laundry 2 (see photos below). It is recommended that a licenced electrician be engaged to inspect and check the operation of safety switches and electrical circuits.

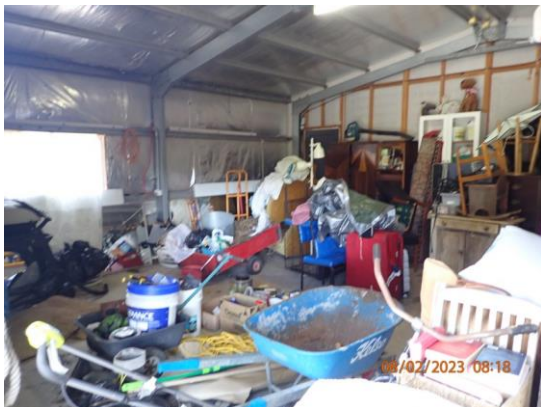
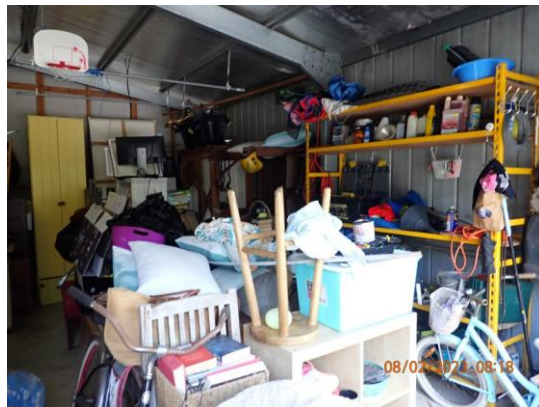
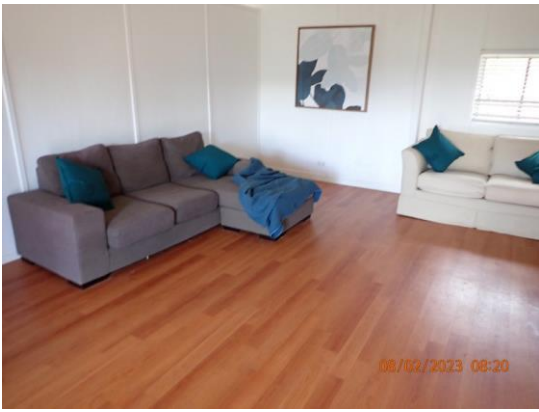
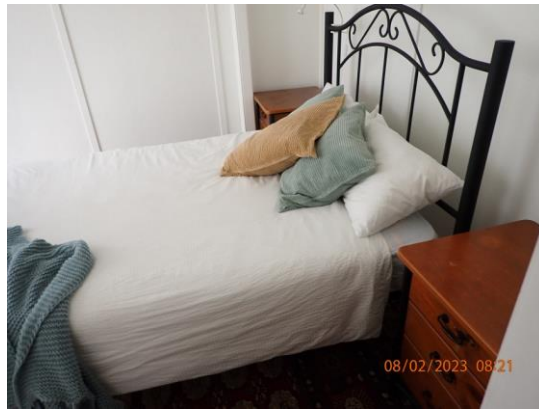
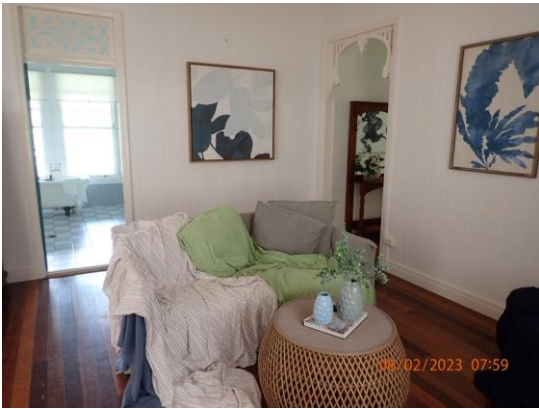
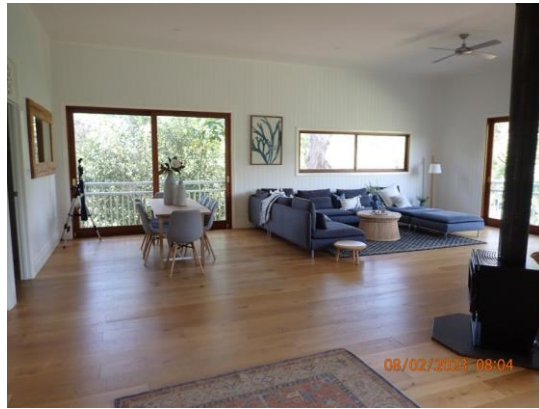
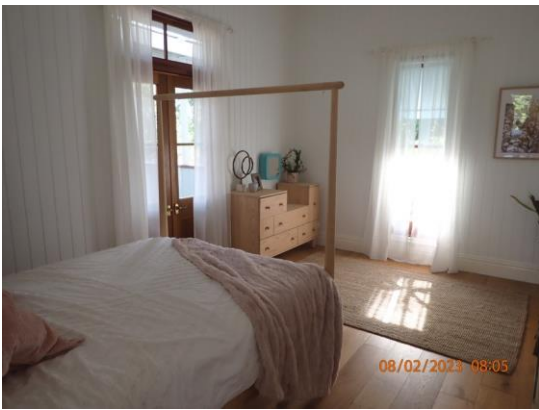
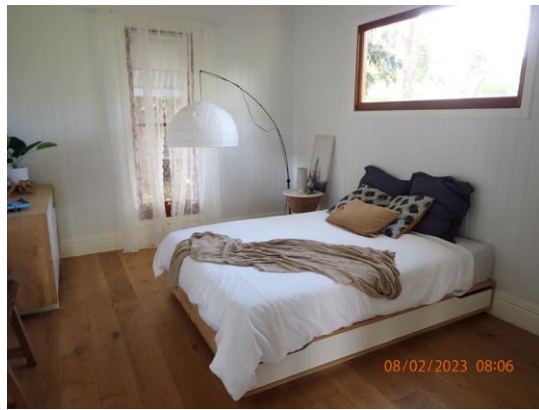
The inspection was limited due to excessive stored items and furnishings (see photos below).

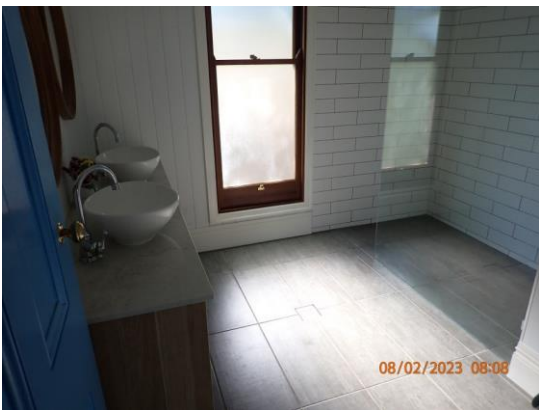
The bathroom 2 is part of the extension and it is recommended that the relevant documentation be obtained in regard to the extensions/renovations (Water Proofing Certificate) see photo below).

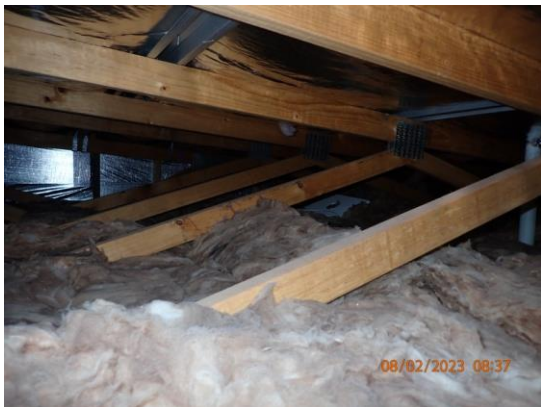
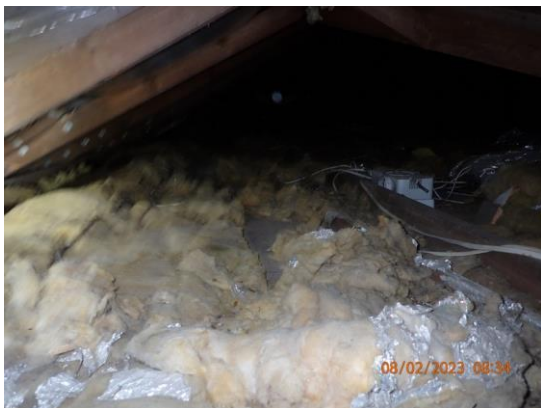
The inspection of the roof void was limited due to the timber members, truss configuration, low crawl space, insulation and Anticon (see photos below)

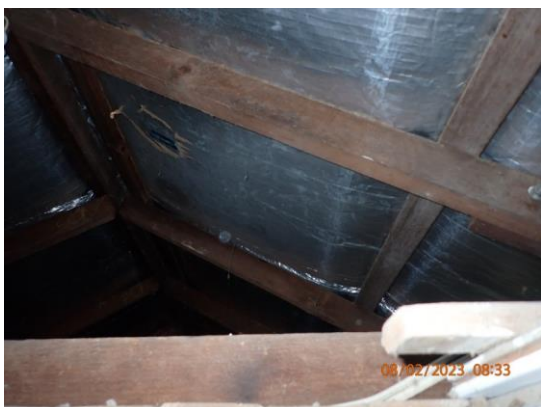
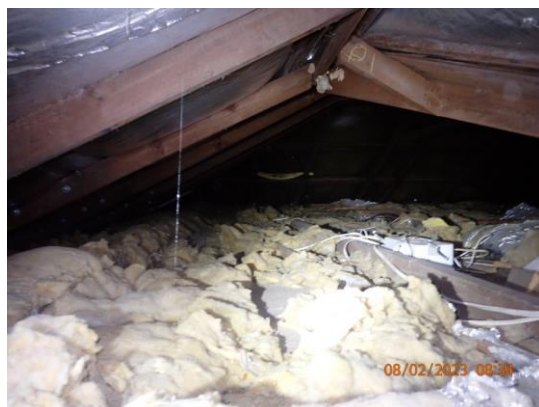
There is deflections/sagging to the ceiling joists and roof framing members in areas due to age and the building techniques used at the time of construction. Hanging beams could be installed in the roof void and the ceiling joists and roof framing fixed to the beams to prevent further deflection/sagging (see photo below)
