Inspection Report

2/22 Hastings Road, Bogangar, New South Wales, 2488

Inspection Date: 24 May 2024

Building Inspection

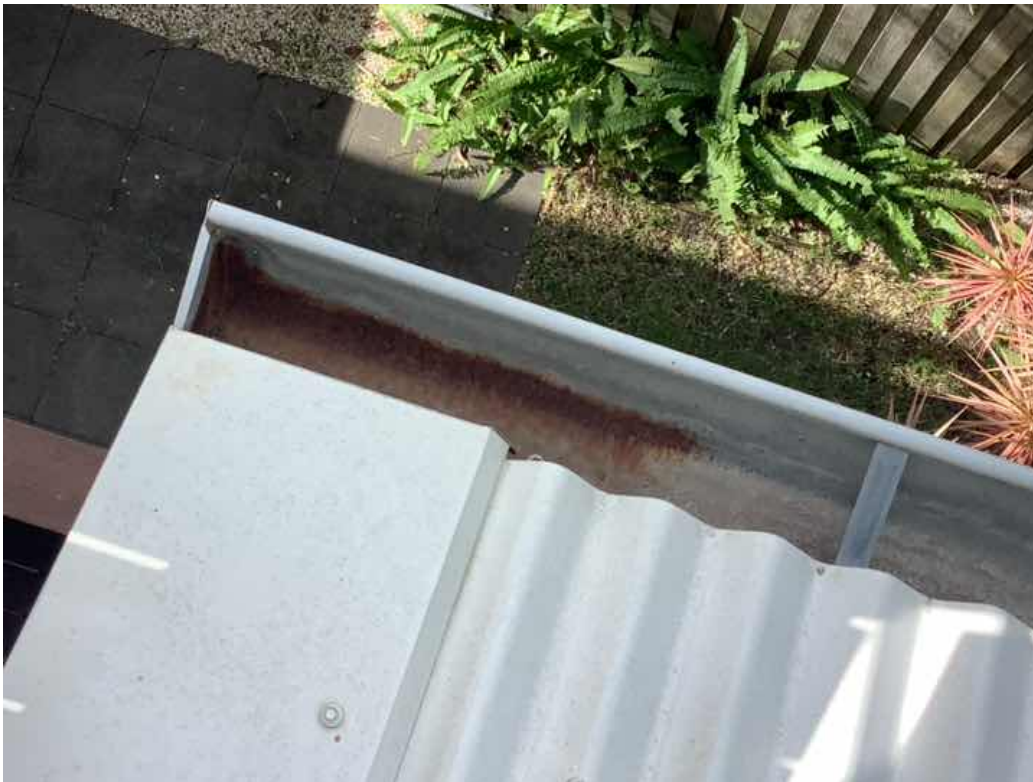
Gutter Findings

Gutter surface rust in sections- the rust is yet to penetrate and repairs/sealing may be an option. A qualified roof plumber should be engaged for advice and recommendations.

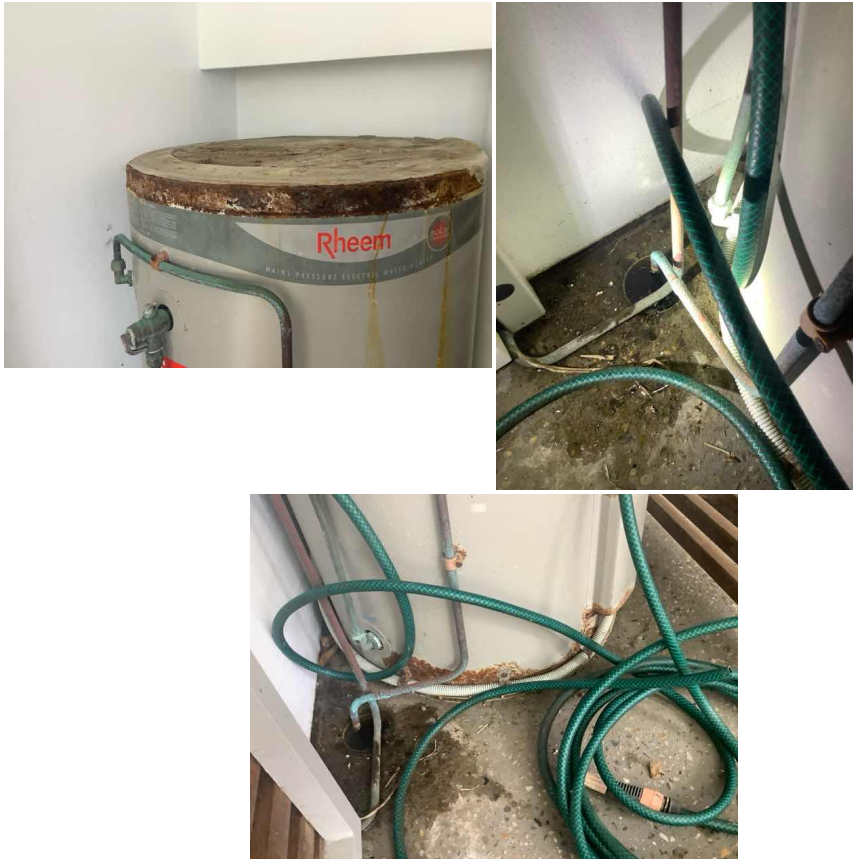
The hot water overflow requires diverting to a drain or further from the dwellings wall or footings. Excess water ponding alongside walls and into perimeter footings has the potential to cause rising damp, differential settlement and wall cracks over time. It is also conducive to termite infestation. Recommendations: Engage a plumber to rectify.

General rust deterioration was observed on the hot water unit casing.

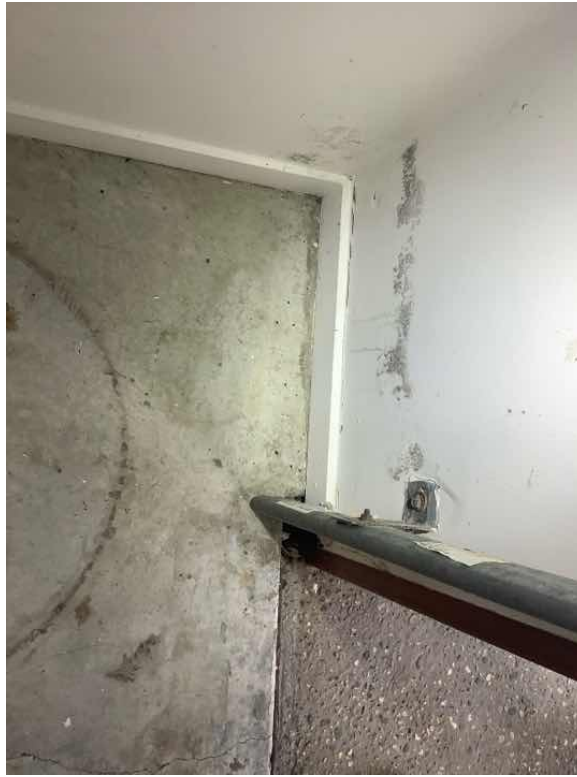
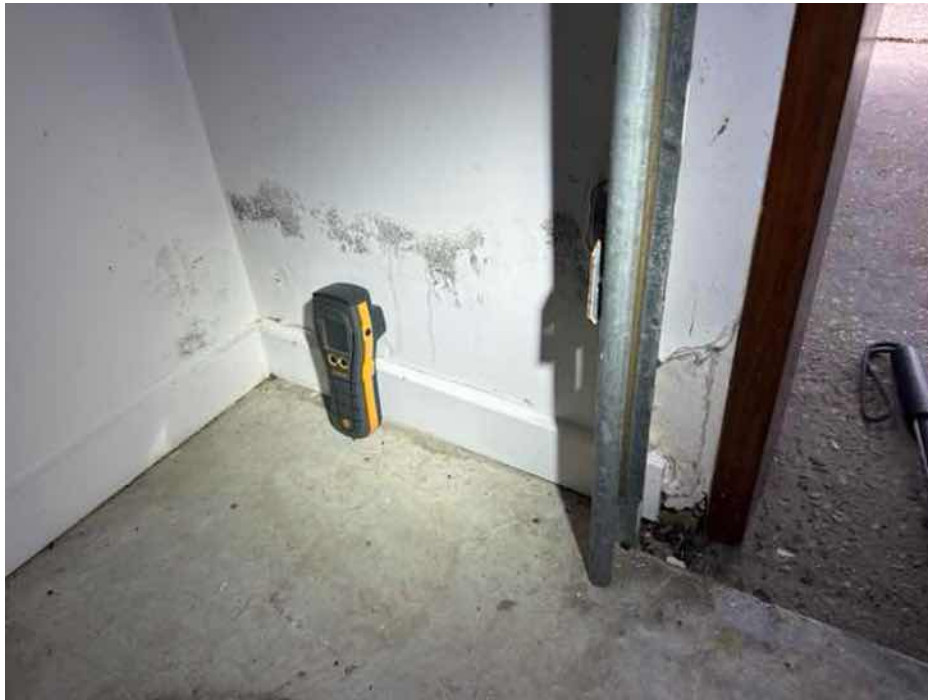
Internal Wall Findings

Dampness and mould noted to lower wall beside garage door. This section of wall is plaster direct fixed to masonry. Recommendations, strip away plaster and apply water proofing to masonry wall.

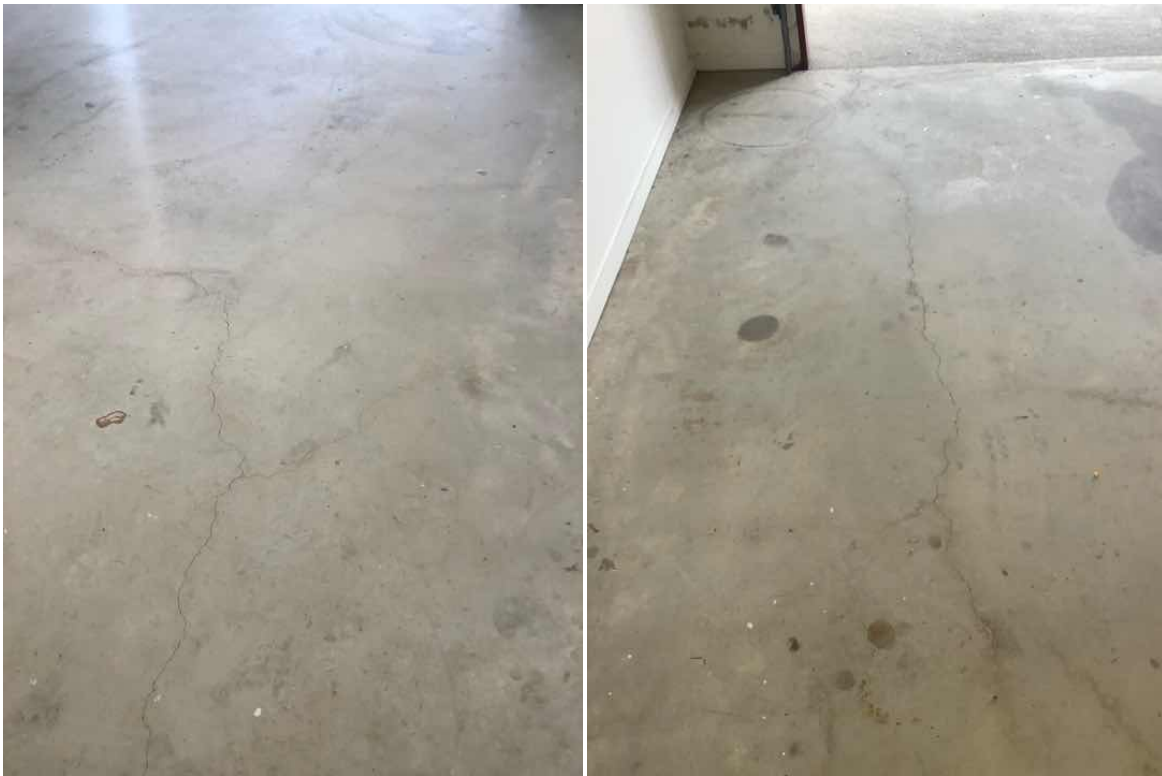
Floor Findings

Minor hairline slab cracks - Note. Whilst these cracks appeared to be minor at the time of inspection, we strongly recommend you monitor these cracks and if worsening occurs contact a qualified concreter for further advice.

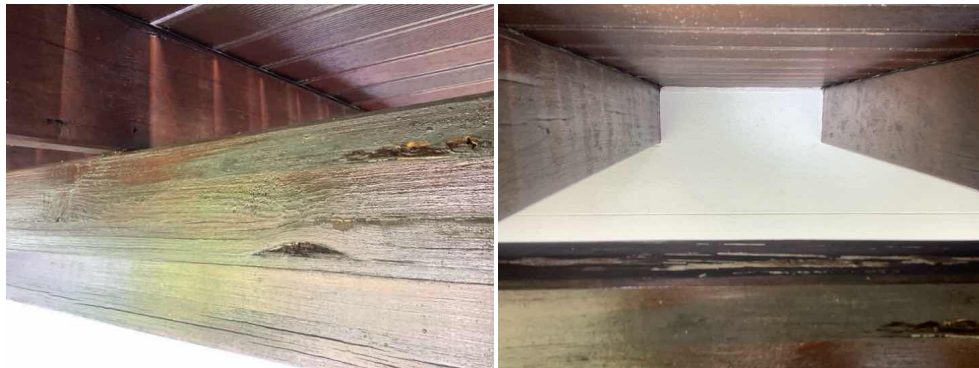
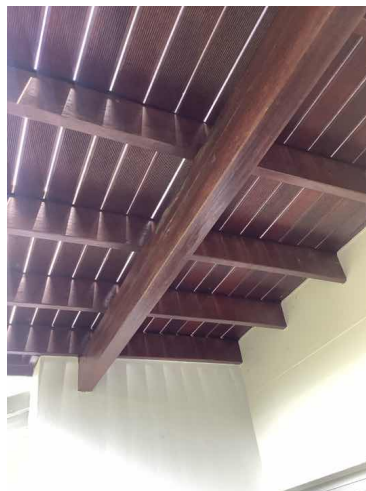
Frame Condition

Timber fungal decay in section of bearer. A qualified carpenter should be engaged for advice and recommendations.

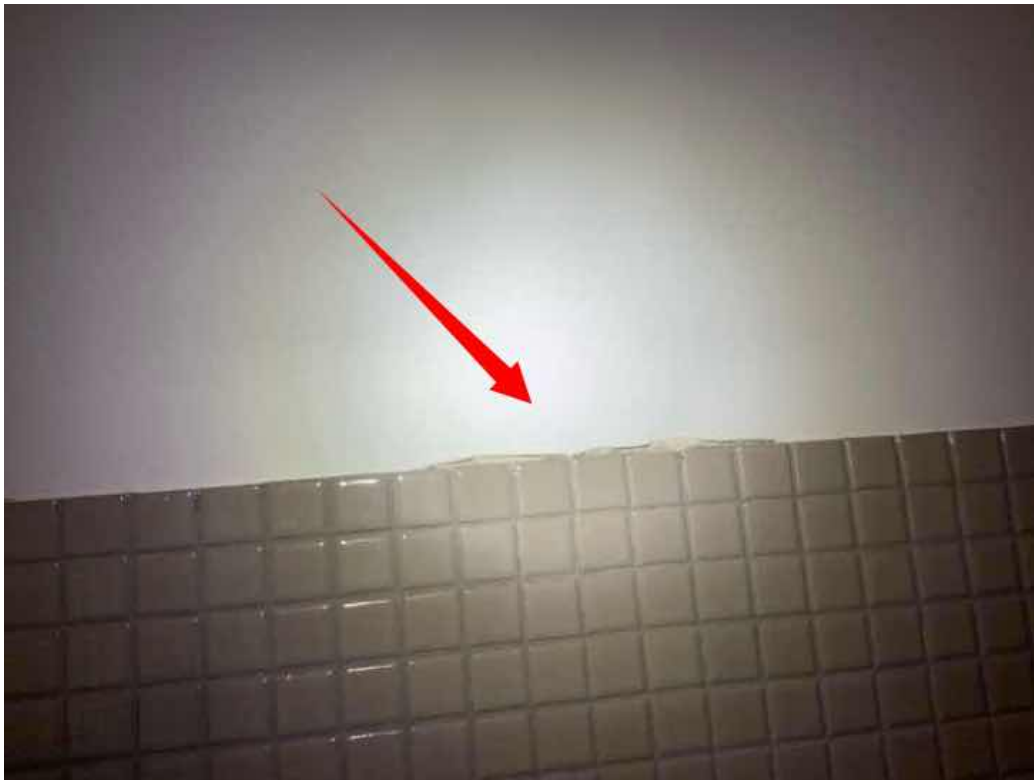
Walls

Minor damage to walls above tile line in shower. Consult a painter for repairs.

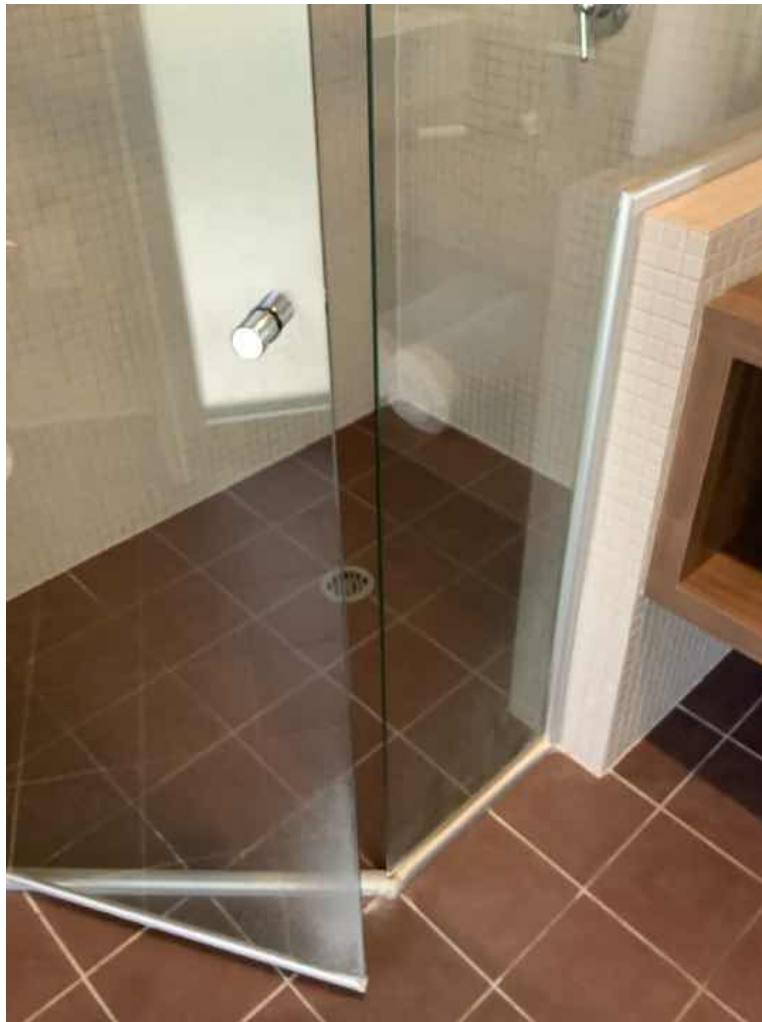
Shower And Bath

Shower door binding when closing. Recommendations, consult a licensed contractor for repairs.
