CLIENT: Nikki Smith

PROPERTY INSPECTED ADDRESS: 2/22 Hastings Road, Bogangar

INSPECTION DATE: 24th May, 2024

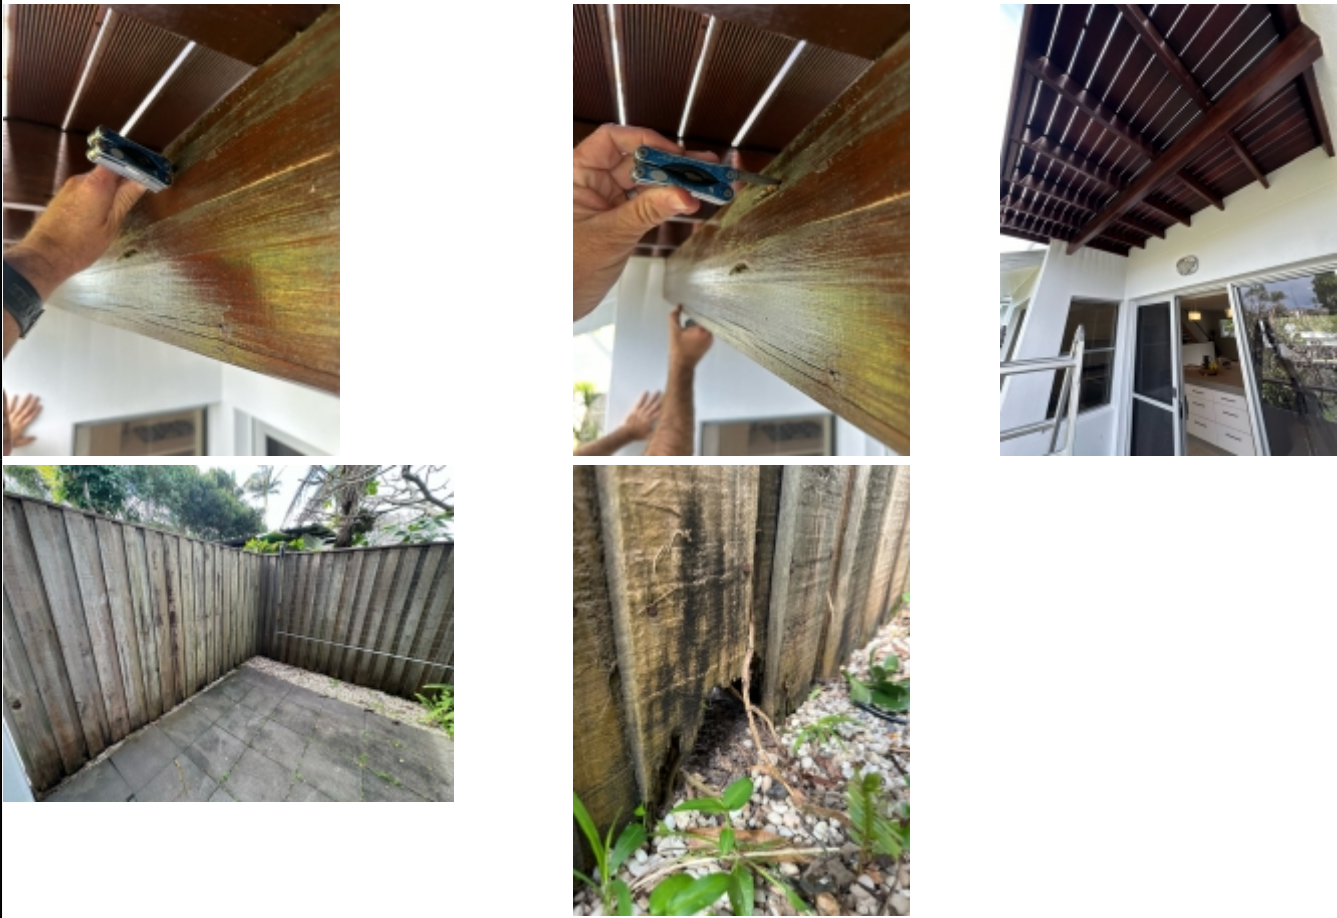
D7 Fungal decay

At time of inspection fungal decay was located in, but not necessarily limited to: upper level rear deck beam and to fencing timbers at rear.

Removal/replacement of the affected timbers is recommended.

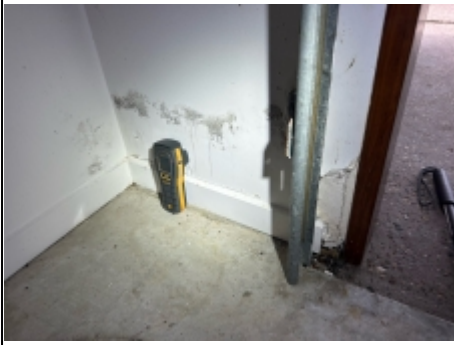
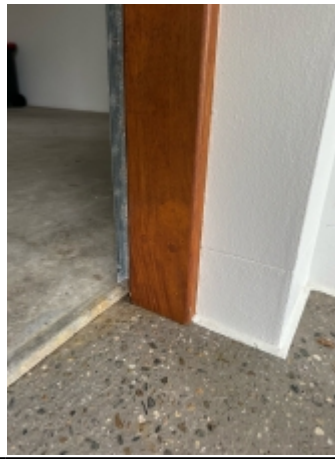
D10 The presence of excessive moisture

At time of inspection elevated moisture readings were located in, but not necessarily limited to the: interior garage wall linings adjacent to the garage door

The wall lining appears to be gyprock affixed directly to brickwork.

The presence of moisture stains

Further inspection to these areas is recommended to locate and rectify the source of the moisture.

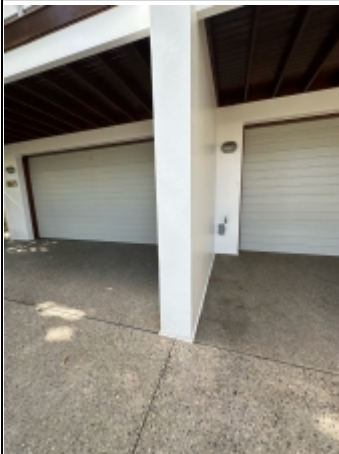
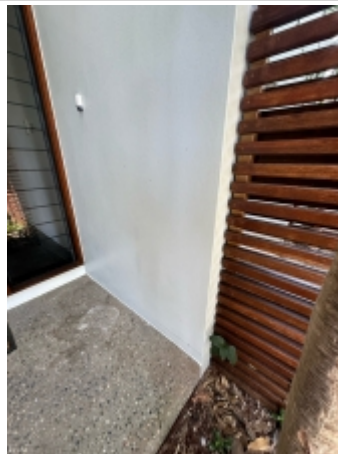
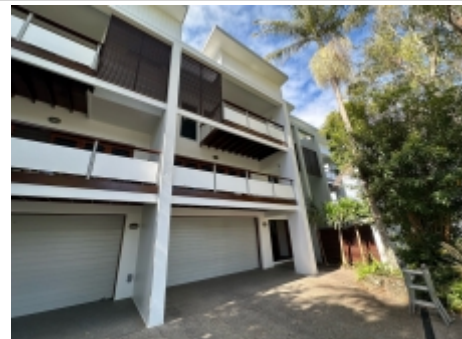
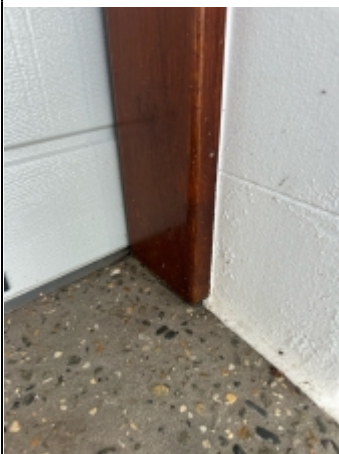
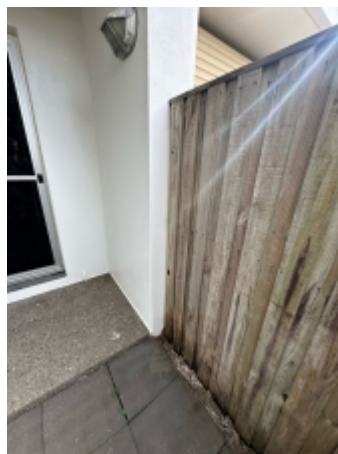
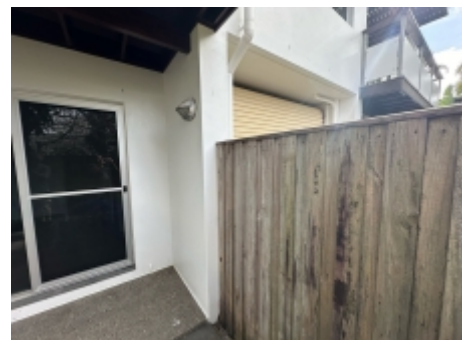
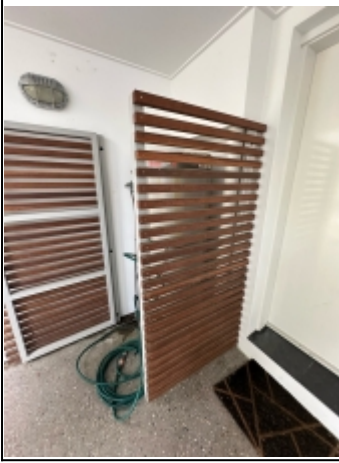
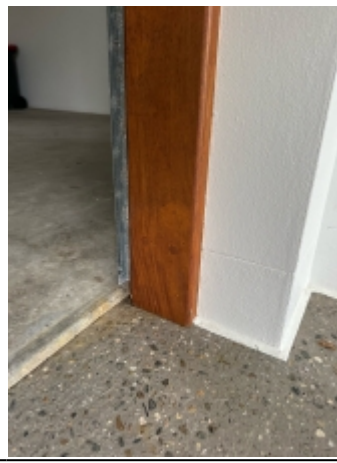
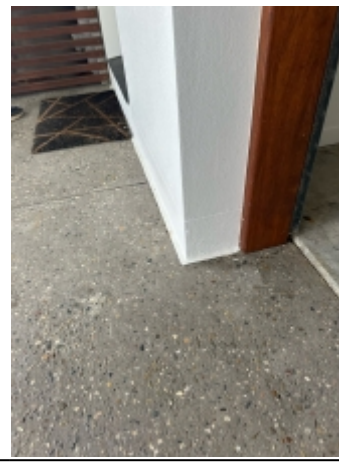
D11 Bridging or breaching of termite barriers and inspection zones

The visual inspection zone was bridged by the adjacent dwellings &/or common property the garage door jamb timbers on ground floor and by the hot water unit enclosure.

The visual inspection zone was concealed, or partially concealed by the adjacent dwellings &/or common property, and by the dividing fences.

Adjustment of the above items is recommended to prevent bridging the visual inspection zone and to provide a minimum of 75mm clearance to this area.

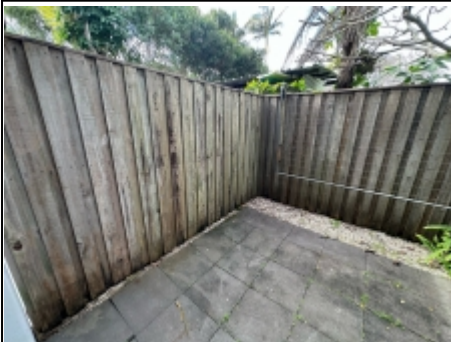
D12 Untreated or non-durable timber used in a hazardous environment

All timber items in ground contact, including but not necessarily limited to: Timber fences

These items should be adjusted to provide a minimum of 75mm ground clearance, or replaced with termite and decay resistant materials.

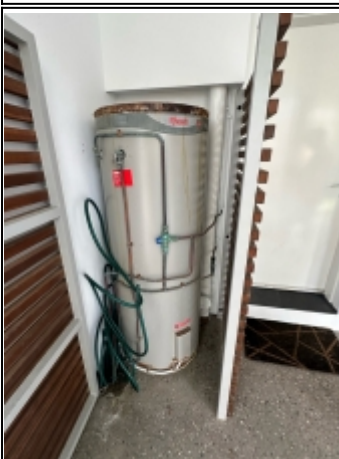
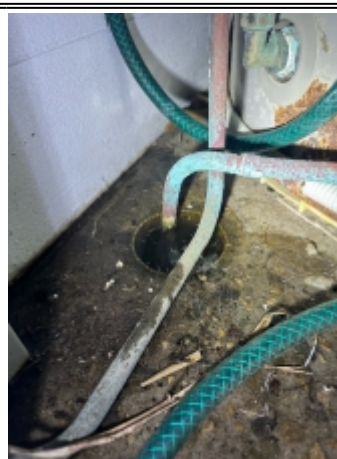
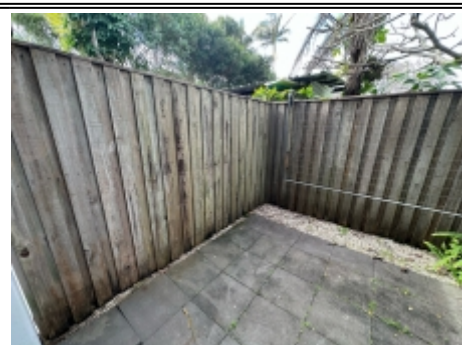
D13 Other conditions conducive to timber pest attack

- All timber items in ground contact including but not necessarily limited to timber fences, landscaping and retaining wall timbers should be adjusted to provide a minimum of 75mm ground clearance or replaced with termite and decay resistant materials.
- the hot water unit overflow drain should be unblocked to prevent moisture buildup against the structure.
