Quack PEST CONTROL
"All our Patients Die!"

49 Bagshaw Crescent, Gray

Standard Termite
Detection Report

08th Jun, 2023

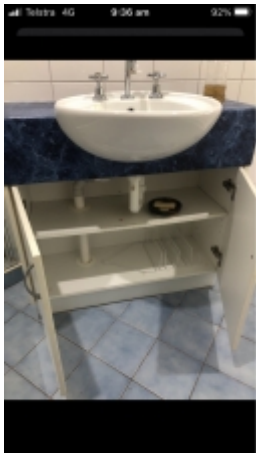
Were there any obstructions that may conceal possible termite attack?	Yes
Obstructions	Building Interior
Interior Type	Cupboards over plumbing penetrations., Internal perimeter block walls are gyprock lined
Obstructions	Building Exterior
Exterior Type	Block rendered walls can conceal termite entry points.
Comments	The above obstructions can provide termites undetected access.

Undetected access obstructions.

RECOMMENDATION: Where the risk is considered "Moderate" or "Moderate-High" or "High", a further inspection is strongly recommended of areas that were not readily accessible, and of inaccessible or obstructed areas once access has been provided or the obstruction removed. This may require the moving, lifting or removal of obstructions such as floor coverings, furniture, stored items foliage and insulation. In some instances, it may also require the removal of ceiling and wall linings, and the cutting of traps and access holes. Seek further advice from your Consultant.

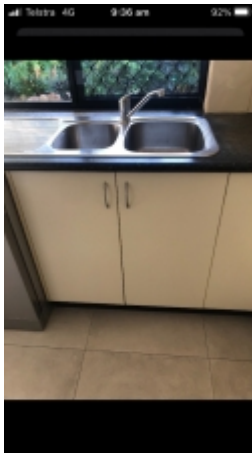
Undetected access obstructions.

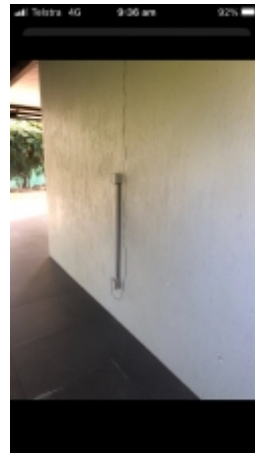
Undetected access obstructions.

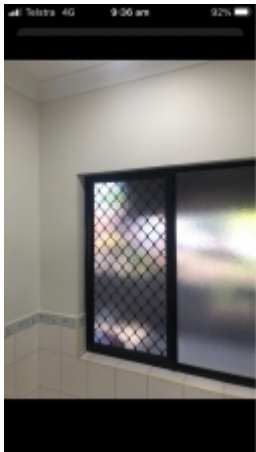
Undetected access obstructions.

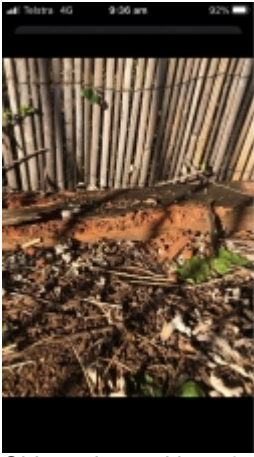
Was evidence of termite workings or damage found?	Yes - see clauses A.4 and A.5
The extent of any visible damage appears:	Localised

Old termite workings & damage to sleeper.

<p>Details - indicate the location of all accessible timbers and other materials showing signs of attack, and a description of any termite workings found:</p>	<p>Old termite workings & damage to sleeper in front garden. No evidence found in the dwelling.</p>
--	---

RECOMMENDATION: Where evidence of damage to building timbers exists, competent advice (e.g. from a licensed and practicing building contractor) should be obtained to determine the extent of any structural damage and as to the need or otherwise for rectification or repair work. See also Item 3.5 'Frequency of Future Inspections' recommendation.

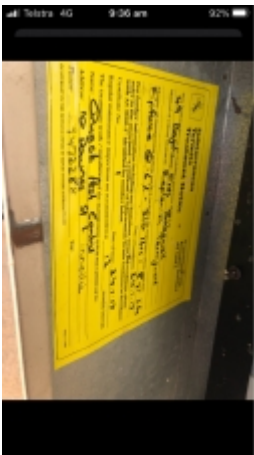
Notification of treatments in the meter box.

<p>Notes:</p>	<p>In 2017 Quack Pest Control replenished the Termguard Termite Management System to the perimeter PartB with the product Fipforce @ 8 years life. The system is current until 2025.</p>
---------------	--

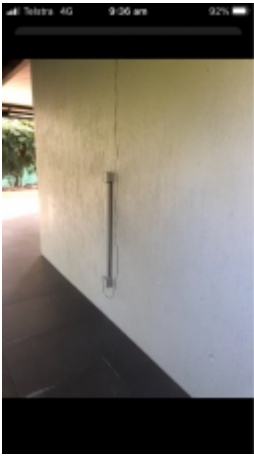
Was the finished ground or paving level above the adjacent internal floor level or damp-proof-course or obstructing any weephole or vent face on external walls?	Not Applicable
Was evidence of bridging or breaching including the condition insufficient slab edge exposure found?	Yes - see clauses A.4 and A.5
Include any visible evidence of bridging or breaching or slab edges obstructed by:	Rendered walls
Details (include the location and any recommendation for further expert advice e.g. from a licensed a building contractor):	Render over slab edge can conceal termite entry points.

Obstructed slab edge exposure.
