## **PRE-PURCHASE PROPERTY & TIMBER PEST REPORT**

Report number: PTPR\_9444  
Inspection date: Wednesday 12th June 2024  
Property address: 1893 Comboyne Road,  
Killabakh  
NSW 2429

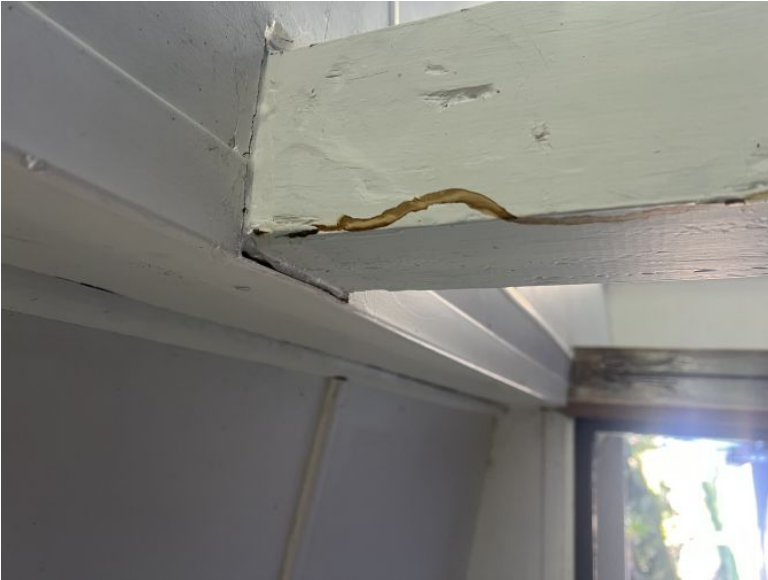
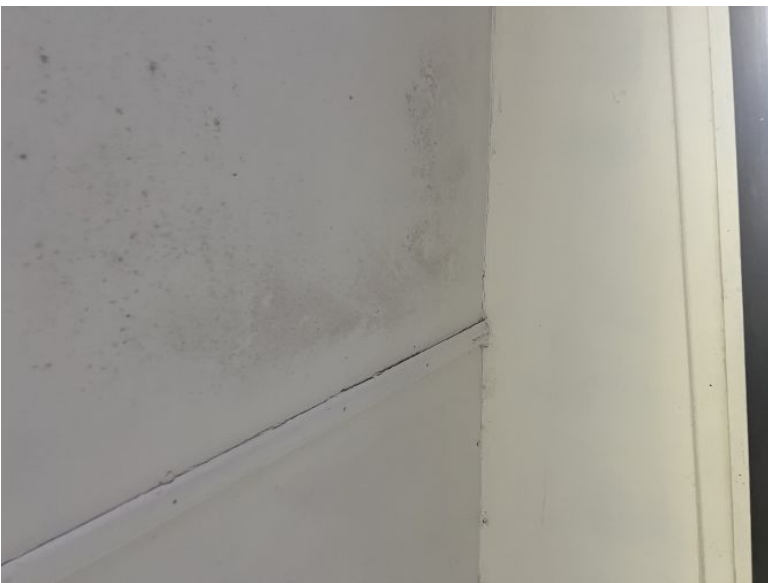
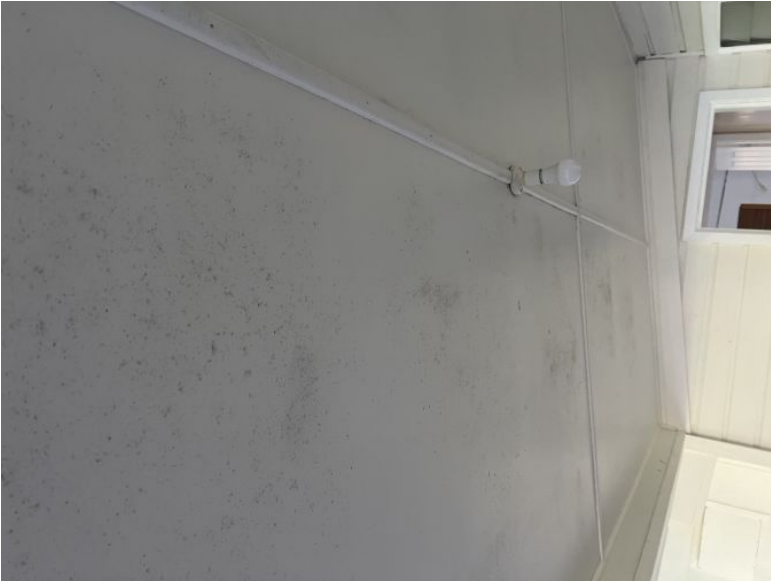
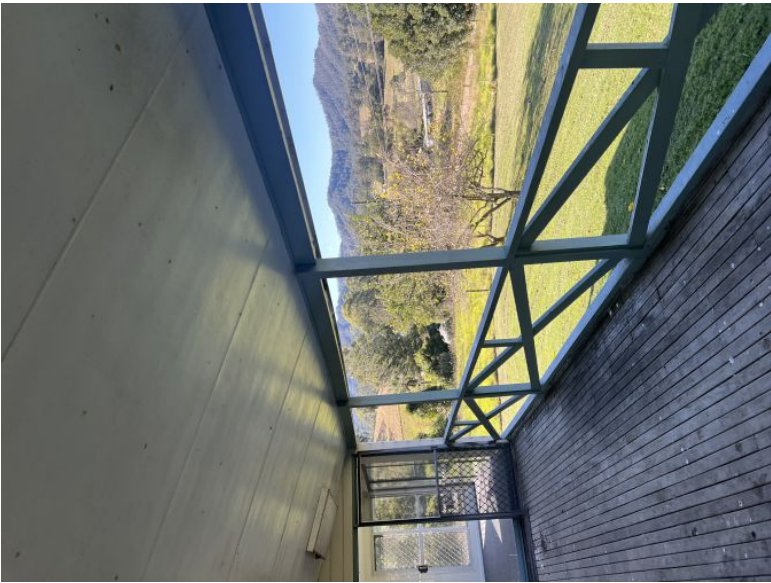
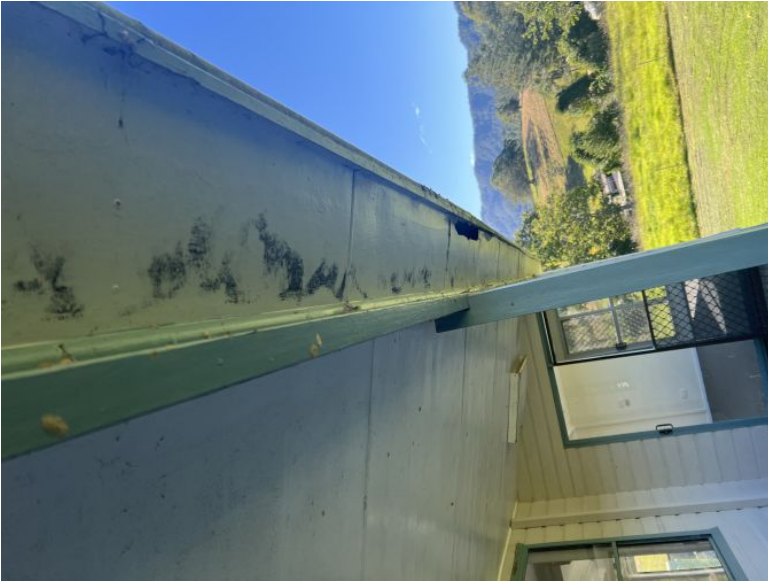
Image comments: Water marks ceiling

Recommendation: Recommendations:  
a. Perform ALL external roof and stormwater recommendations as per this report.

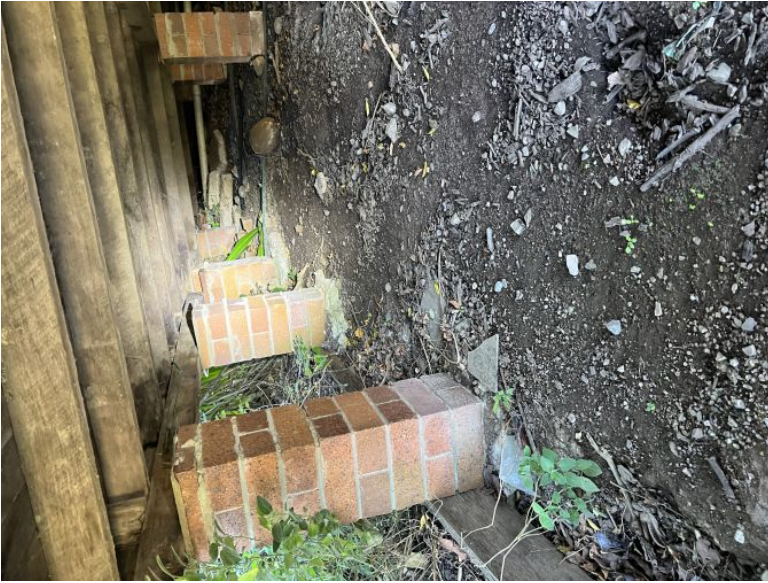
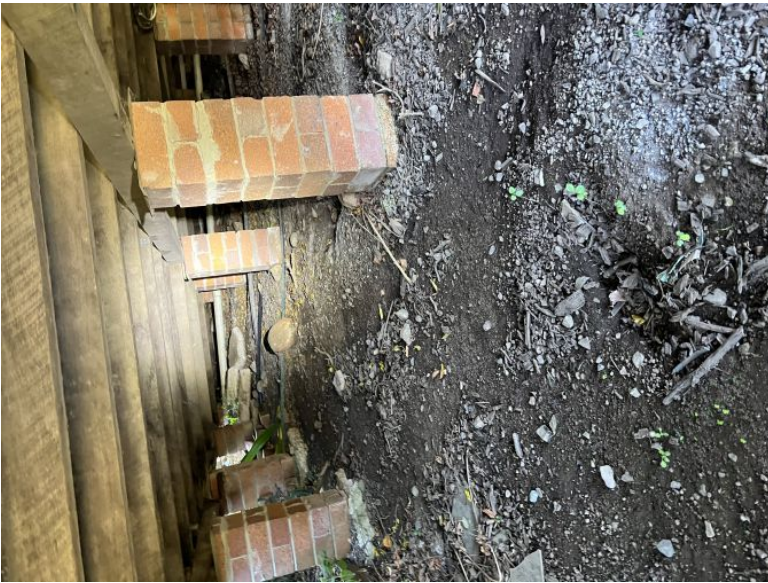
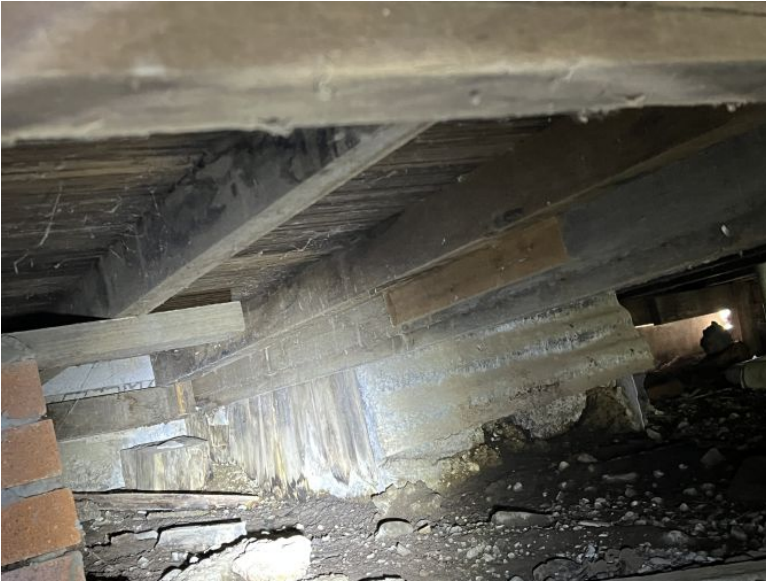
Area	Subfloor space
Location:	Below the building in general.
Affected element:	Piers.
Defect or Sign:	Leaning. Piers. a. Leaning and sunken piers main dwelling.
Visible extent:	Localised.
Recommendation:	Recommend: a. Perform ALL groundwater and stormwater recommendations as per this report. b. Straighten and pack as required. Danny Christie Carpentry 0434 943 571

Image comments: Leaning piers

Image comments: Sunken wooden pier

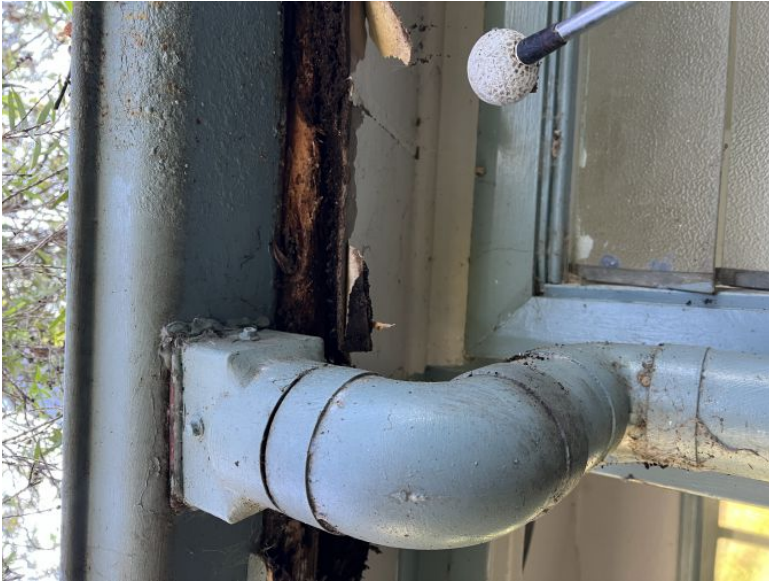
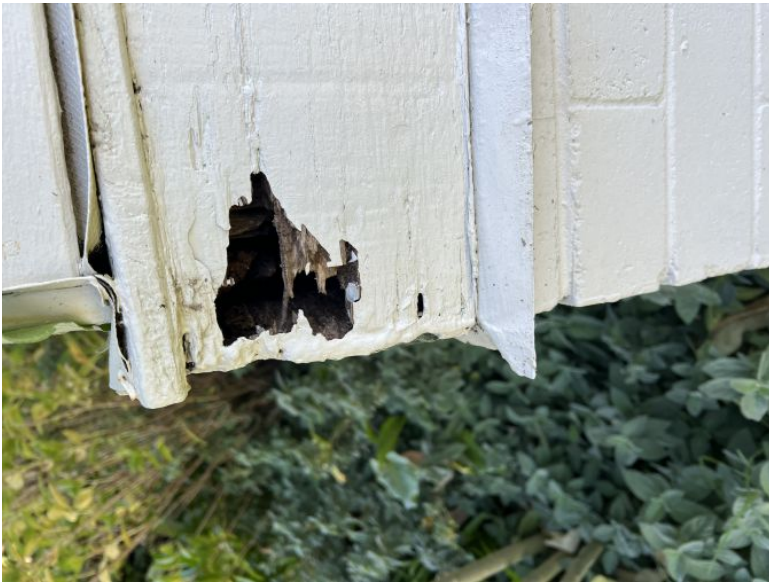
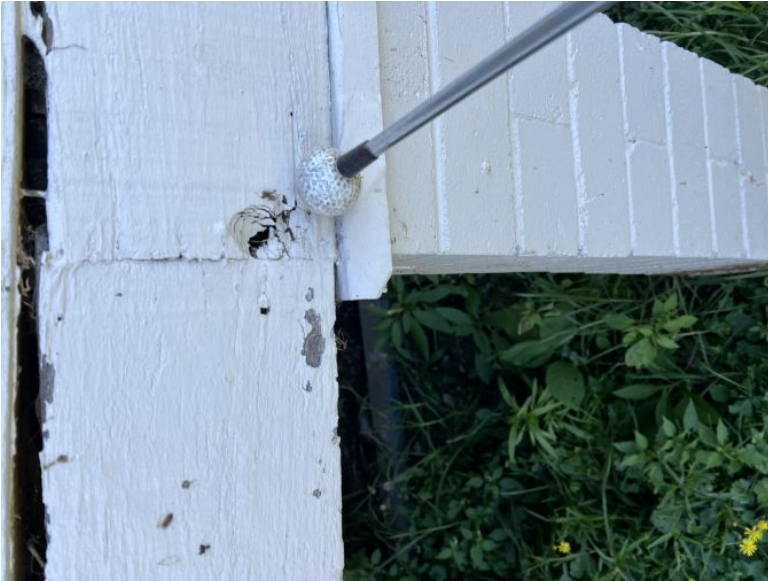
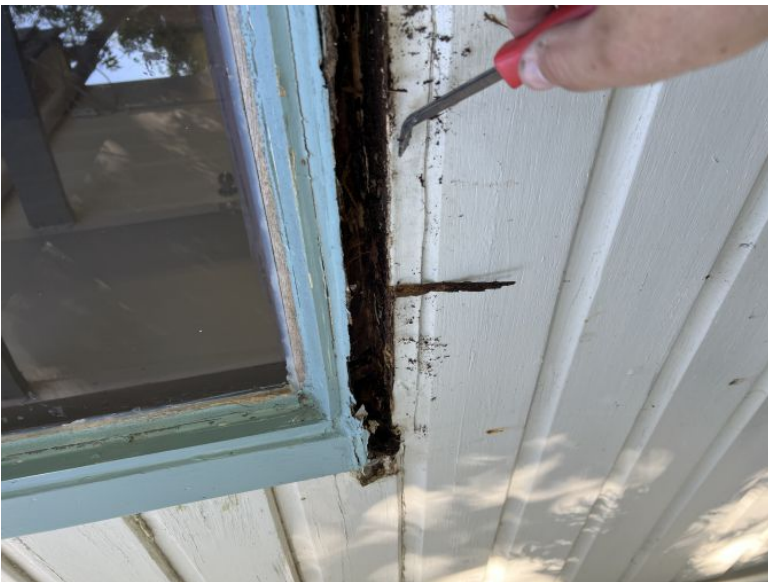
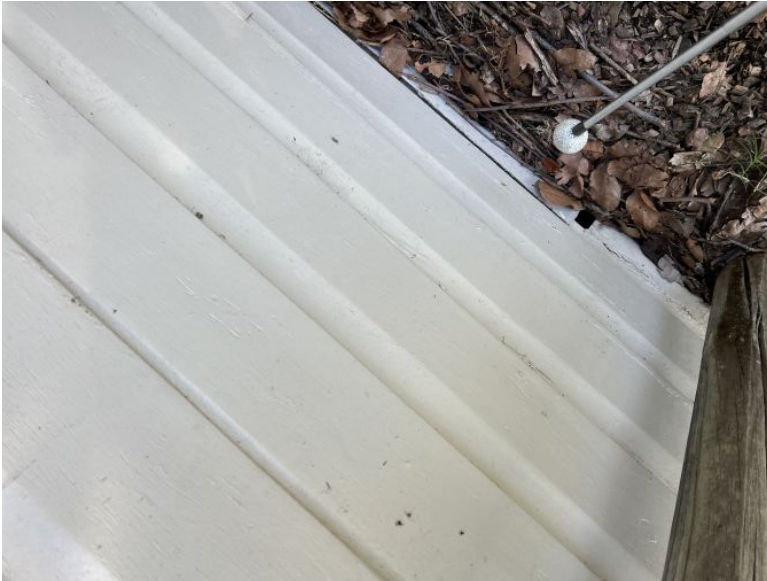
Area	Building exterior
Location:	Outside of the building in general.
Affected element:	Weatherboards.
Defect or Sign:	Weathering damage. Timber rot external carpentry/ timbers.
Visible extent:	Widespread.
Recommendation:	Recommendations: a. Perform all stormwater and groundwater recommendations as per this report. b. Repair/ replace timber carpentry as required. c. Seal timbers and joins. d. Monitor/ consult a licenced builder. Danny Christie Building 0434 943 571

Image comments: Timber rot carpentry

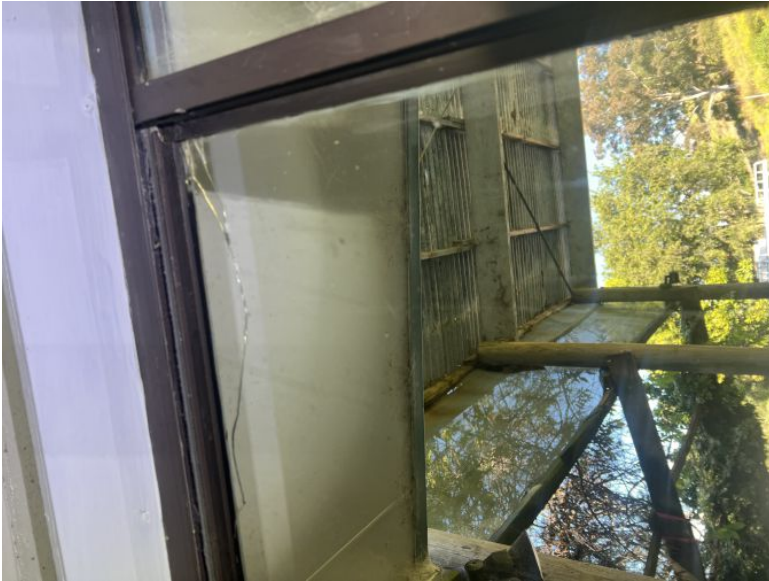
Area	Building exterior
Location:	Outside the building.
Affected element:	Glass.
Defect or Sign:	Cracked glass windows included: a. Rear living room cracked glass windows.
Visible extent:	Localised.
Recommendation:	Recommendations: a. Consult a licenced glazier. Matt Garland MG Glass. 0447 220 171 <a href="https://www.facebook.com/p/MG-Glass-Solutions-100054405703577/">https://www.facebook.com/p/MG-Glass-Solutions-100054405703577/</a>

Image comments: Cracked glass

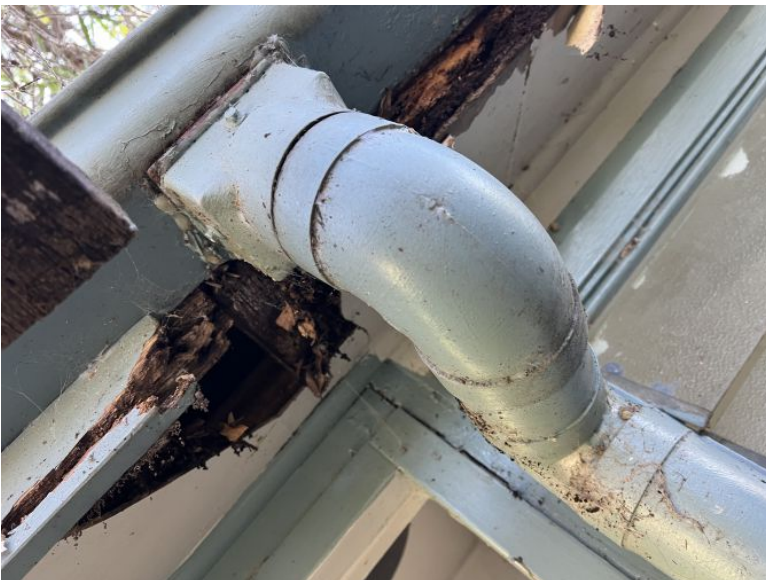
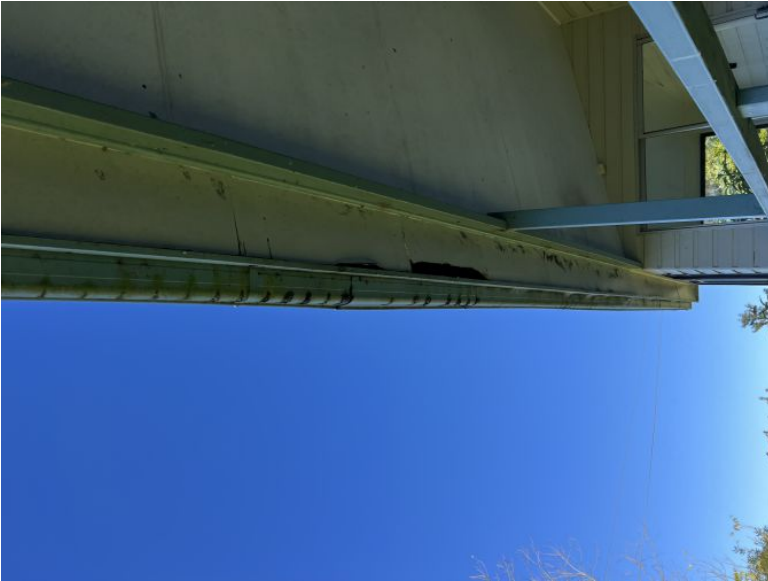
Image comments: Timber rot eaves

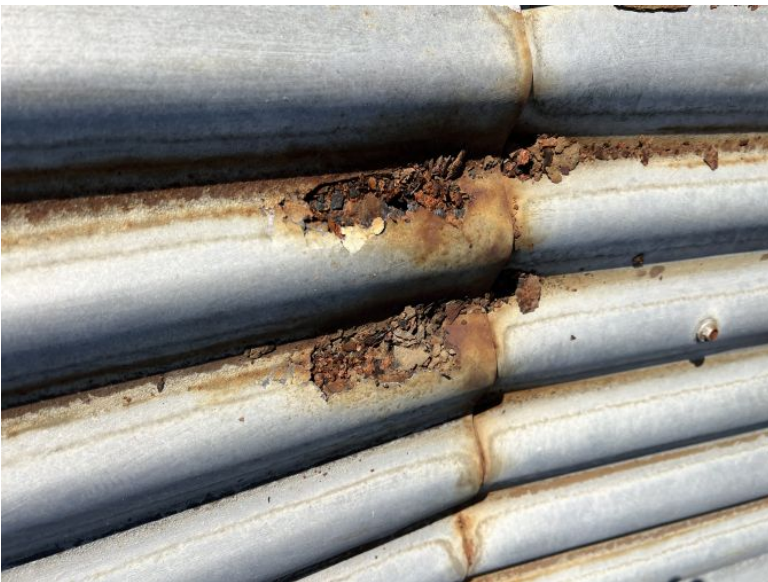
Image comments: Rusted roofing iron

a. Repair/ replace rusted roofing iron.

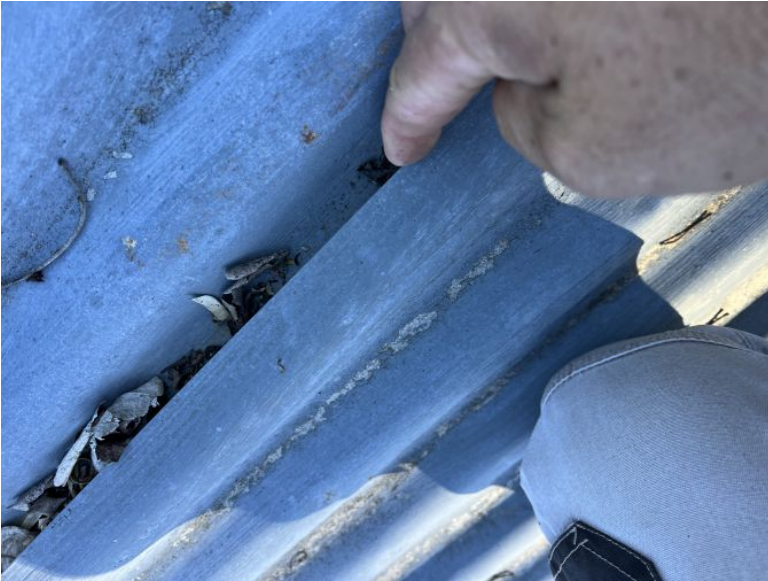
Image comments: Loose roofing iron

e. Refix iron down from loose nails.

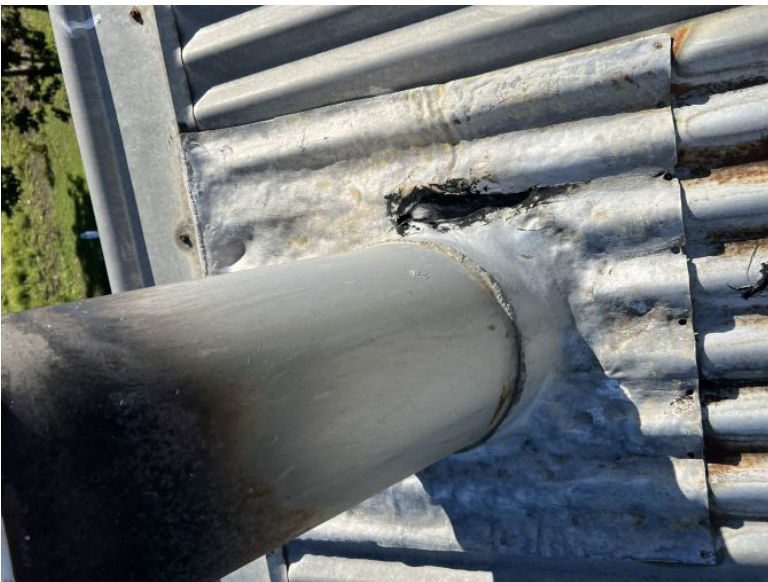
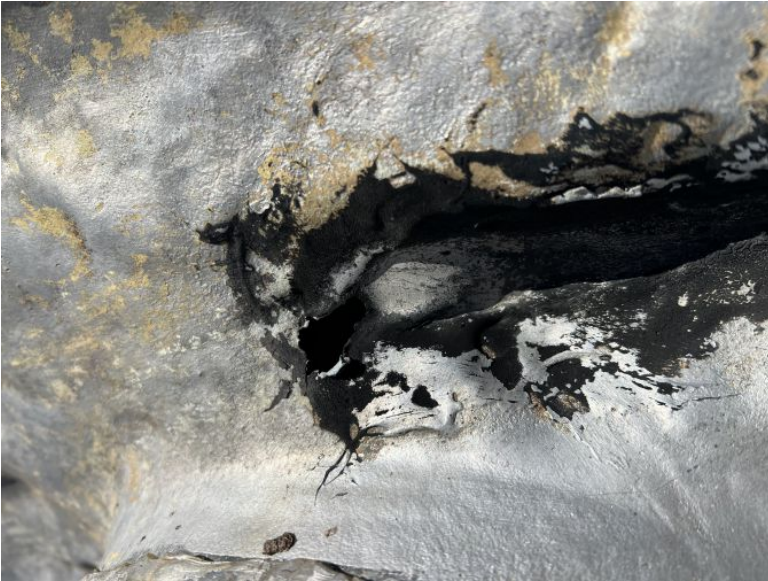
Image comments: Hole in flashing

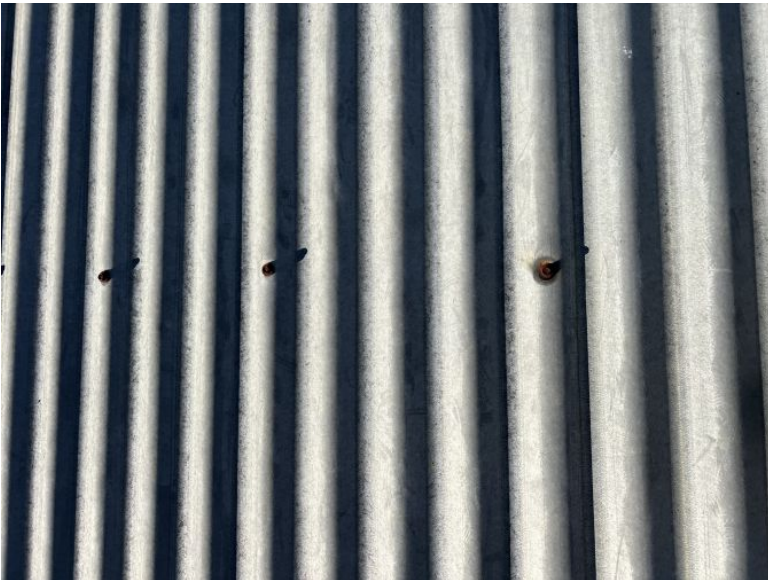
Image comments: Rusted roofing screws

c. Replace rusted roofing screws.

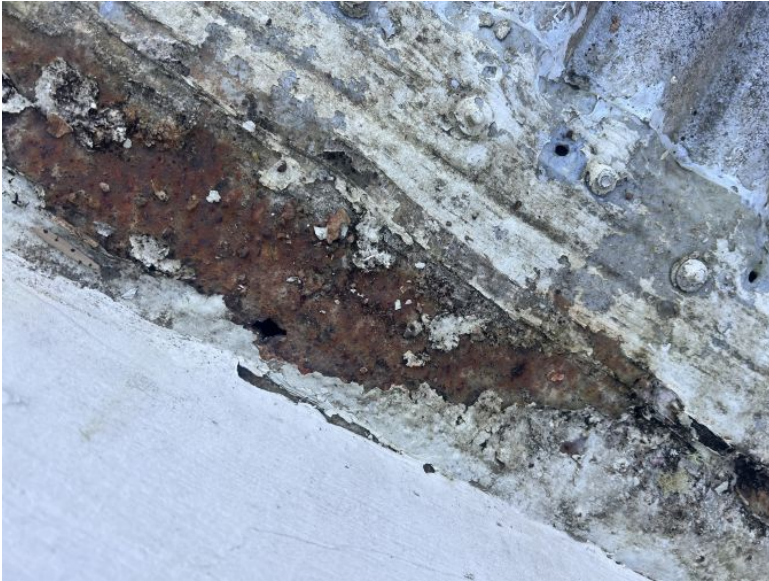
Image comments: Rust holes in apron flashing

b. Replace rusted apron flashing under gable end.

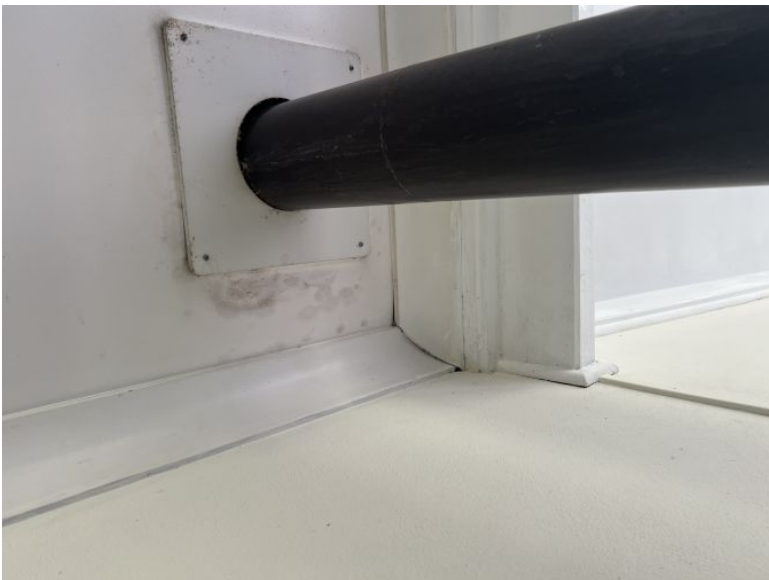
Image comments: Water marks around flue

d. Replace damaged/ leaking dektite.

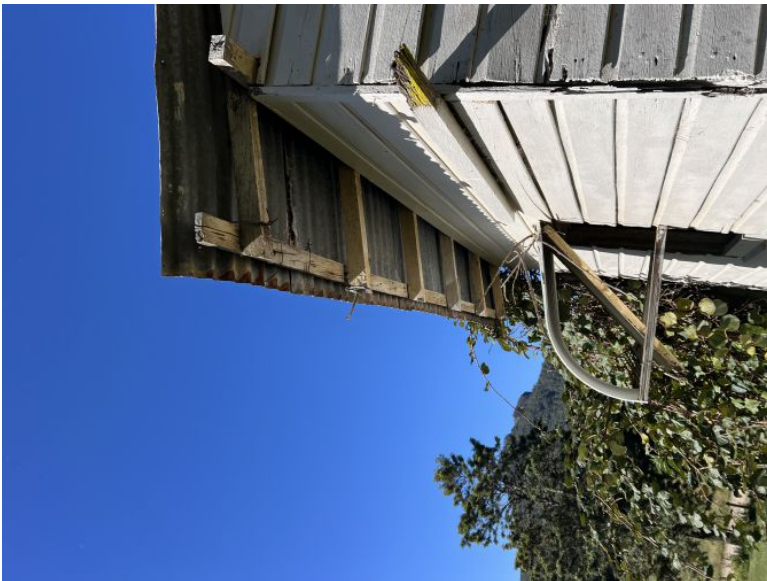
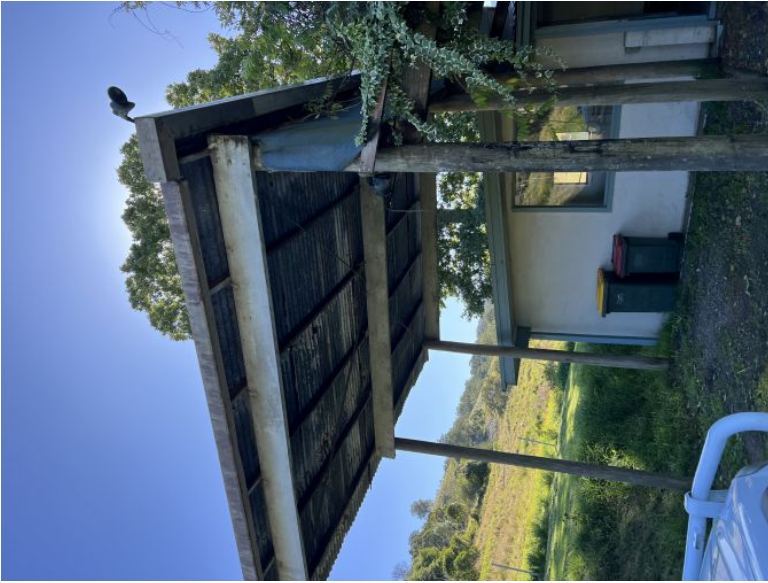
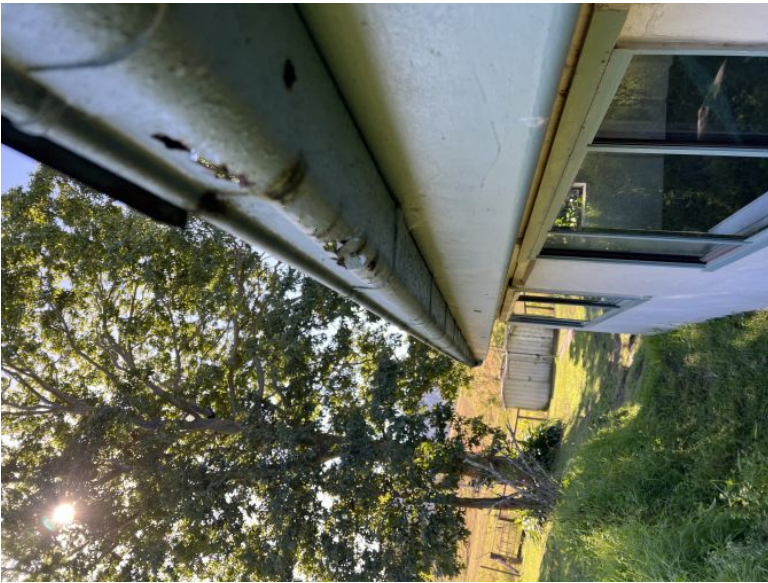
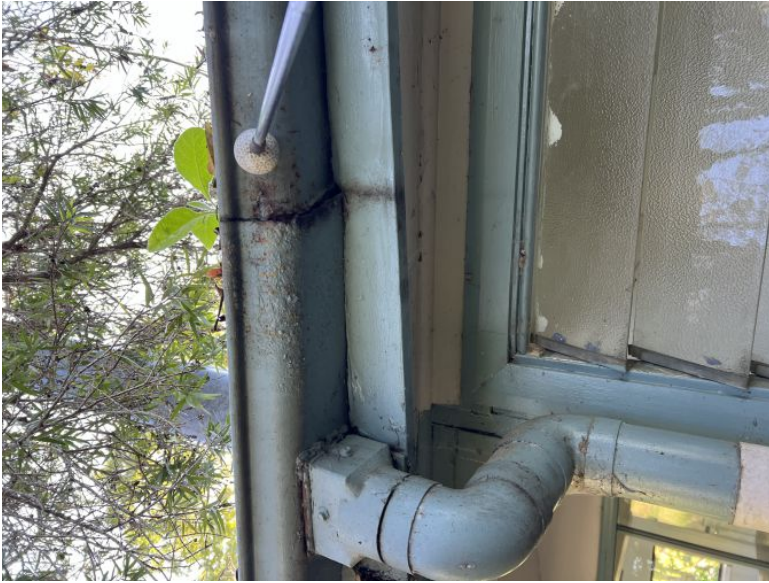
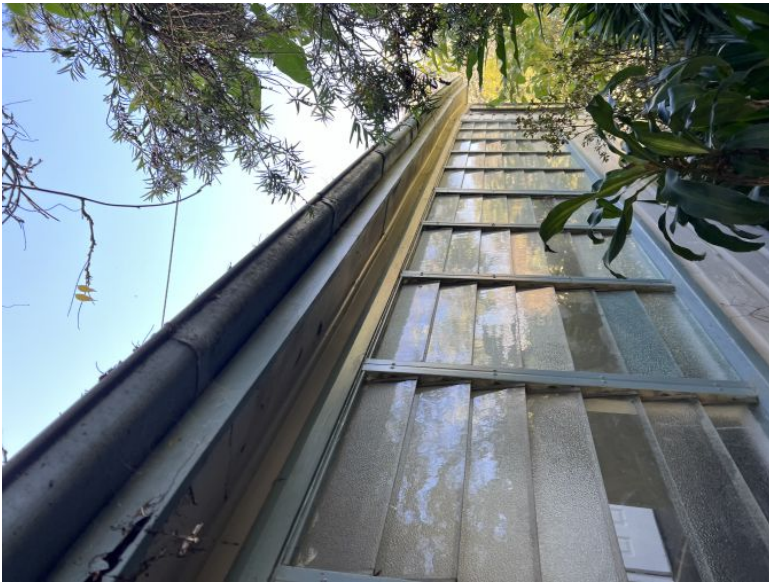
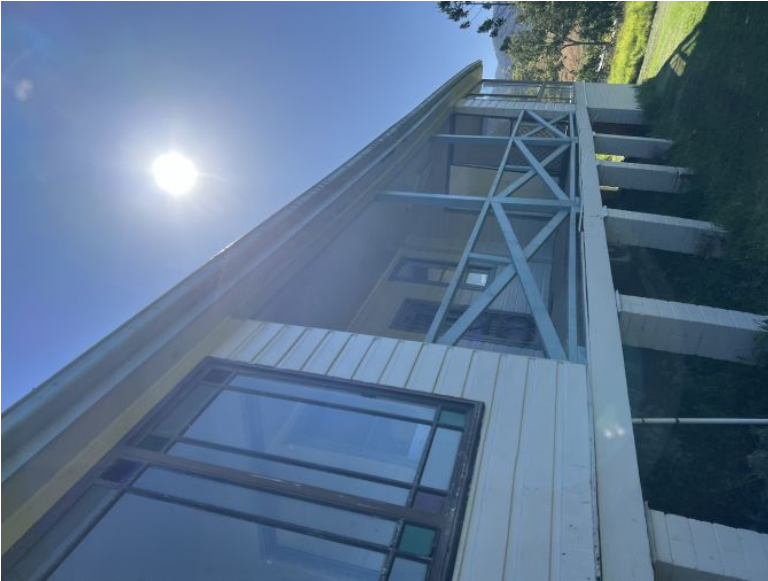
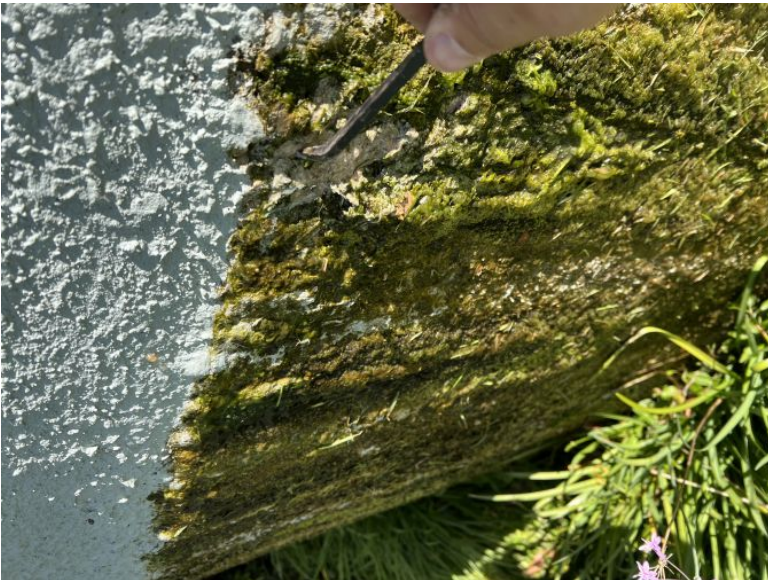
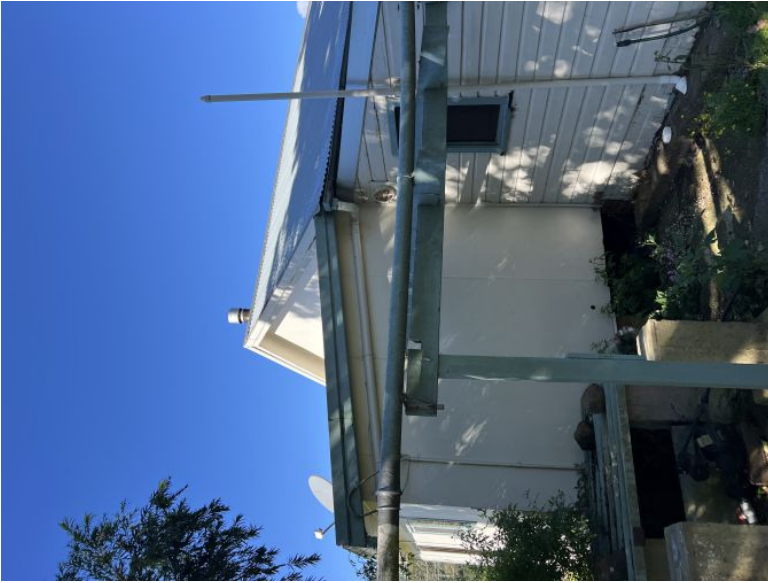
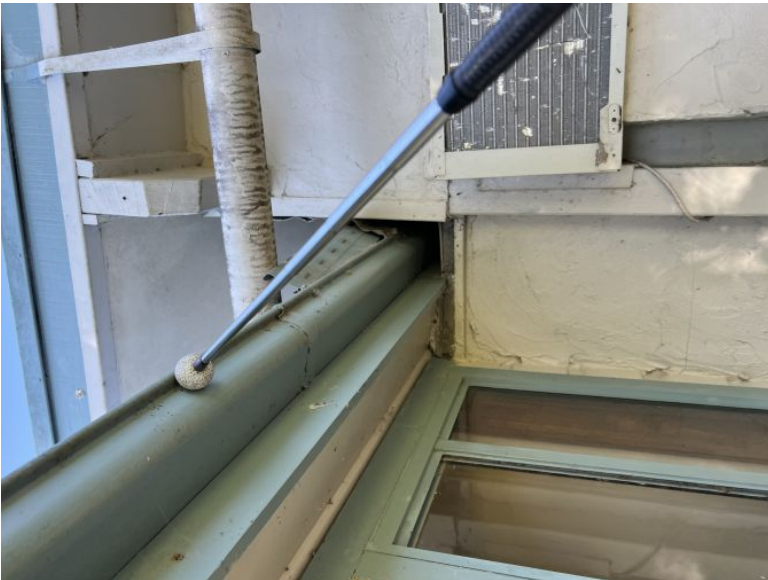
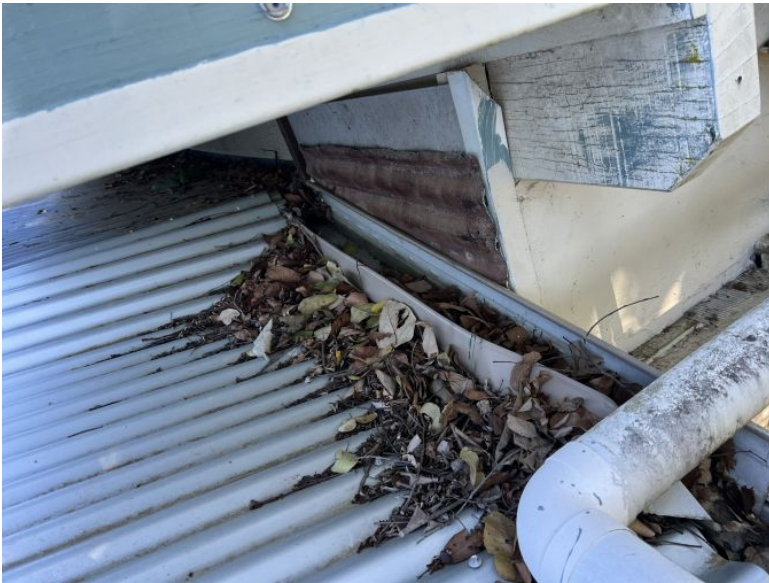
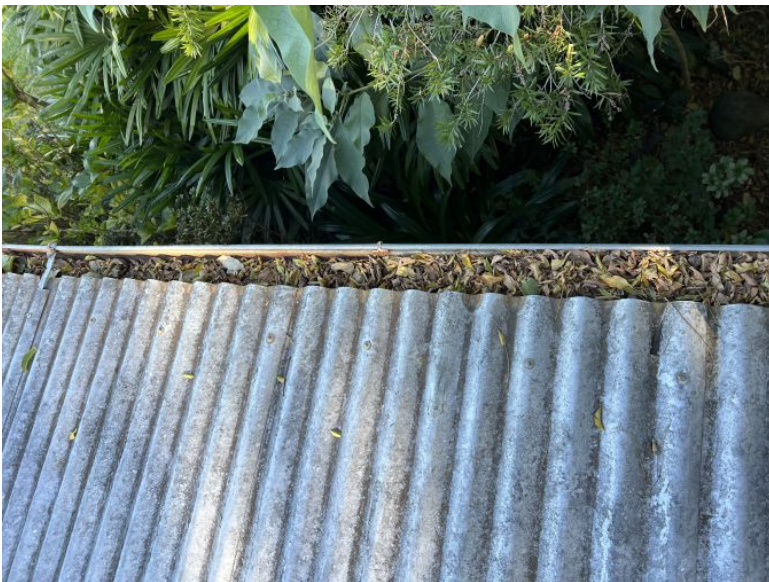
Image comments: Dairy no guttering

Image comments: Carport rusted out guttering

Image comments: Rusted out guttering

Image comments: Saggign guttering

Image comments: Leaking water tank around crack

Image comments: Inadequate DPs and guttering

Image comments: Sagging rusted guttering into box section

Image comments: Rusted guttering full of debris

- Recommendation: Recommendation:
- a. Remove and replace rusted guttering perimeter of dwellings.
  - b. Remove and replace boxed guttering.
  - c. Clear guttering DP chain to water tanks. Repair and ensure ALL DPs chain to water tanks.
  - d. Clear foliage from dwelling.
  - e. Consult a licenced plumber or builder. Blake Crossingham Easy Flo plumbing and gas 0437 404 692. OR builder Danny Christie Building 0434 943 571
- Monitor and IF required.
- a. Add at least 1 x additional DP to the front LH and RH corners of the main dwelling directed to water tanks.

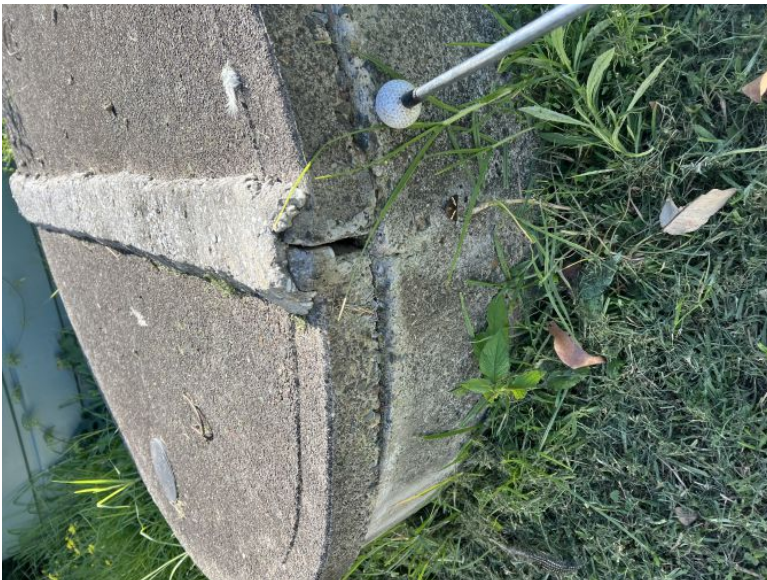
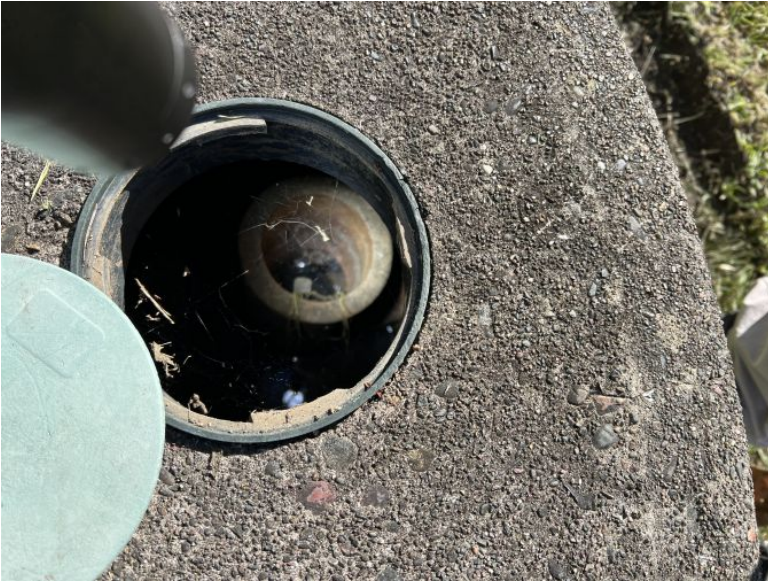
Image comments: Unsealed septic tank

Image comments: Septic tank

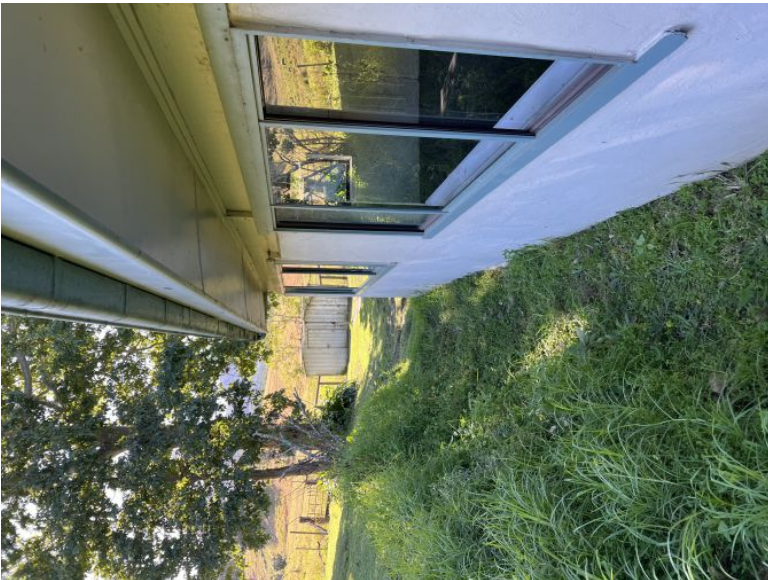
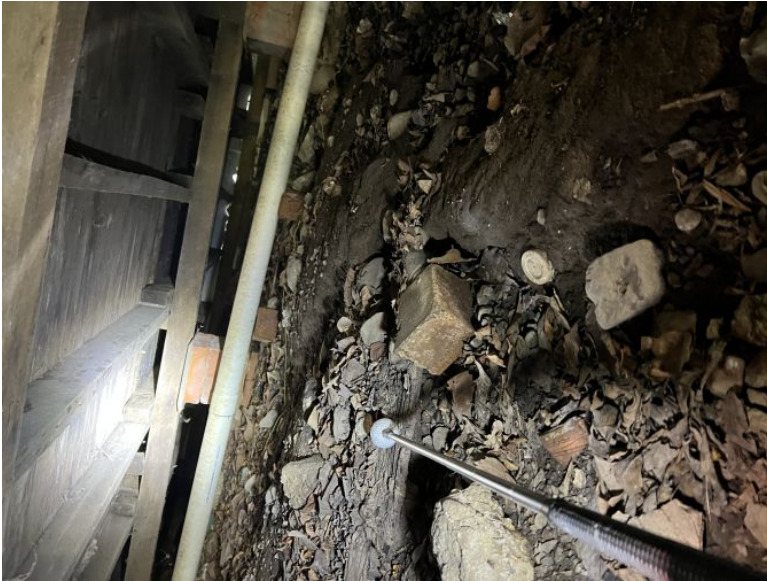
Image comments: Runoff to rear of dwelling to subfloor

Visible extent: Localised.  
Recommendation: Recommendation:  
a. Perform all stormwater recommendations as per this report.  
Monitor and IF required.  
a. Add a rubble drain and AG line OR dish drain top of dwelling and carport directed to storm water.  
b. Consult a licenced plumber or builder. Blake Crossingham Easy Flo plumbing and gas 0437 404 692. OR builder Danny Christie Building 0434 943 571

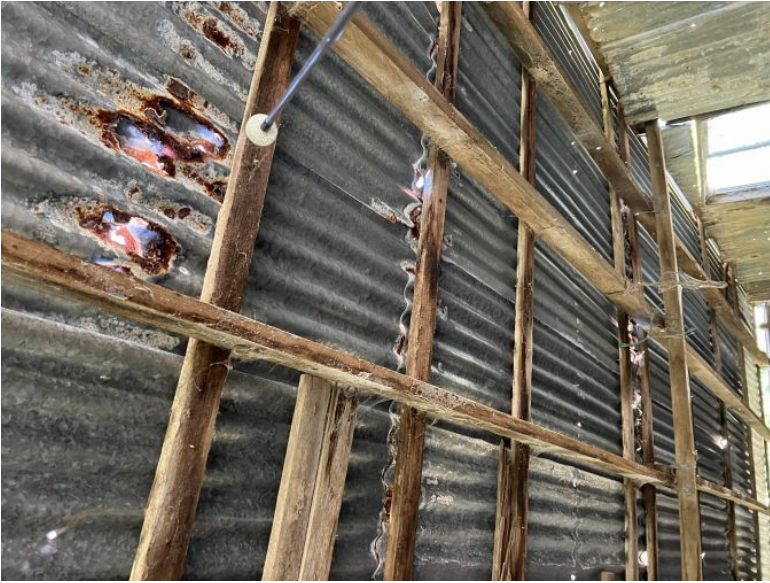
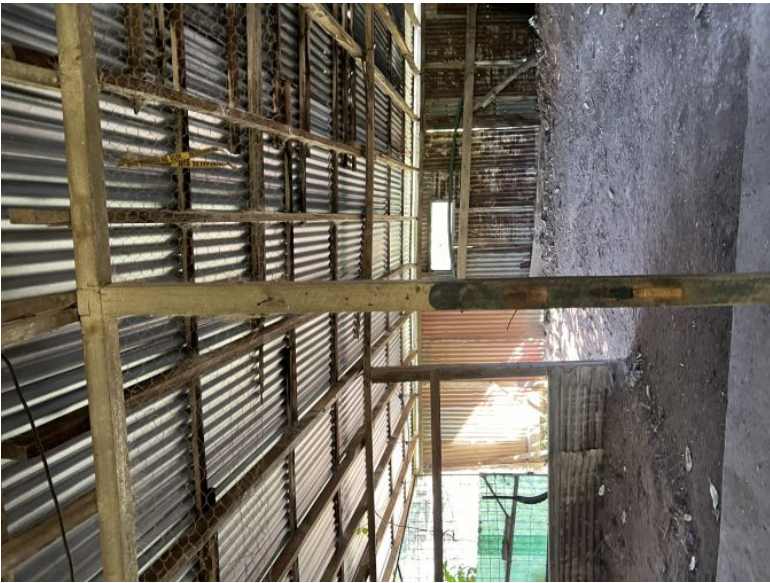
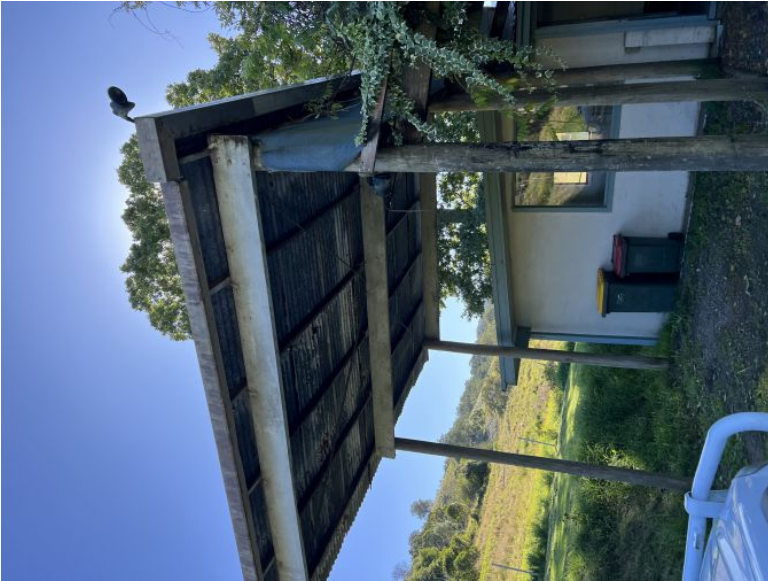
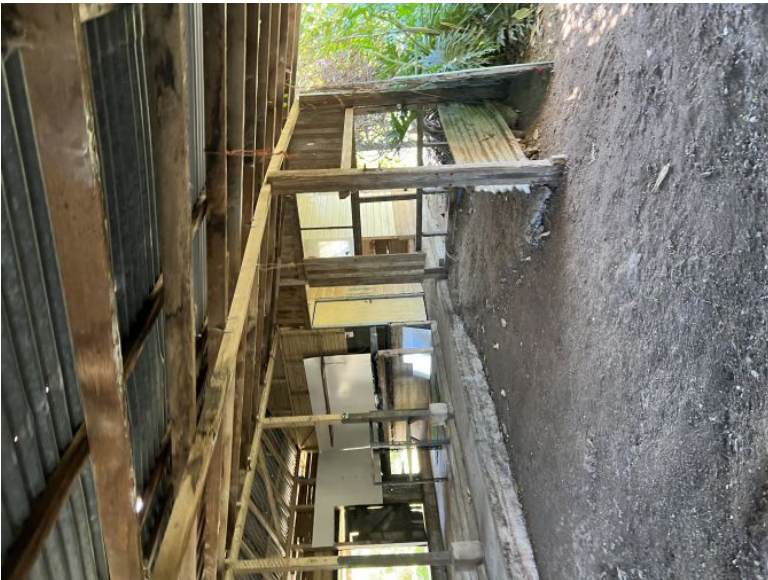
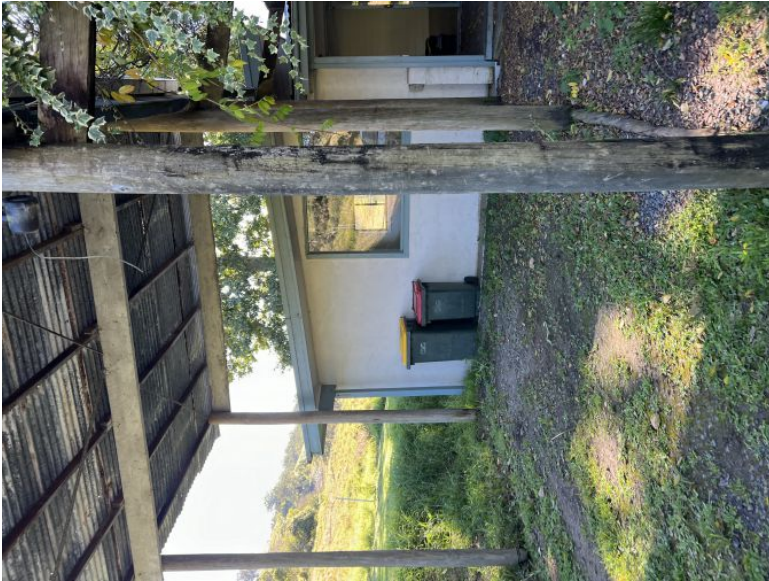
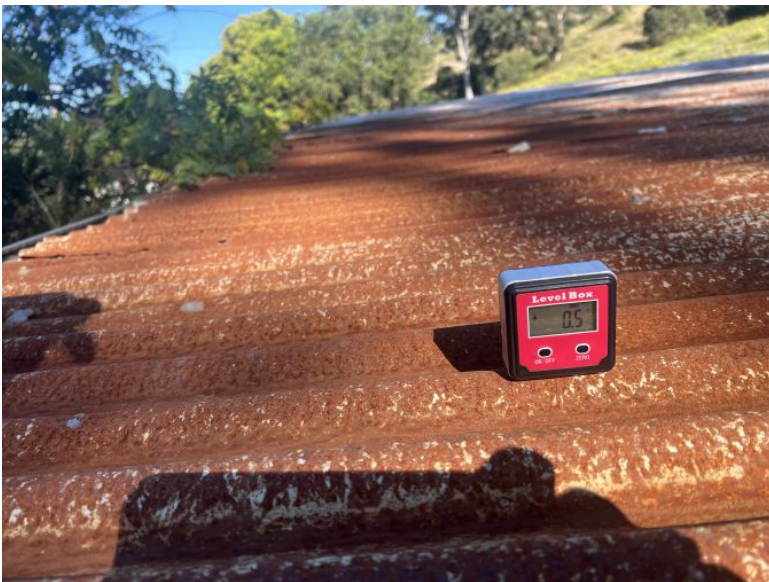
Area	Outbuildings
Location:	Detached carport and shedding
Affected element:	Structure.
Defect or Sign:	Current carport and shedding not constructed to standards. a. Iron under pitched. Sag in rafters, too large of span for timbers used. Wall frames into ground.
Visible extent:	Localised.
Recommendation:	Recommendations: a. Repair/ replace. Consult a licenced builder. Danny Christie Carpentry 0434 943 571

Image comments: Dairy building span of timbers sags

Image comments: Under pitched carport

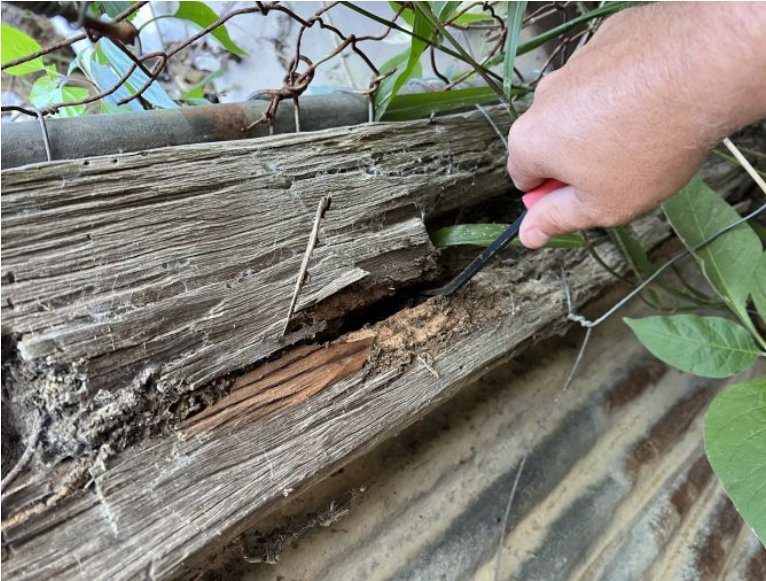
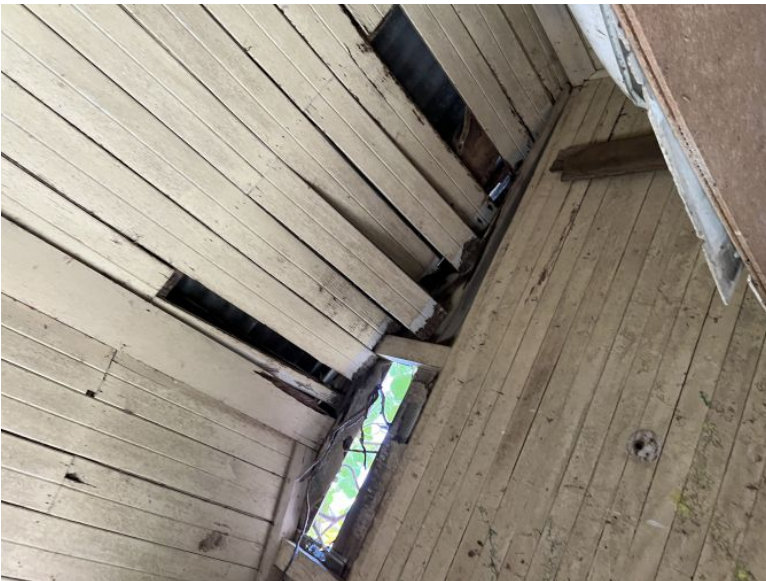
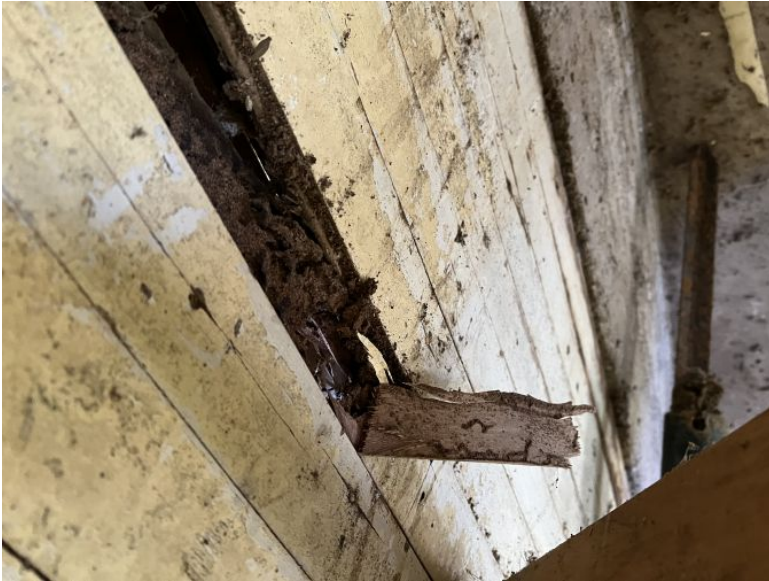
Image comments: Widespread damage

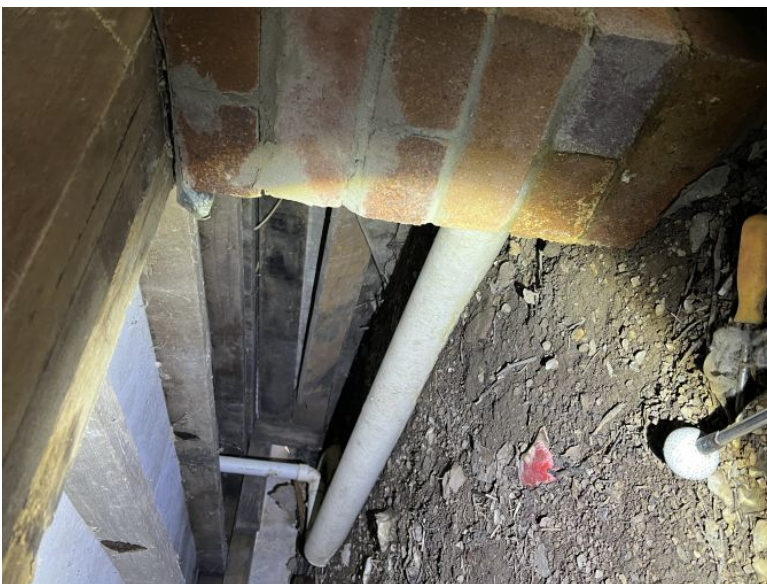
Area	Subfloor space
Location:	In general.
Adequacy:	Partially inadequate as cross ventilation is restricted.
Visible extent:	Localised.
Recommendation:	To help protect against the degradation of timber caused by fungal decay and/or insect attack, subfloor ventilation should be monitored

Image comments: Limited crossflow ventilation
