## **PRE-PURCHASE PROPERTY & TIMBER PEST REPORT**

Report number: PTPR\_9444  
Inspection date: Wednesday 12th June 2024  
Property address: 1893 Comboyne Road,  
Killabakh  
NSW 2429

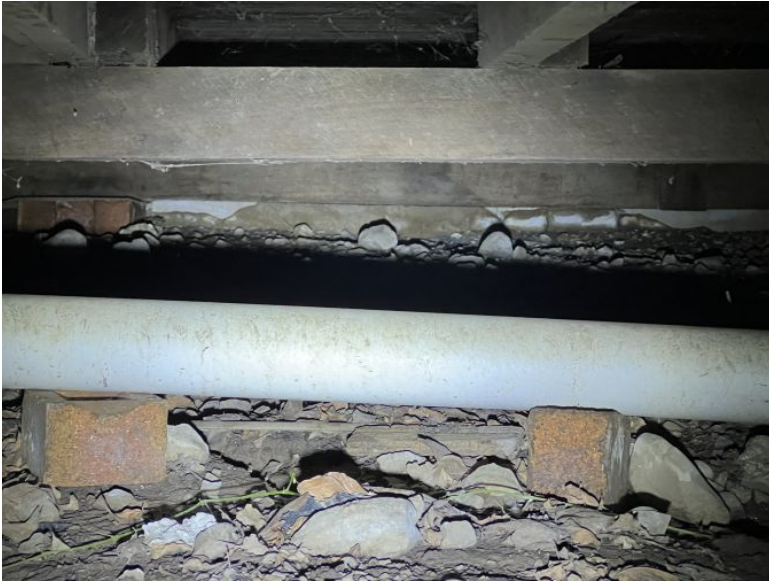
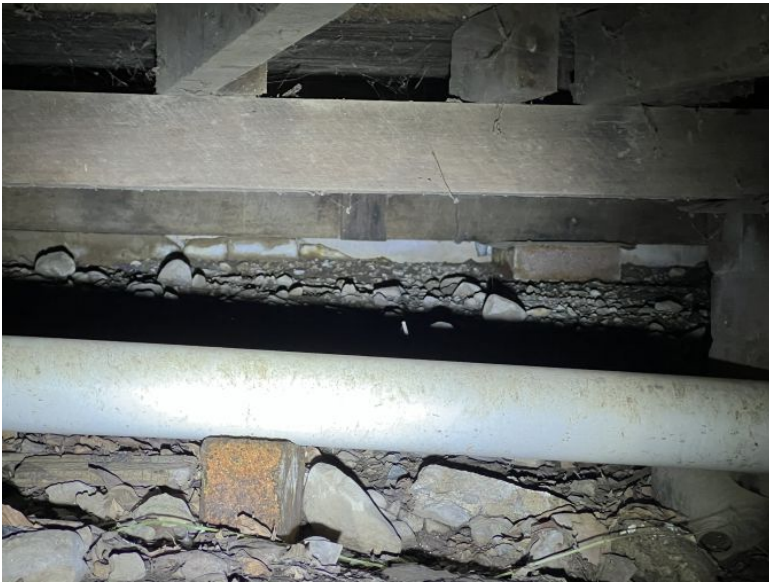
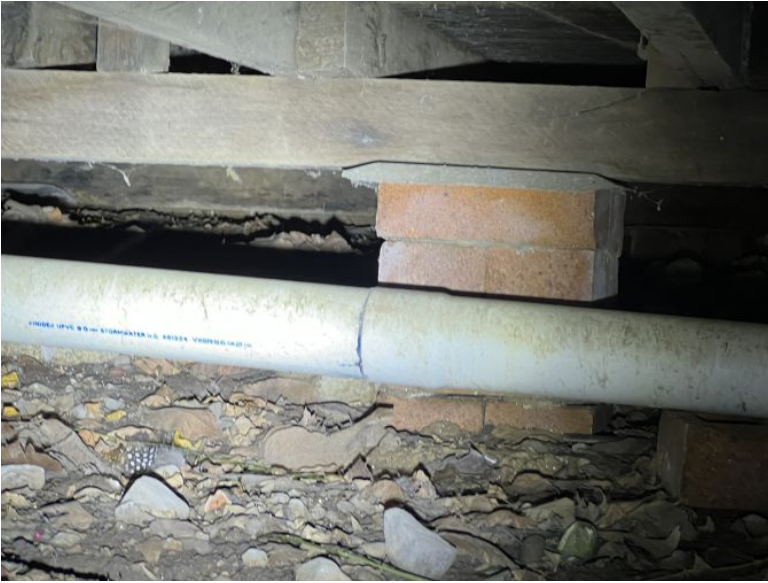
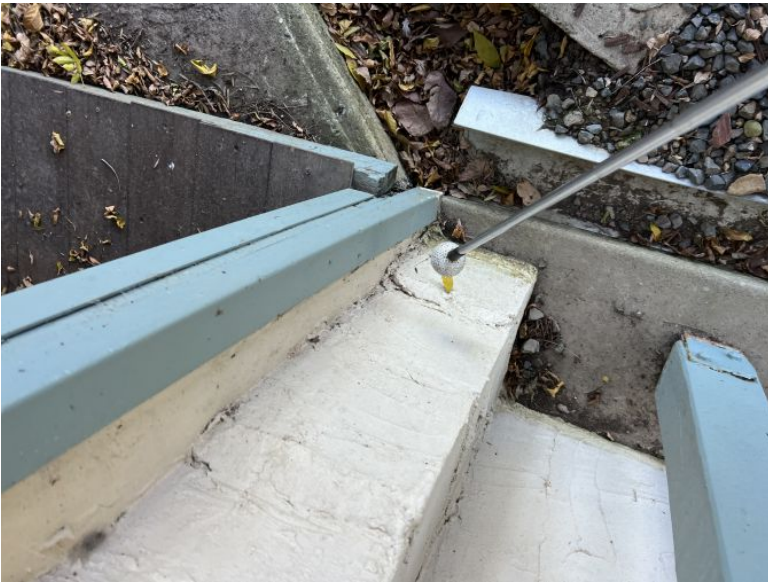
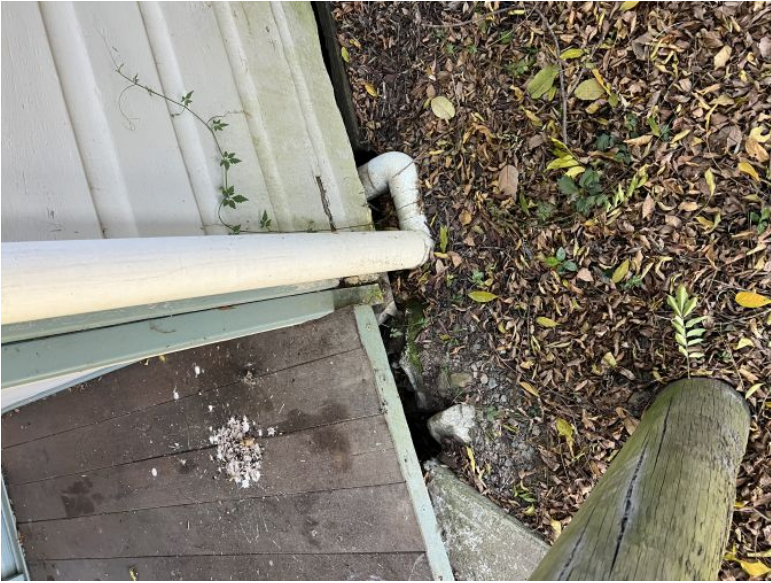
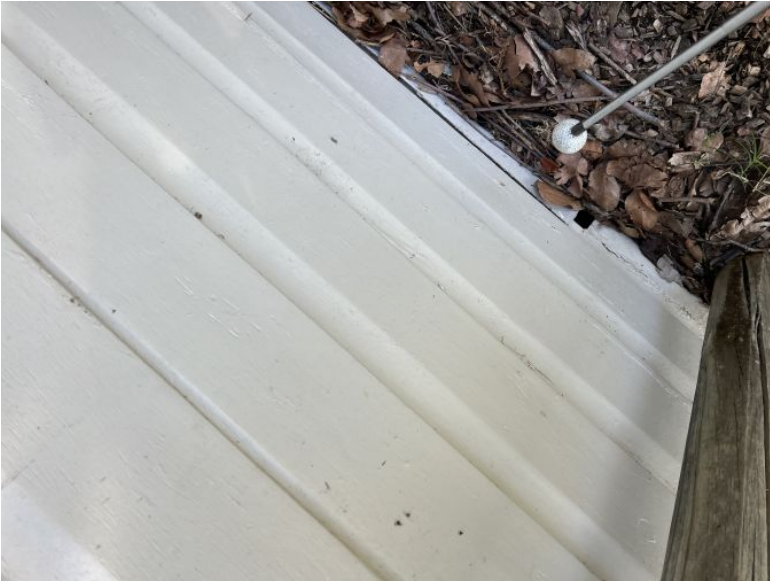
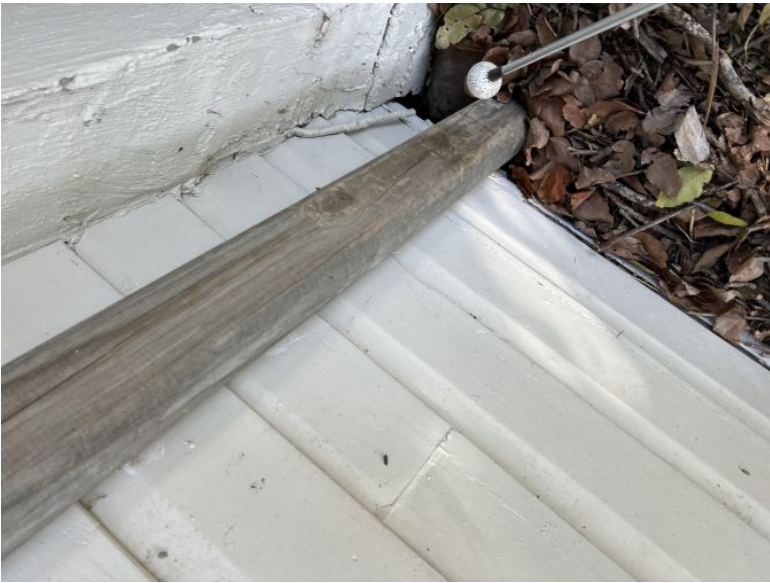
Area	Subfloor space
Location:	At the rear of the building.
Affected element:	Inspection zone.
Defect or Sign:	Bearers concealed by earth.
Visible extent:	Widespread.
Recommendation:	Unless appropriate written evidence of an alternative termite management program is provided, to help protect against undetected termite entry to the building, a continuous inspection zone of at least 75 mm should be provided and maintained. The inspection zone forces termites into the open where they can be detected more readily during regular inspections. For further advice consult the person who carried out this inspection.
Area	Outbuildings
Location:	Detached shed.
Affected element:	Inspection zone to the slab edge.
Defect or Sign:	Bridged.
Visible extent:	Widespread.
Recommendation:	With a concrete slab building, it is essential that the edge of the slab is permanently exposed. An inspection zone of at least 75 mm should be maintained so that termites are forced into the open where they can be detected more readily during regular inspections. Importantly, the edge of the slab should not be rendered, tiled, clad or concealed by flashings, adjoining structures, paving, soil, turf, landscaping or the like. For further advice consult the person who carried out this inspection.

Image comments: Rear dwelling bearers to ground

Image comments: Timbers to ground

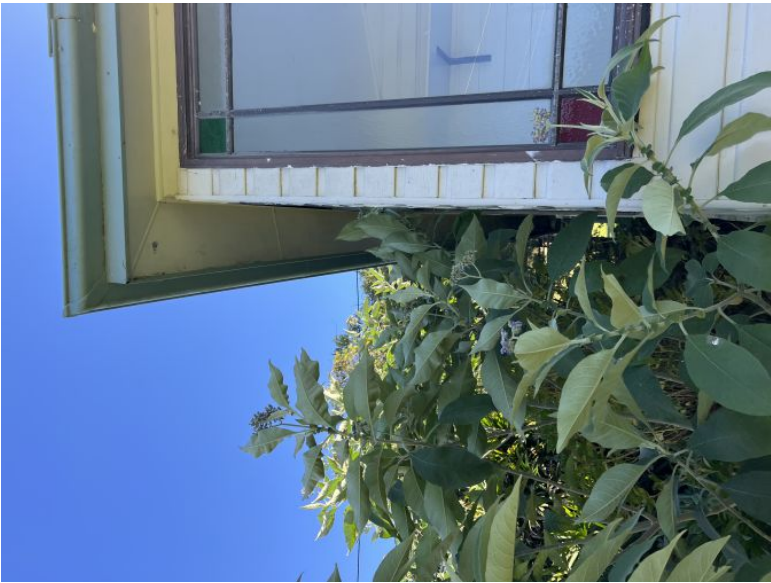
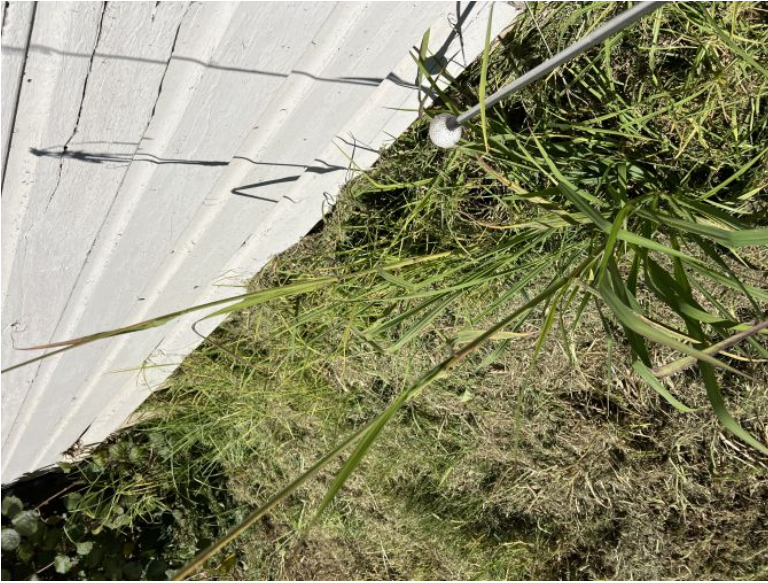
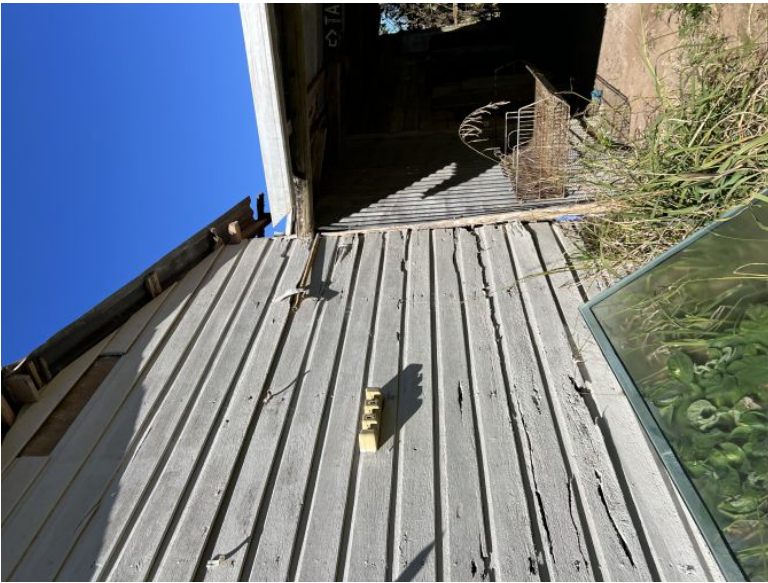
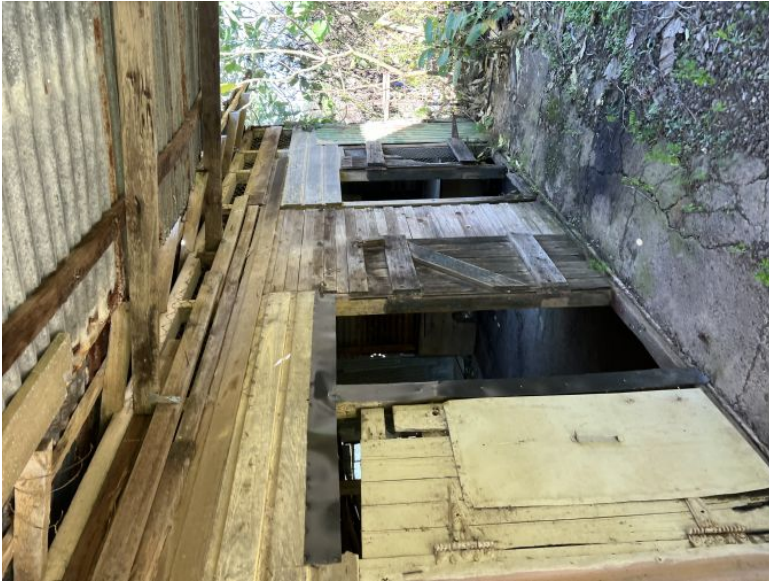
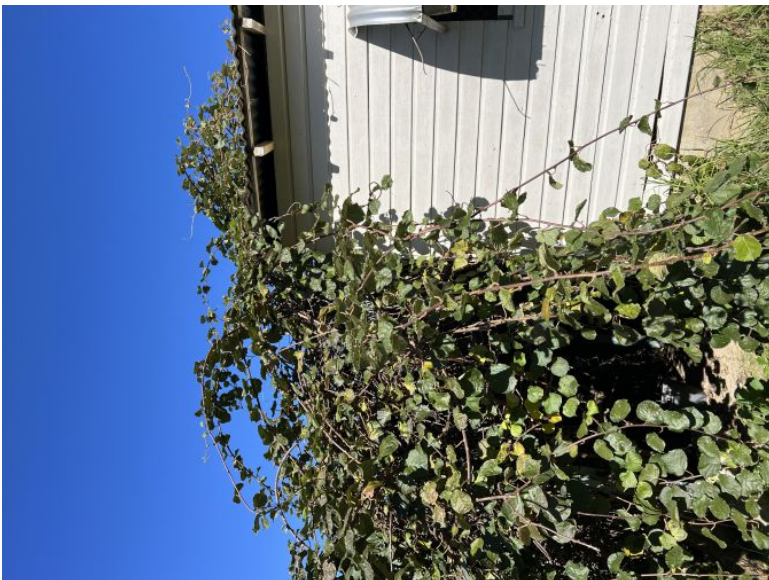
Image comments: Foliage to dwelling

Image comments: Dairy foliage and weatherboards

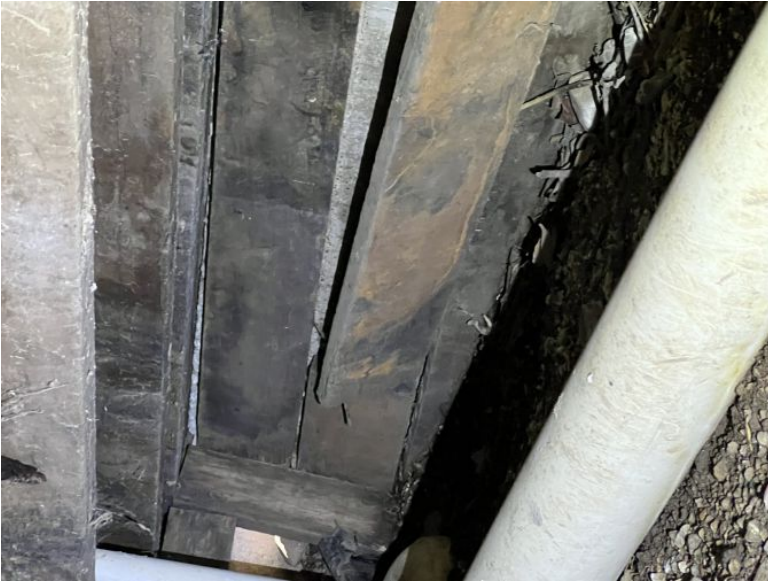
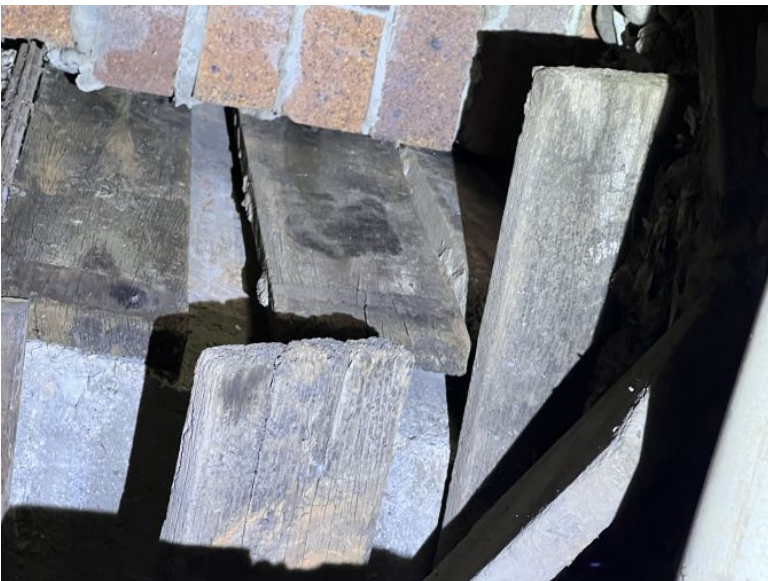
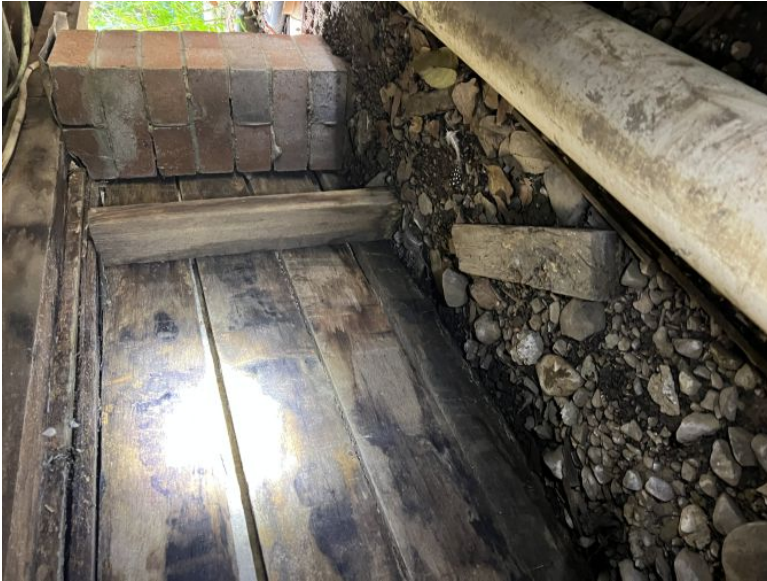
Image comments: Formwork still in position
