Building and Timber Pest Inspection Report

Inspection Date: Sat, 22 Aug 2020

Property Address: 2 Cynthia St, Pymble NSW 2073, Australia

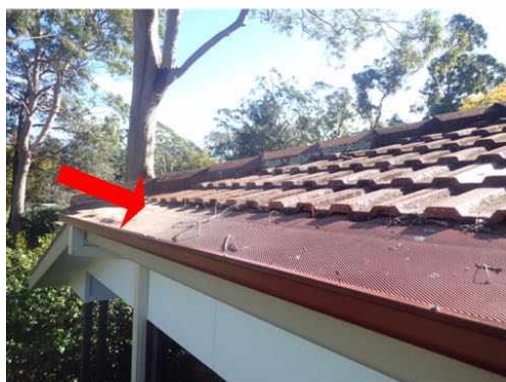
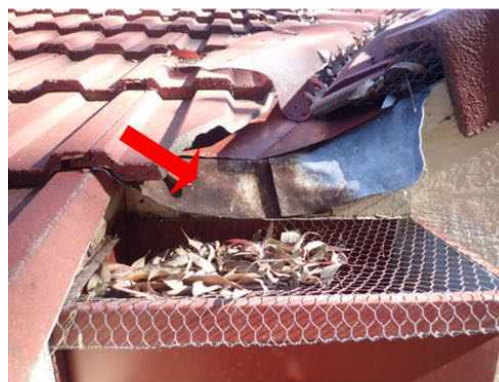
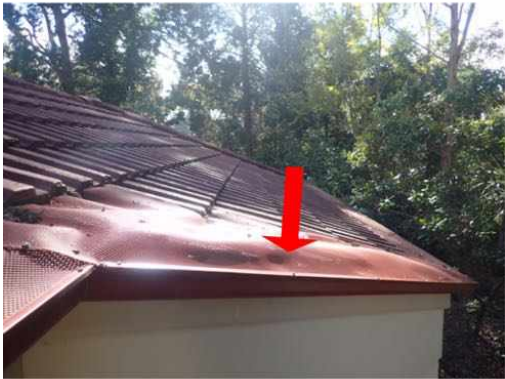
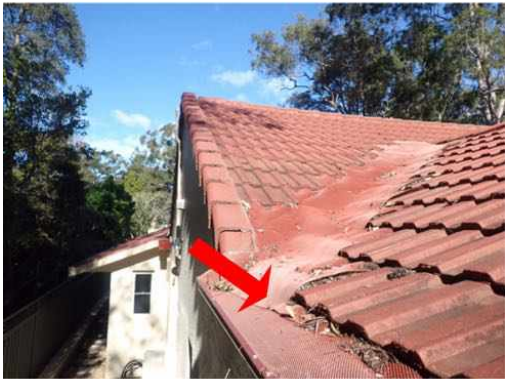
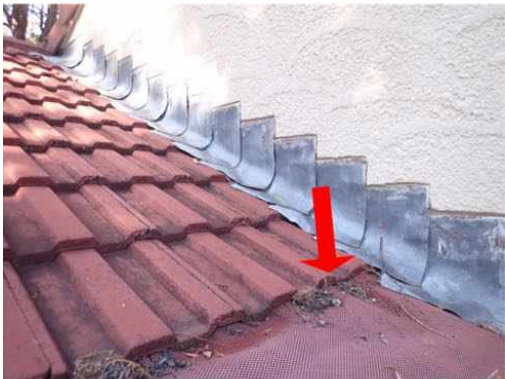
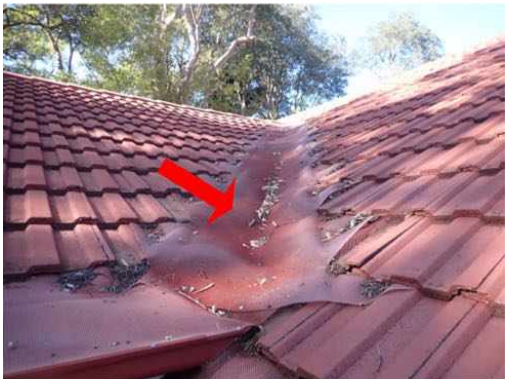
Finding 3.01

Location: Roof Exterior

Finding: External Roof Covering & Plumbing - (Maintenance Information)

All roof coverings & plumbing, flashings, exterior guttering, box gutters and downpipes, even with gutter guard products installed, should remain free of all debris and possible blockages.

Blockages may lead to pooling, accumulated water overflows, possible water ingress and the associated damage to adjoining building elements.

Regular inspections & maintenance of all roof coverings & plumbing is recommended to ensure stormwater flows are adequate and to ensure no water ingress into the property.

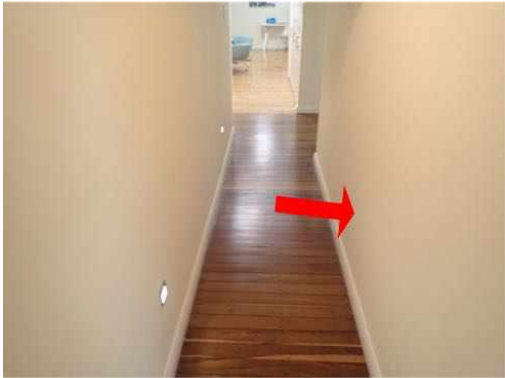
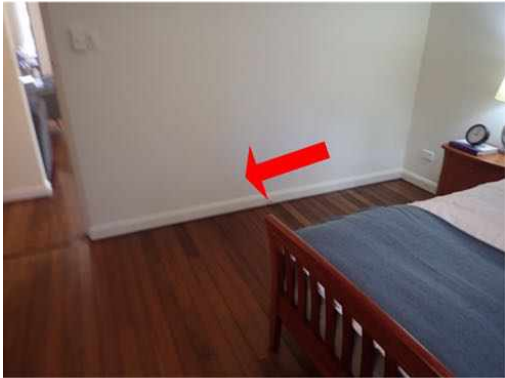
Finding 3.02

Building:
Location: Masonry Walls
Finding: Moisture Levels - Information Only -
Information:

At the time of inspection, all lower ground floor masonry walls appeared dry with normal (low) moisture readings detected in the tested areas and no visual signs of any rising or lateral damp evident.

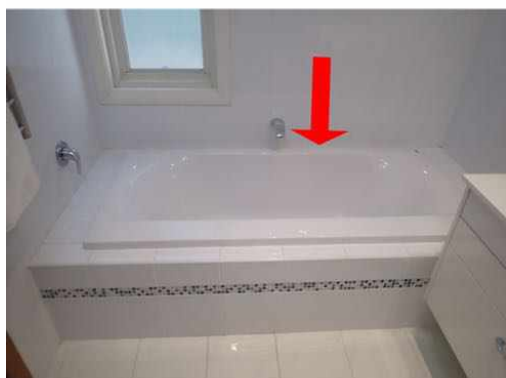
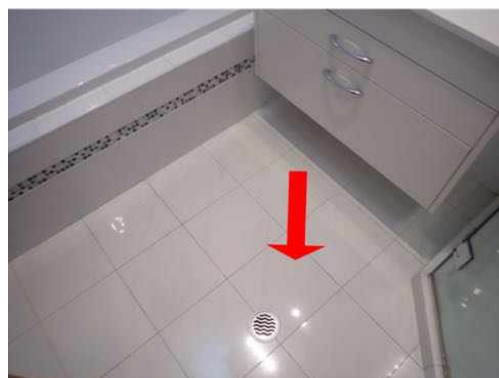
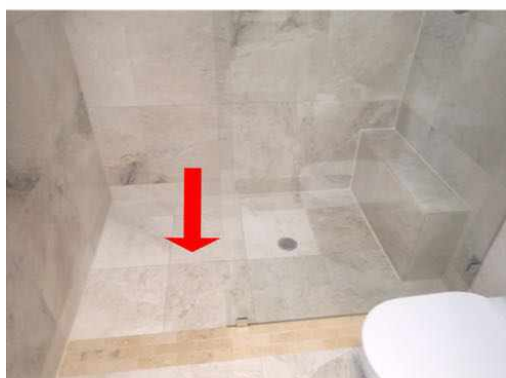
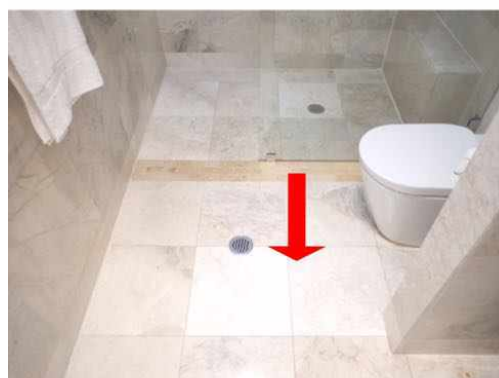
Finding 3.03

Location: Wet Areas

Finding: Water Proofing Membranes - Information Only -

Internal Water Proofing Membranes, are crucial in preventing water ingress into the property is important to know that the Membrane System used is to Australian Standards and has been installed correctly.

With older property's where this information is unavailable all wet areas should be monitored. If any leaks, water staining, peeling or bubbling of the paint become evident to any adjacent walls or ceilings below a licensed builder or waterproofing specialist is recommended to investigate further.

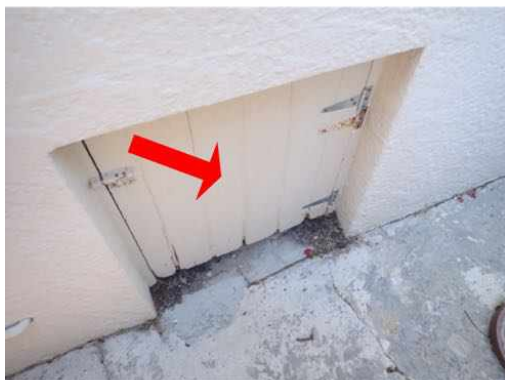
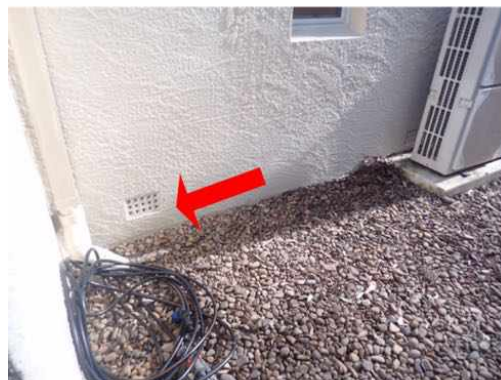
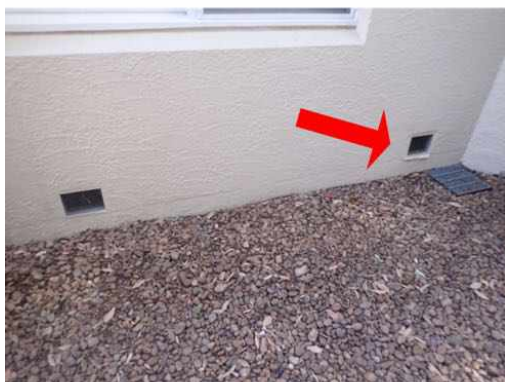
Finding 3.04

Location: Subfloor
 Finding: Subfloor - Maintenance
 Information:

With 'subfloor' type construction, good ground/ stormwater drainage & ventilation/ air movement is crucial in maintaining dry conditions, preventing rising damp and/ or secondary damage such as wood rot and pest activity.

- Subfloor vents were noted around the property.

- Limited access was possible to subfloor, the accessible areas appeared dry.

Subfloor areas should be monitored ensuring moisture levels, drainage & ventilation remains adequate. Regular pest inspections should also be carried out.

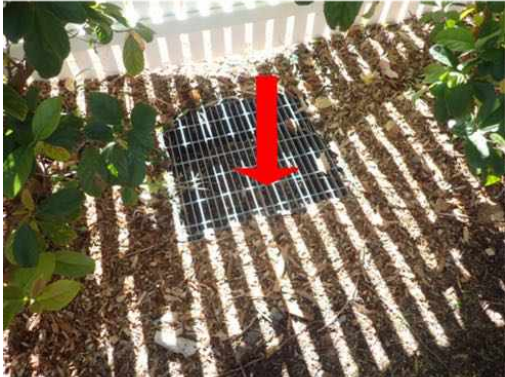
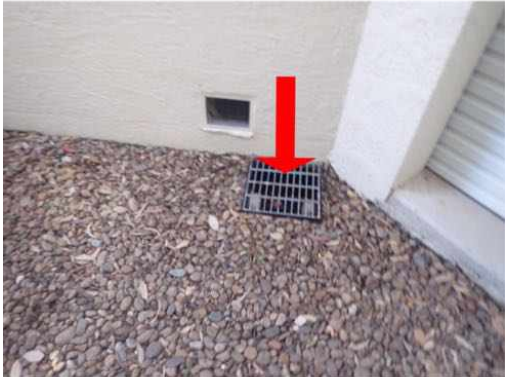
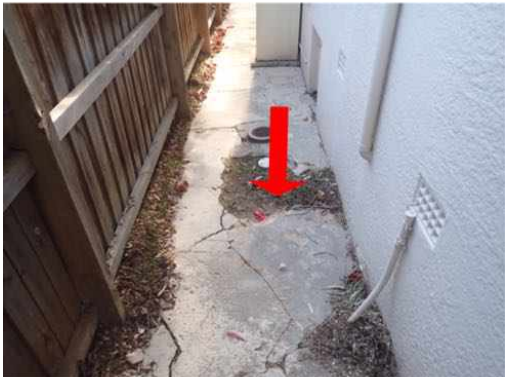
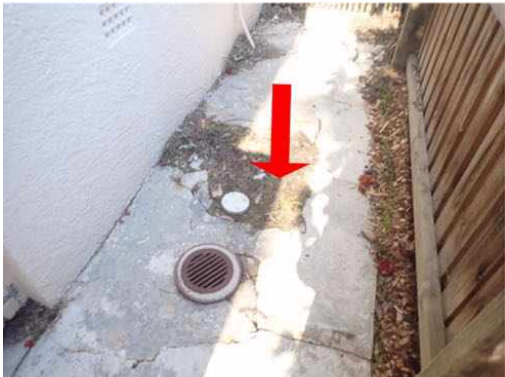
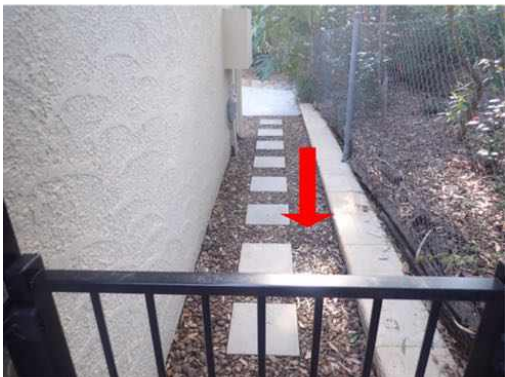
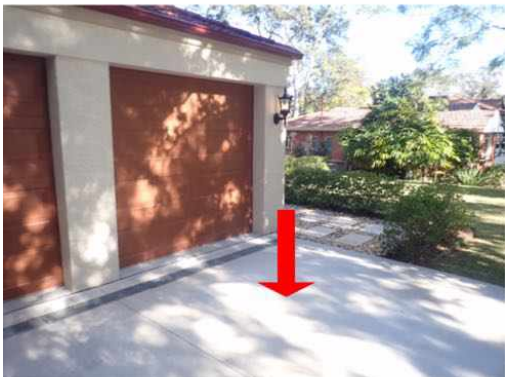
Finding 3.05

Building:
 Location: External Drainage
 Finding: Stormwater Drainage - (maintenance information)
 Information:

Storm water drainage points were noted to the sides and rear of the property.

It is important that water does not lie against the base of walls; surrounding paths and ground levels should be sloped to drain water away from walls creating potential for subsequent water damage to associated building elements,

These areas should be monitored during rain events to insure water flow is adequate.

A licensed plumber can advise further on regular maintenance solutions.

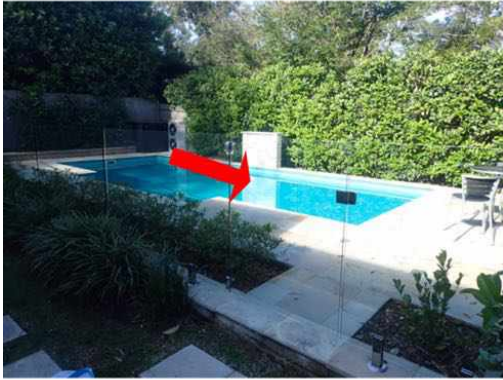
Finding 3.06

Building:
Location: Pool Fence
Finding: Pool Fence - Certification

Information: This report does not cover pool fence compliance. However at the time of the inspection the pool fence did appear to be in good condition with the gate self closer operational.

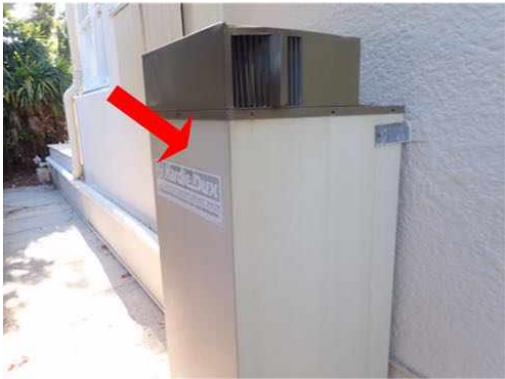
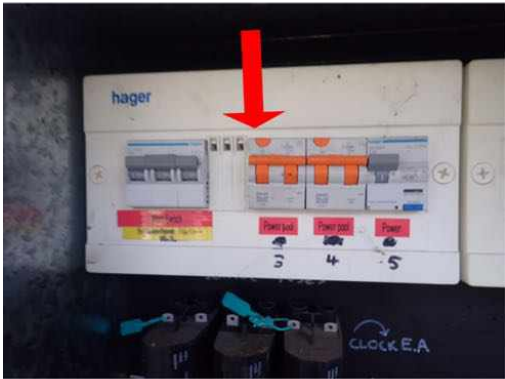
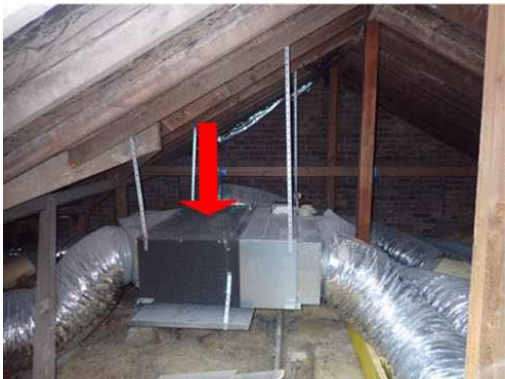
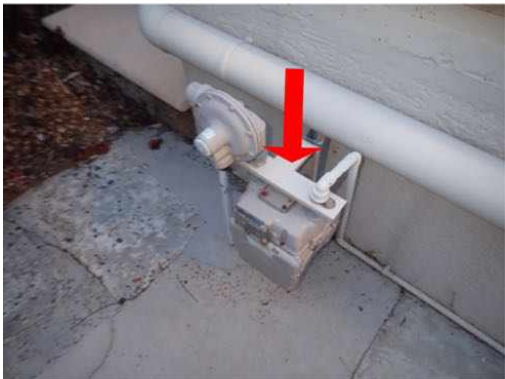
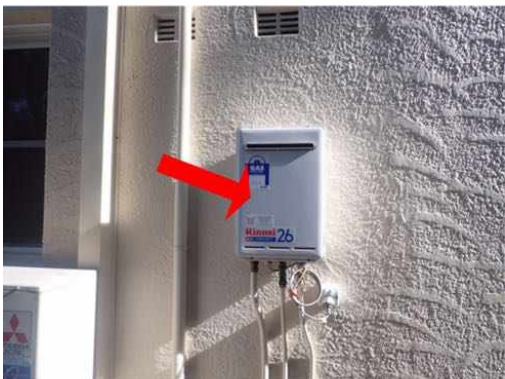
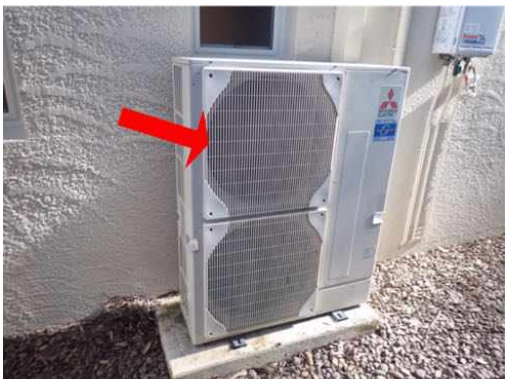
Finding 3.07

Services

Services - Maintenance (information only)

It is recommended that a Licensed Electrician and a Licensed Plumber check over any newly purchased property with the new owners to avoid any electrical or plumbing problems in the future and to instruct new owners on proper use, care and maintenance of all electrical, plumbing and any other elements to prolong their life time and safety.

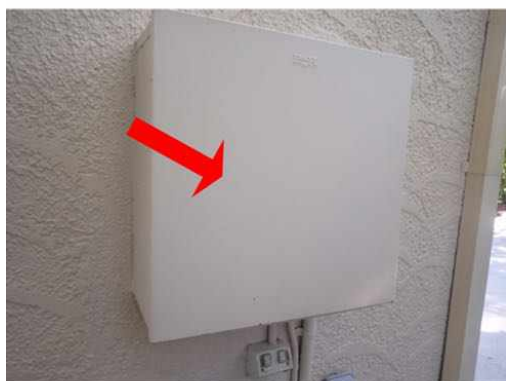
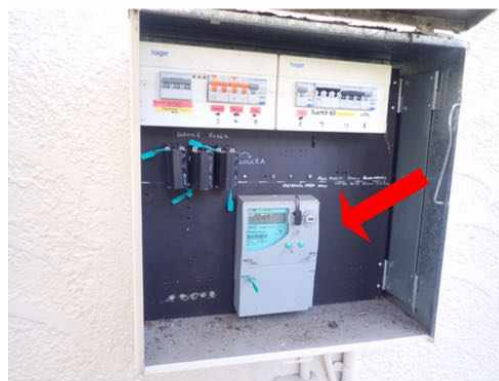
Finding 6.01

Location: Mains Board

Finding: Termite Management System - no evidence of installation (mains board)

A durable notice should be placed in the switchboard unit to indicate current termite barriers. At the time of inspection, it appeared as though no termite management system has been installed. With no termite management, lack of full subfloor access, surrounding trees, vegetation & possible concealed entry points, this puts the property at risk.

The application of a post-construction chemical termite barrier is highly recommended for all properties.

A licensed termite treatment specialist should be engaged to investigate further and advise on possible treatment solutions.
