Site Classification

Neilson Street, Edgeworth –

Stage 11

Report Ref: G0109-SC-001-Rev1

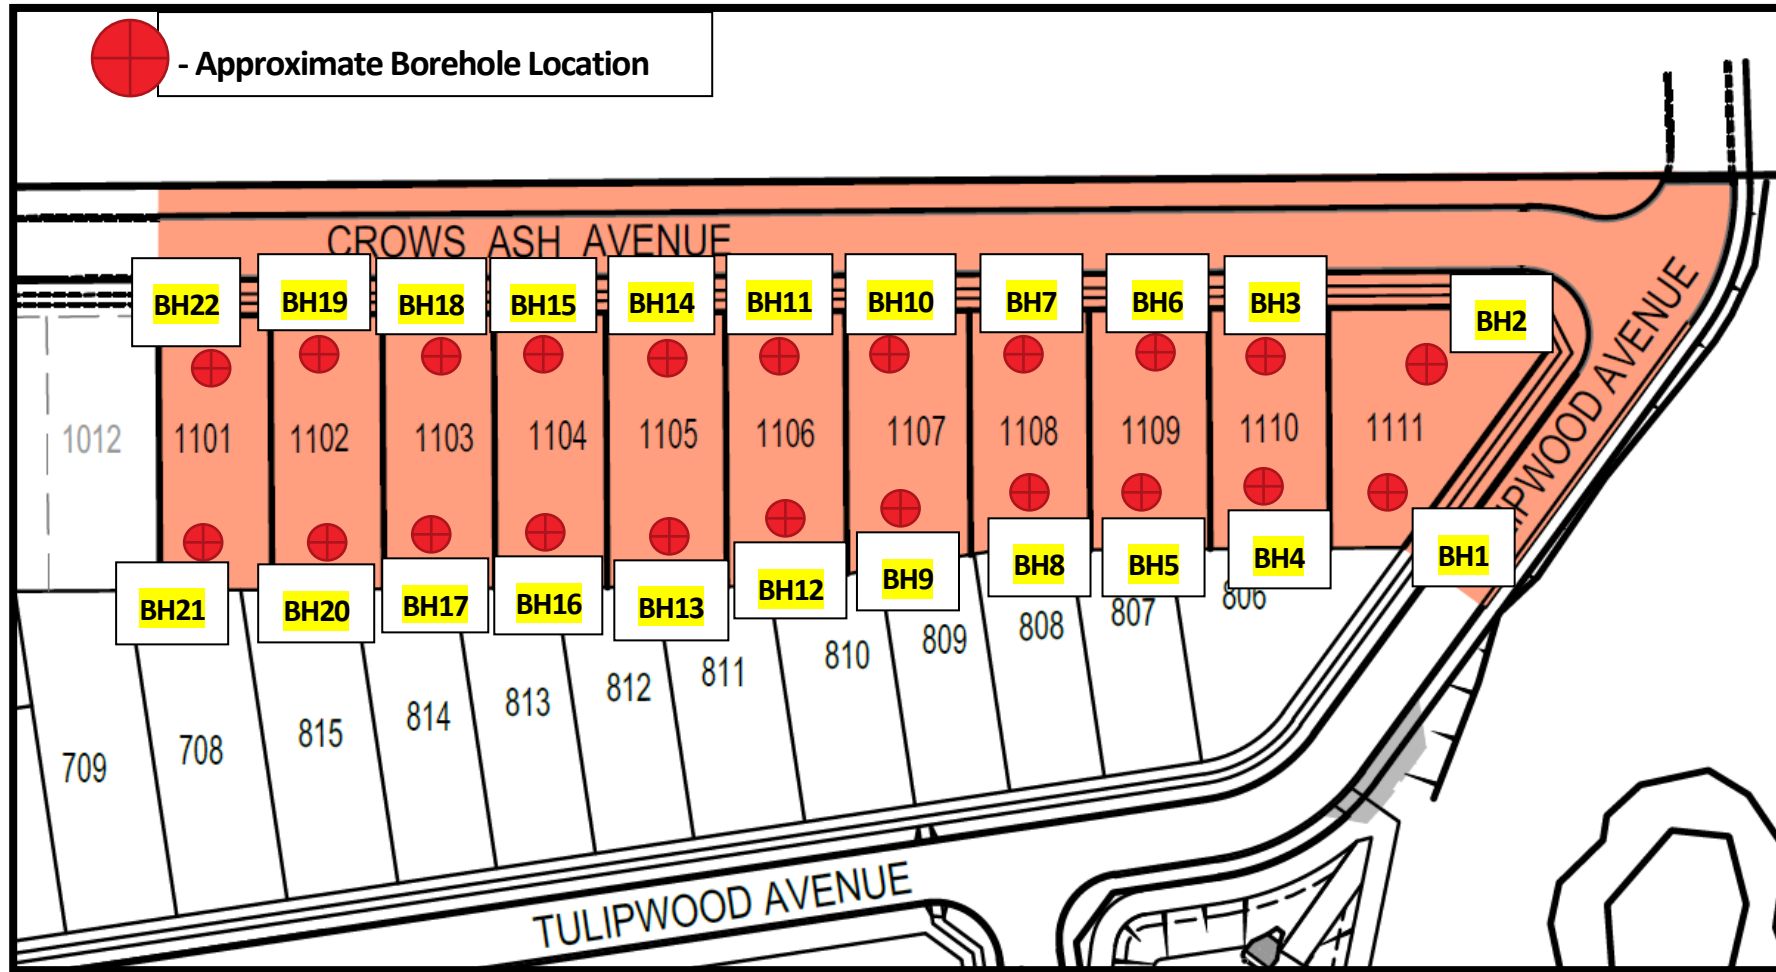
Figure 1 – Plan of the development at Neilson Street, Edgeworth showing the approximate location of the Geotechnical boreholes.
