**PRE SALE
STANDARD PROPERTY REPORT**

Report number: PPI202367

Inspection date: Wednesday 8th February 2023

Property address: 25 Yandala Place Clothiers Creek NSW

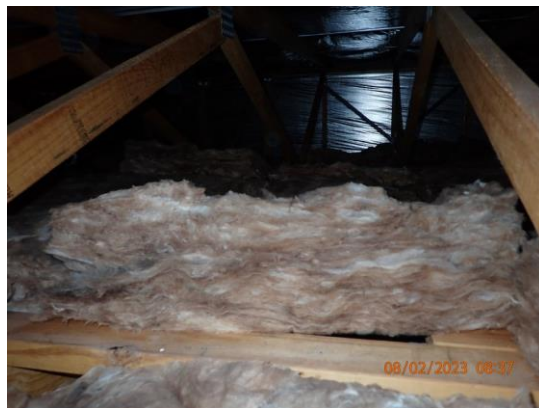
3

There is deflections/sagging to the ceiling joists and roof framing members in areas due to age and the building techniques used at the time of construction. Hanging beams could be installed in the roof void and the ceiling joists and roof framing fixed to the beams to prevent further deflection/sagging (see photo below)
