Inspection Report

2/22 Hastings Road, Bogangar, New South Wales, 2488

Inspection Date: 24 May 2024

Building Inspection

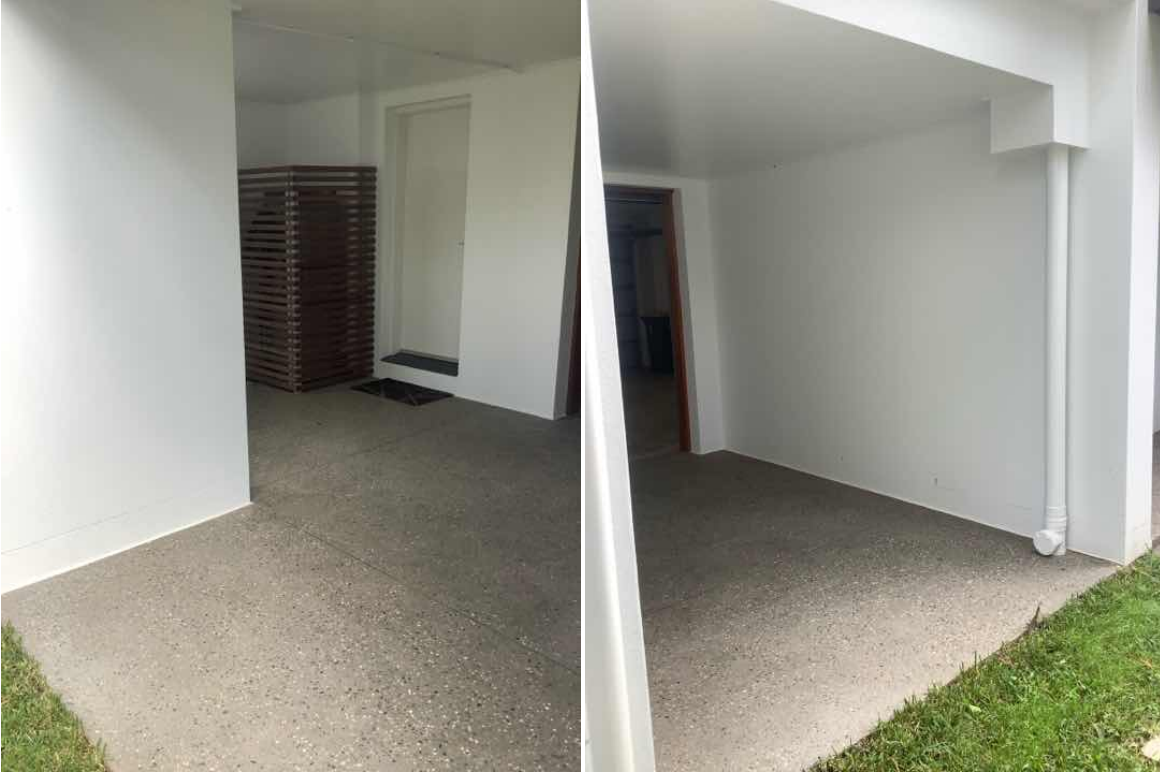
Visible sections of the Alfresco area are serviceable or in reasonable or condition for the age of this dwelling.

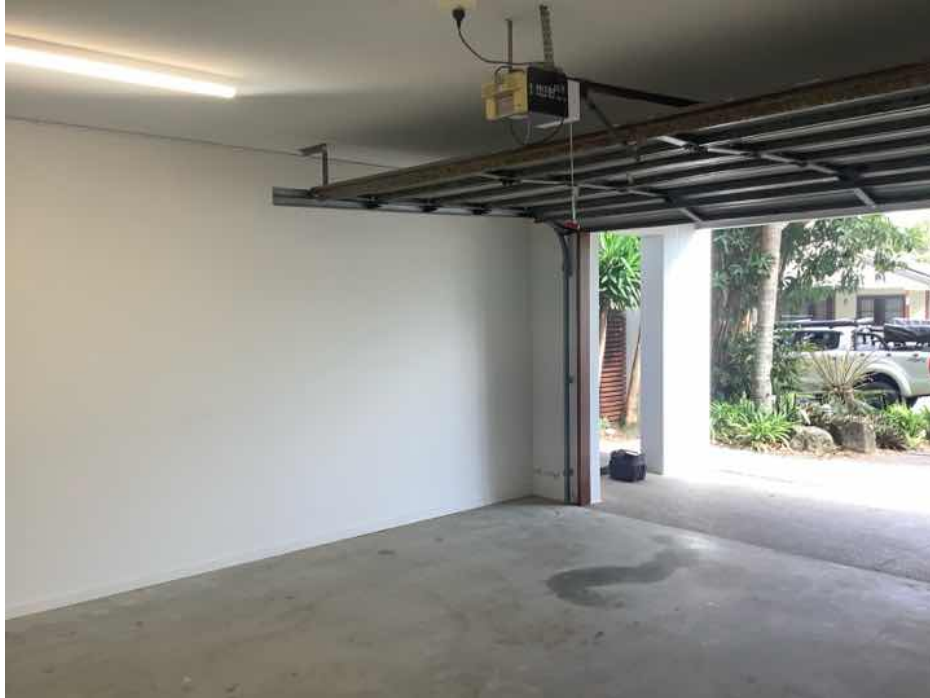
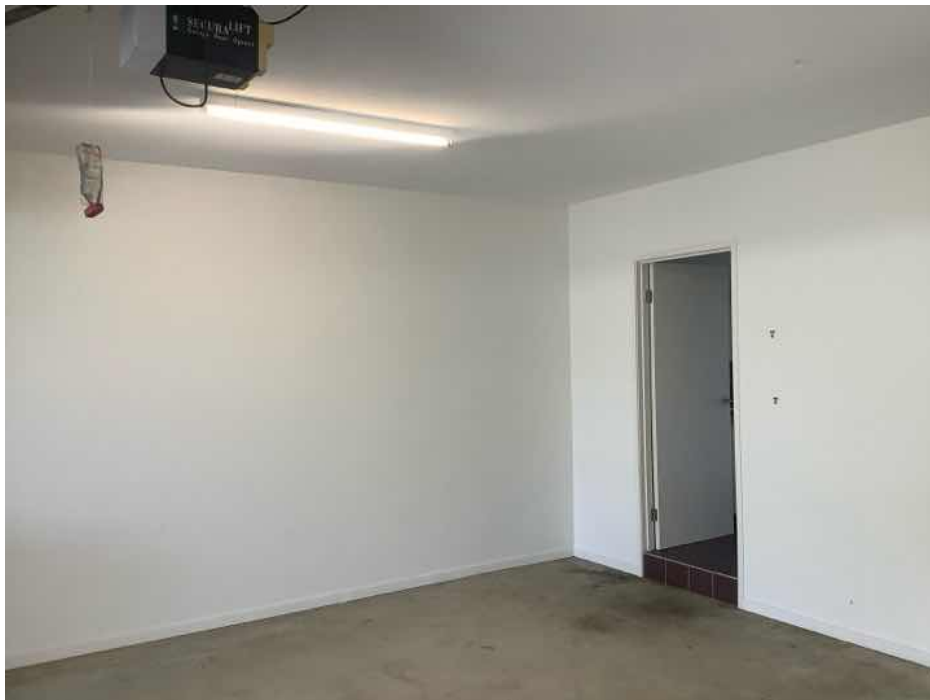
On inspection, defects were present that will require further assessing and recommendations by qualified trades persons, please read below for details.

Dampness and mould noted to lower wall beside garage door. This section of wall is plaster direct fixed to masonry. Recommendations, strip away plaster and apply water proofing to masonry wall.

Minor hairline slab cracks - Note. Whilst these cracks appeared to be minor at the time of inspection, we strongly recommend you monitor these cracks and if worsening occurs contact a qualified concreter for further advice.

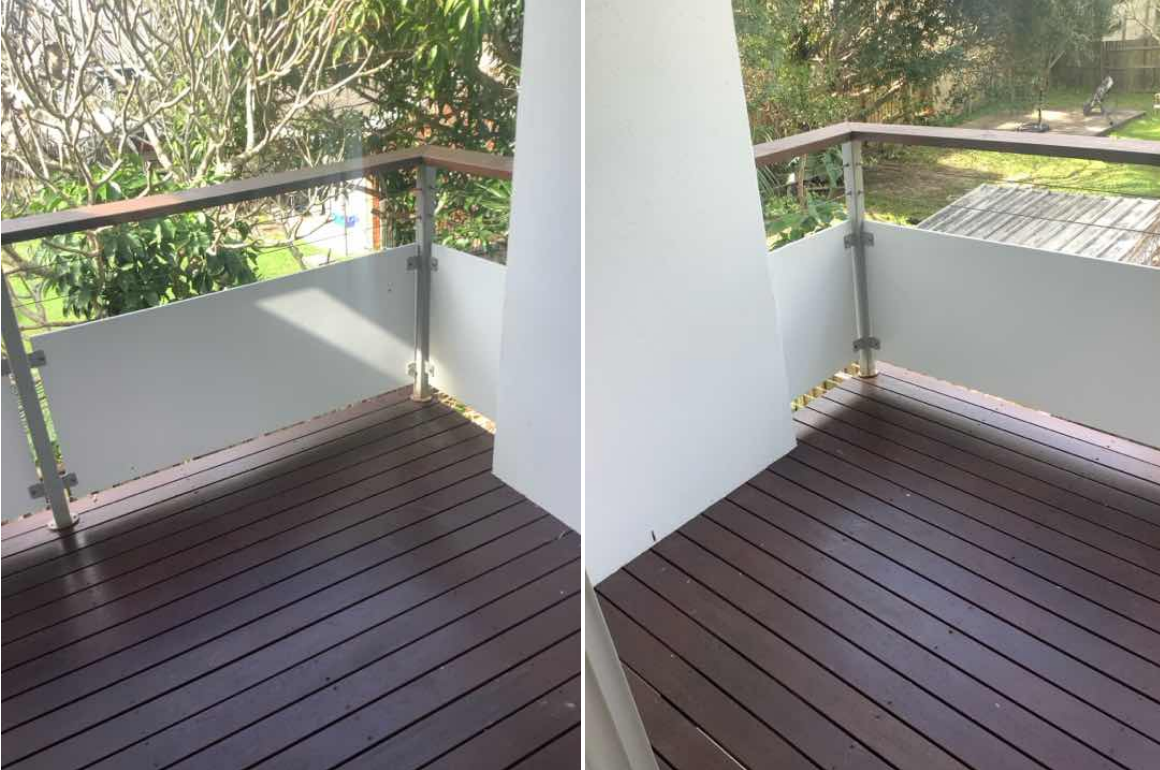
Though we are not structural engineers the balcony/s appear to be in a serviceable condition.

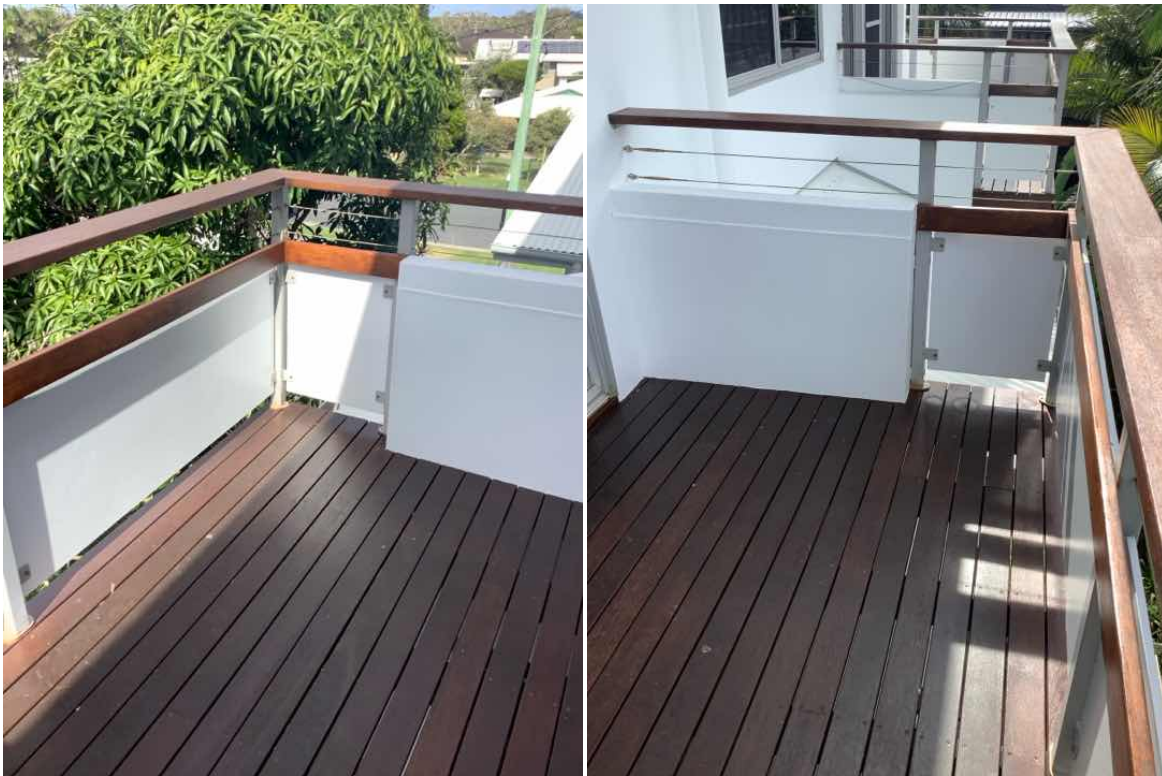
Frame Condition

On inspection, defects were present that will require further assessing and recommendations by licensed and qualified trades persons, please read below for details.

Timber fungal decay in section of bearer. A qualified carpenter should be engaged for advice and recommendations.

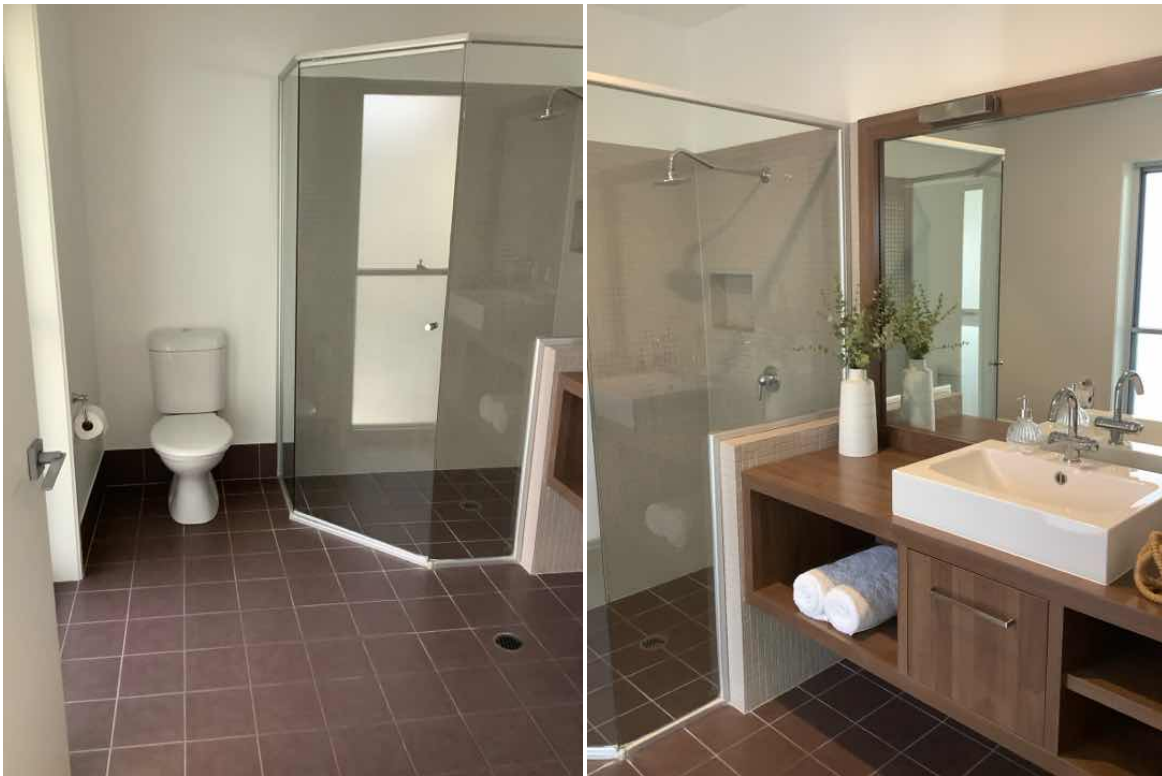
Walls

On inspection, defects were present that will require further assessing and recommendations by licensed and qualified trades persons, please read below for details.

Minor damage to walls above tile line in shower. Consult a painter for repairs.

Shower door binding when closing. Recommendations, consult a licensed contractor for repairs.
