Building and Timber Pest Inspection Report

Inspection Date: Sat, 22 Aug 2020

Property Address: 2 Cynthia St, Pymble NSW 2073, Australia

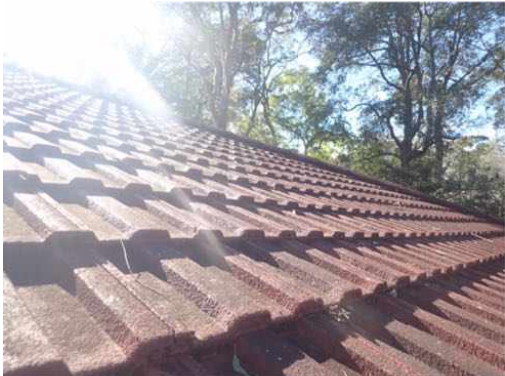
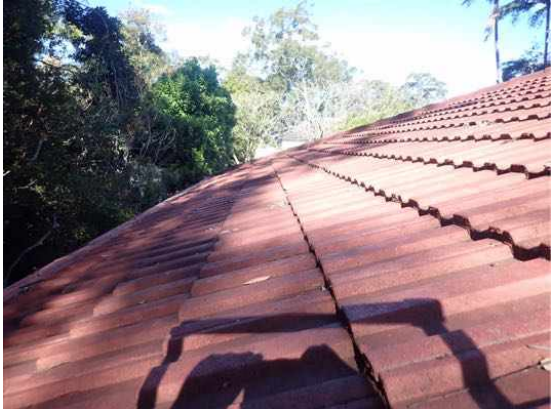
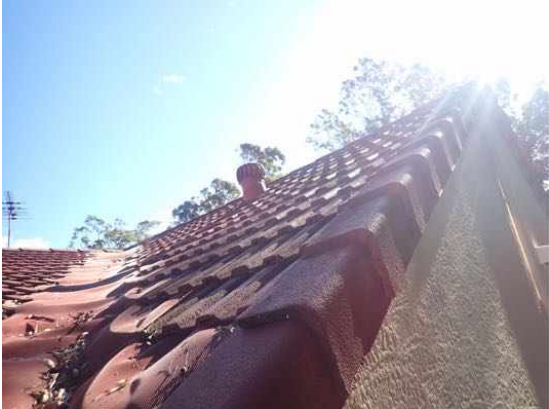
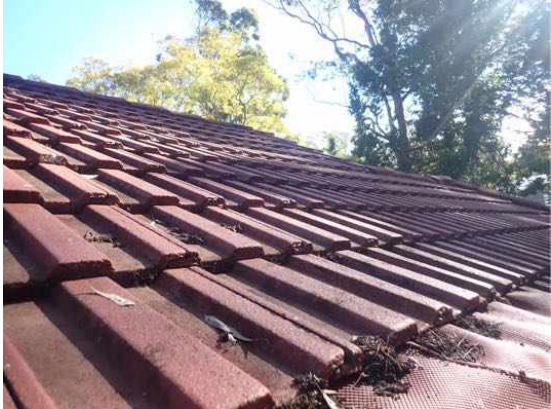
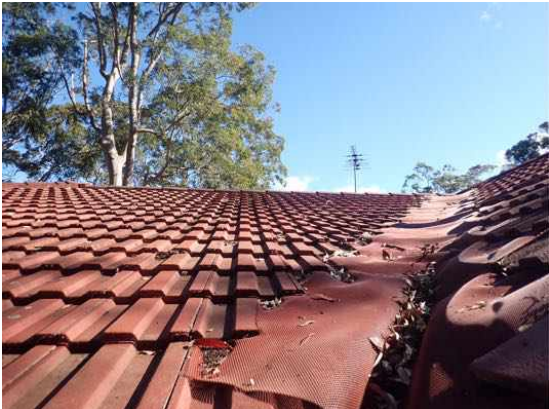
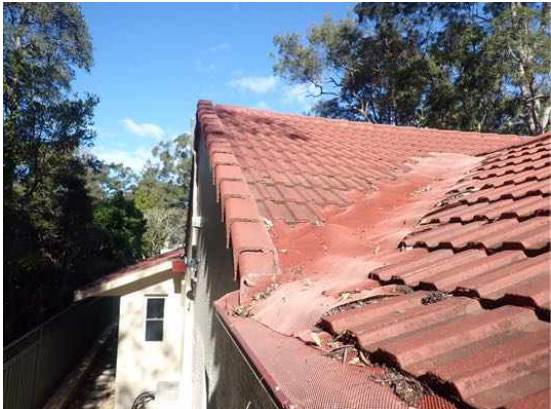
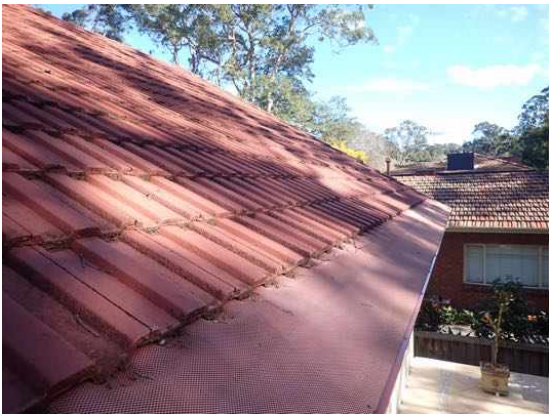
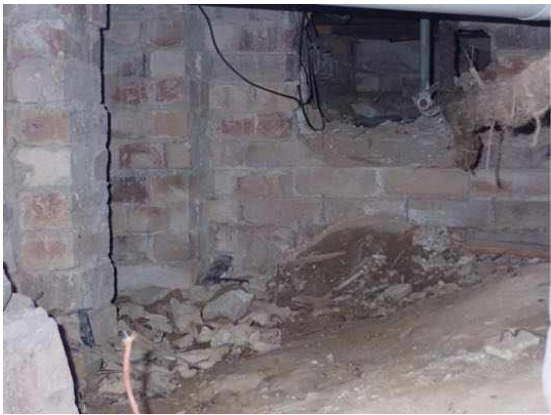
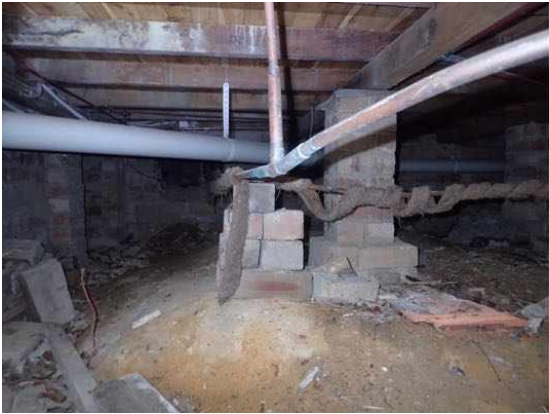
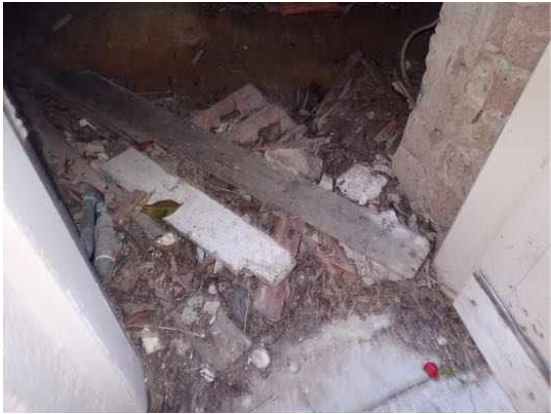
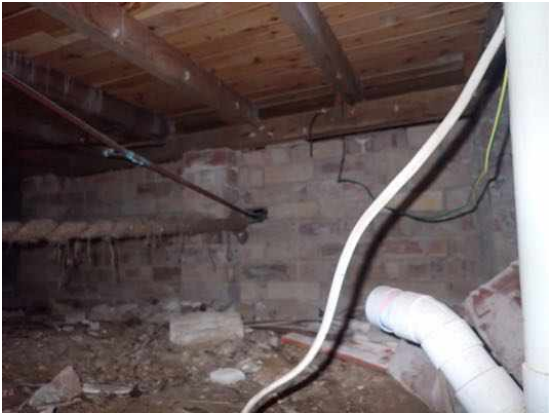
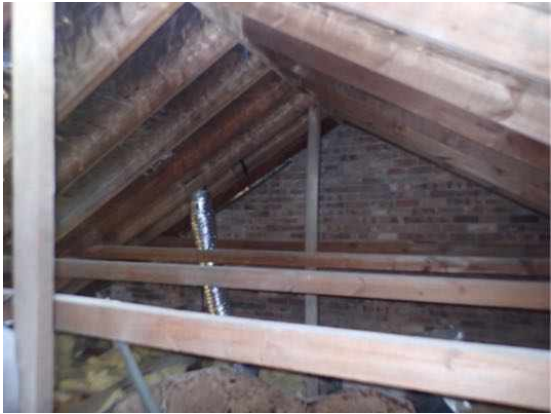
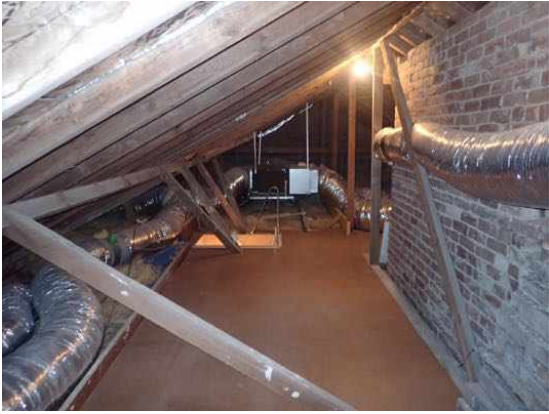
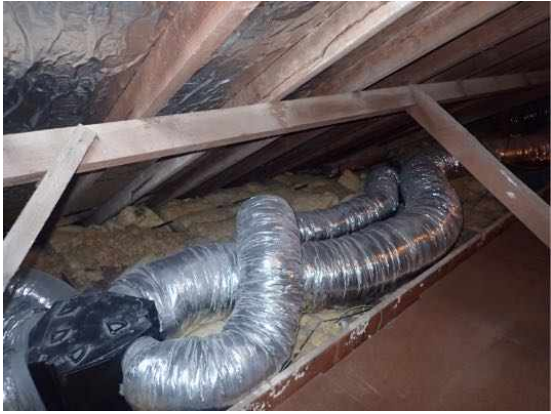
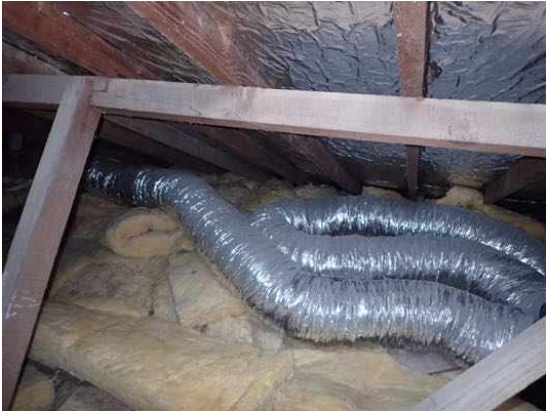
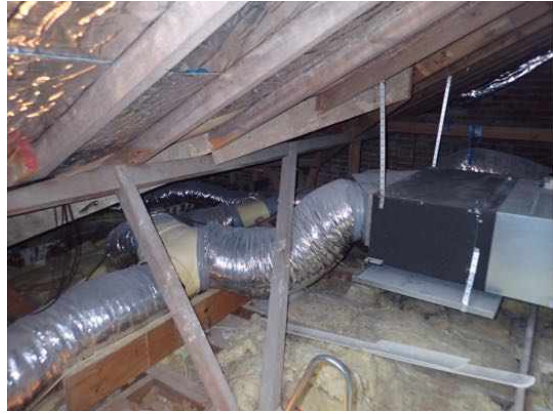
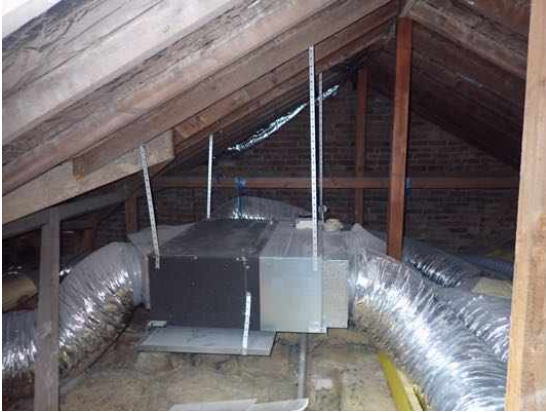
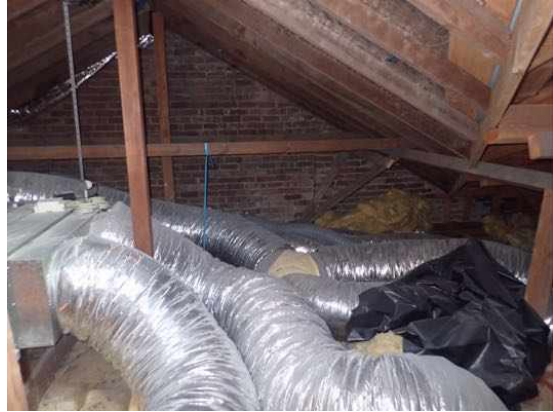
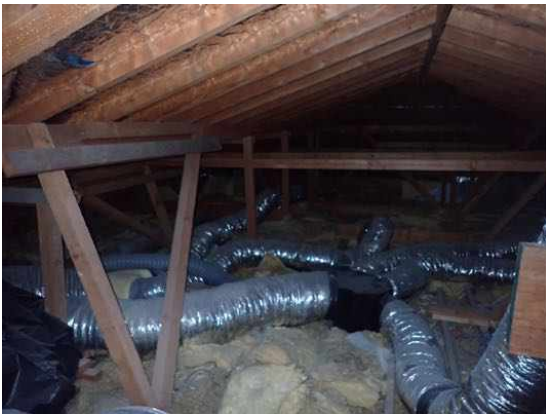
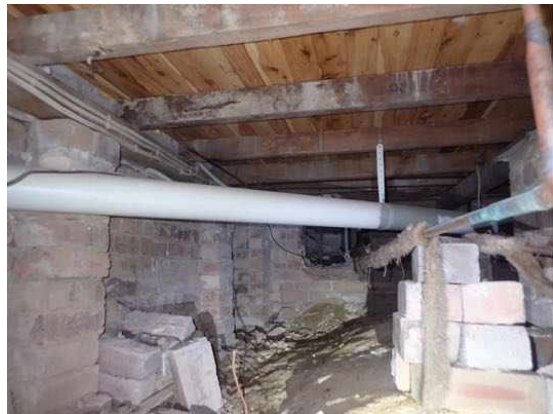
Finding: Additional Photos - Information Only

Information: Additional photographs of the roof exterior, roof void & subfloor (when accessible) are provided for general reference.
